John Fisher Park Telecommunications Facility-
Arboricultural Impact Assessment

Project Name	John Fisher Park Telecommunications Facility - Arboricultural Impact Assessment
Project Number	19SUT-12623
Project Manager	Elizabeth Hannon
Prepared by	Elizabeth Hannon
Reviewed by	Beth Medway
Approved by	Beth Medway
Status	Final
Version Number	v1
Last saved on	23 July 2019

Eco Logical Australia Pty Ltd (ELA) was engaged by Urbis to prepare an Arboricultural Impact Assessment (AIA) to form part of a Development Application (DA) for the development of a telecommunications facility in John Fisher Park, Curl Curl. Urbis propose to submit a DA to Northern Beaches Council on behalf of Optus, under Part 4 of the *Environmental Planning and Assessment Act 1979* (EP&A Act).

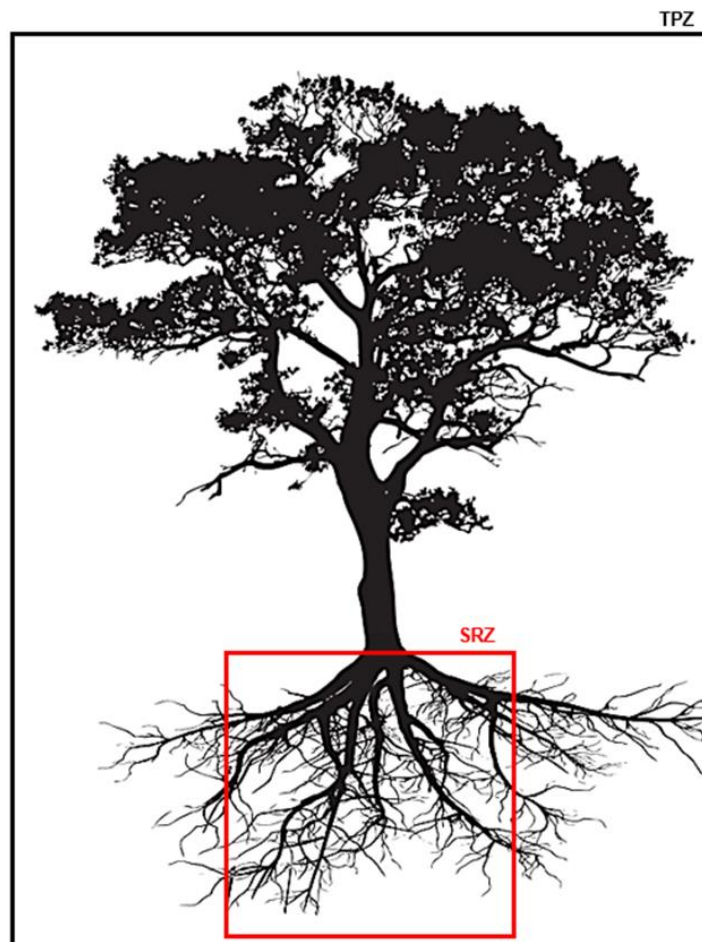
Figure 1: Indicative TPZ and SRZ

The TPZ is the combination of crown and root area (as defined by AS 4970-2009) that requires restriction of access during the construction process. Tree sensitive construction measures must be implemented if works are to proceed within the Tree Protection Zone.

The SRZ is the area of the root system (as defined by AS 4970-2009) used for stability, mechanical support and anchorage of the tree. It is critical for the support and stability of trees. Severance of roots within the SRZ is not recommended as it may lead to the destabilisation and/or decline of the tree.

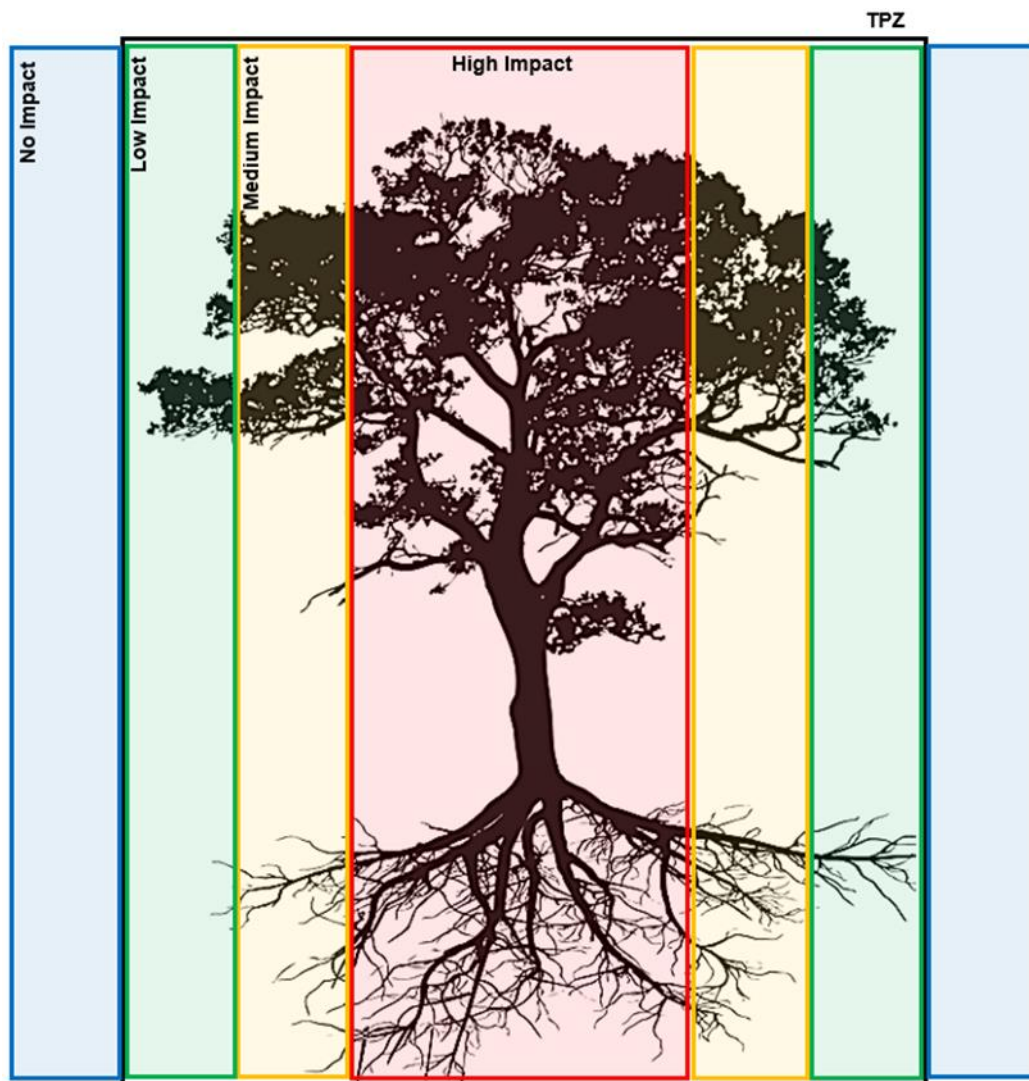
Figure 2: Indicative zones of impact

Trees may be impacted by cutting or damaging roots or branches. Impacts to the tree protection zones are determined by the percentage of the area that the development incurs into the tree protection zone. The following are the definition of these impacts:

- **High impact:** The SRZ may be impacted if the proposed encroachment is greater than 20 % of the TPZ. Trees may not remain viable if they are subject to high impact.
- **Medium impact:** If the proposed encroachment is greater than 10% of the TPZ and outside of the SRZ, the project arborist may require detailed root investigation to demonstrate that the tree(s) would remain viable.
- **Low impact:** If the proposed encroachment is less than 10% (total area) of the TPZ, and outside of the SRZ, detailed root investigations should not be required.
- **No impact:** No likely or foreseeable encroachment within the TPZ.

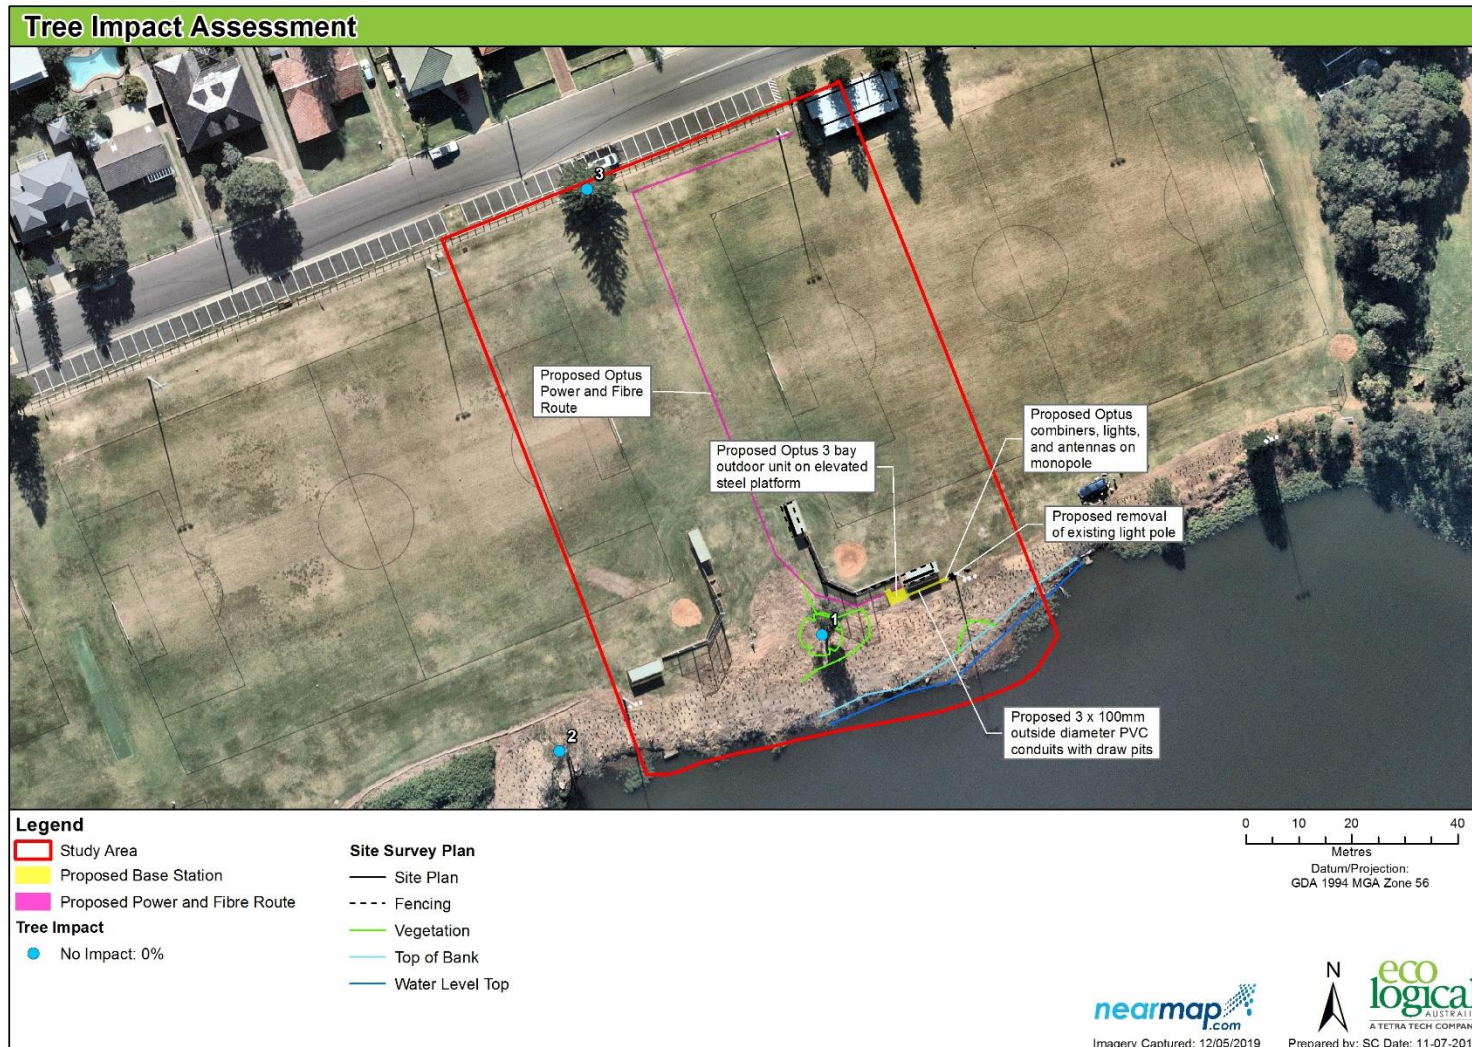
Figure 3: Tree impact map

Results of the arboricultural assessment are tabulated and mapped in Appendix A and Table 1.

- **No impact:** Under the current proposal, all three trees can be successfully retained. These have the following retention values:
 - **one** tree with a low retention value
 - **two** trees with a medium retention value

NO	SCIENTIFIC NAME	HEIGHT	SPREAD	DBHMM	HEALTH	STRUCTURE	NOTES	RETENTION VALUE	SRZ (m)	TPZ (m)	IMPACTS
1	<i>Banksia integrifolia</i>	10	7	560	Good	Fair		Medium	2.59	6.72	No Impact
2	<i>Banksia integrifolia</i>	12	11	750	Poor	Fair	Sparse	Low	2.93	9	No Impact
3	<i>Araucaria hetereophylla</i>	12	10	500	Fair	Fair		Medium	2.47	6	No Impact

Tree protection measures should be implemented by the contractor and would include:

- Tree protection fencing must be established around the perimeter of the TPZ. If the protective fencing requires temporary removal, trunk, branch and ground protection must be installed and must comply with *AS 4970-2009 - Protection of trees on development sites*. Existing fencing and site hoarding may be used as tree protection fencing.
- If temporary access for machinery is required within the TPZ, ground protection measures will be required. The purpose of ground protection is to prevent root damage and soil compaction within the TPZ. Ground protection may include a permeable membrane such as geotextile fabric beneath a layer of mulch, crushed rock or rumble boards.
- Any additional construction activities within the TPZ of the subject trees must be assessed and approved by the project arborist and must comply with *AS 4970-2009 - Protection of trees on development sites*.

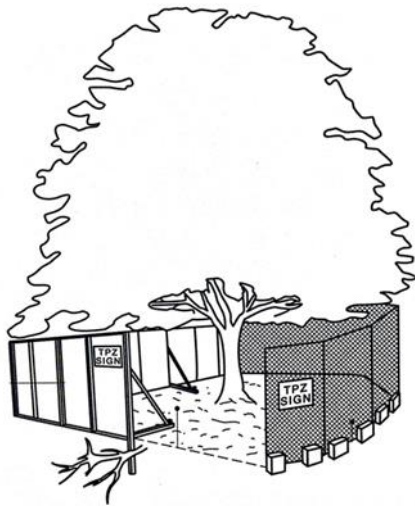
Tree protection fencing

Trees that are to be retained must have protective fencing erected around the TPZ (or as specified in the body of the report) to protect and isolate it from the construction works. Fencing must comply with the Australian Standard, AS 4687-2007, Temporary fencing and hoardings.

- Enclosed to the full extent of the TPZ (or as specified in the Recommendations and Tree Protection Plan).
- Cyclone chain wire link fence or similar, with lockable access gates.
- Certified and Inspected by the Project Arborist.
- Installed prior to the commencement of works.
- Prominently signposted with 300mm x 450mm boards stating "NO ACCESS - TREE PROTECTION ZONE".

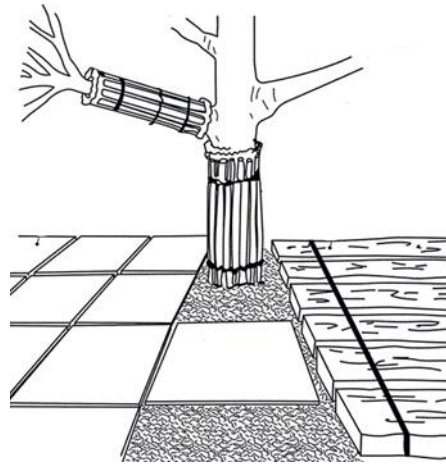
Trunk protection fencing

Trunk protection shall consist of a layer of either carpet underfelt, geotextile fabric or similar wrapped around the trunk, followed by 1.8 m lengths of softwood timbers aligned vertically and spaced evenly around the trunk (with an approx. 50 mm gap between the timbers).

The timbers must be secured using galvanised hoop strap (aluminium strapping). The timbers shall be wrapped around the trunk but not fixed to the tree, as this will cause injury/damage to the tree.
