# Preliminary Site Investigation

1010-1014 Pittwater Road, Collaroy NSW 2097

**Report No:** E26053.E01\_Rev1

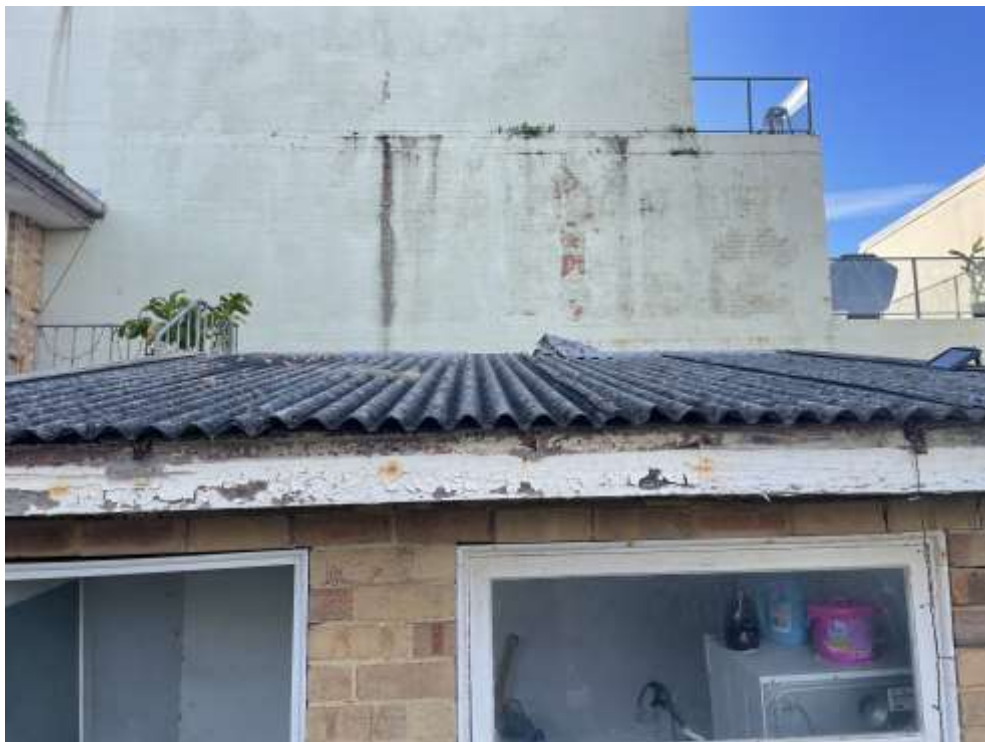
- The internal area of DK Design Kitchens was observed to have been through modern renovations;
- The eastern yard area consisted of a detached laundry and toilet brick structure. Suspected corrugated ACM roofing was evident, observed to be in fair conditions (**Photograph 4**);

**Photograph 4:** Image of the suspected corrugated ACM roof of the detached laundry on Lot 2 DP 314645 (photographed 9/6/2023).

- Before commencement of demolition works, a hazardous materials survey (HMS) should be completed by a suitably qualified consultant, to identify any hazardous materials present within the existing building fabrics;

- All identified hazardous materials must be appropriately managed, to maintain worker health and safety during demolition works and to prevent the spread of potentially hazardous substances onto the site and soil surfaces.

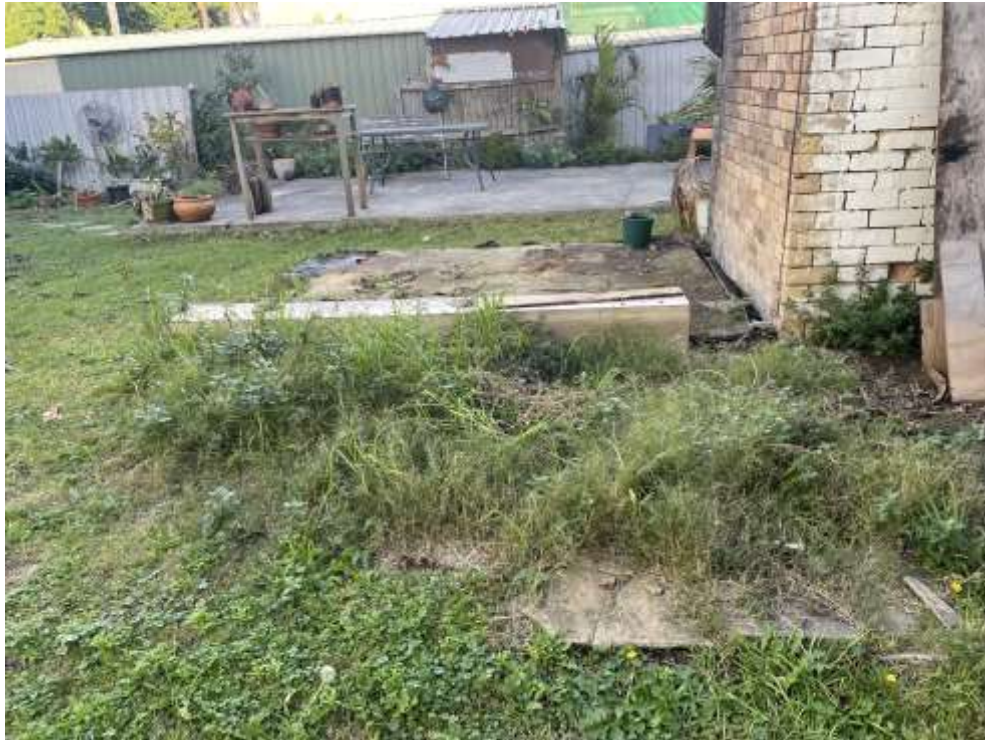
- Aerial imagery shows that the suspected ACM roofing may also be present on the main building;
- Grassed surfaces were observed to be generally well kept. However, overgrown areas were observed along the concrete slabs (**Photograph 5**);

**Photograph 5:** Image of remnant shed footprint concrete slab on Lot 2 DP 314645 (photographed 9/6/2023).

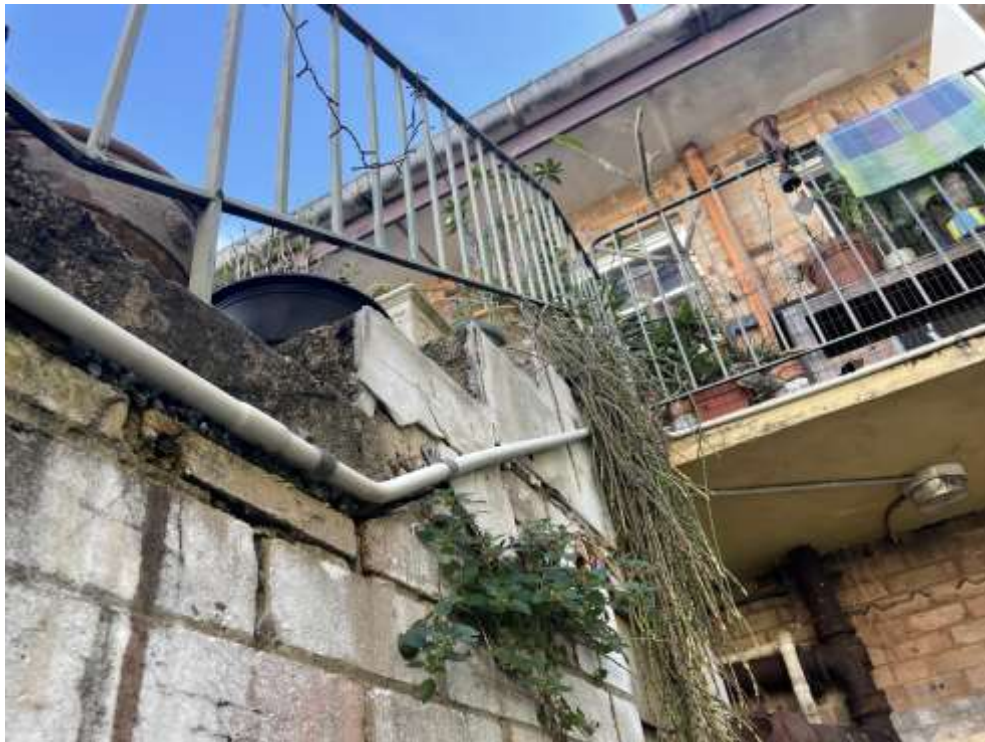
- Suspected ACM formwork sheeting was observed along the external northern vertical brick staircase wall, which leads up to the residential apartments (**Photograph 6**);

**Photograph 6:** Image of suspected ACM sheeting attached to brick formwork on Lot 2 DP 314645 (photographed 9/6/2023).

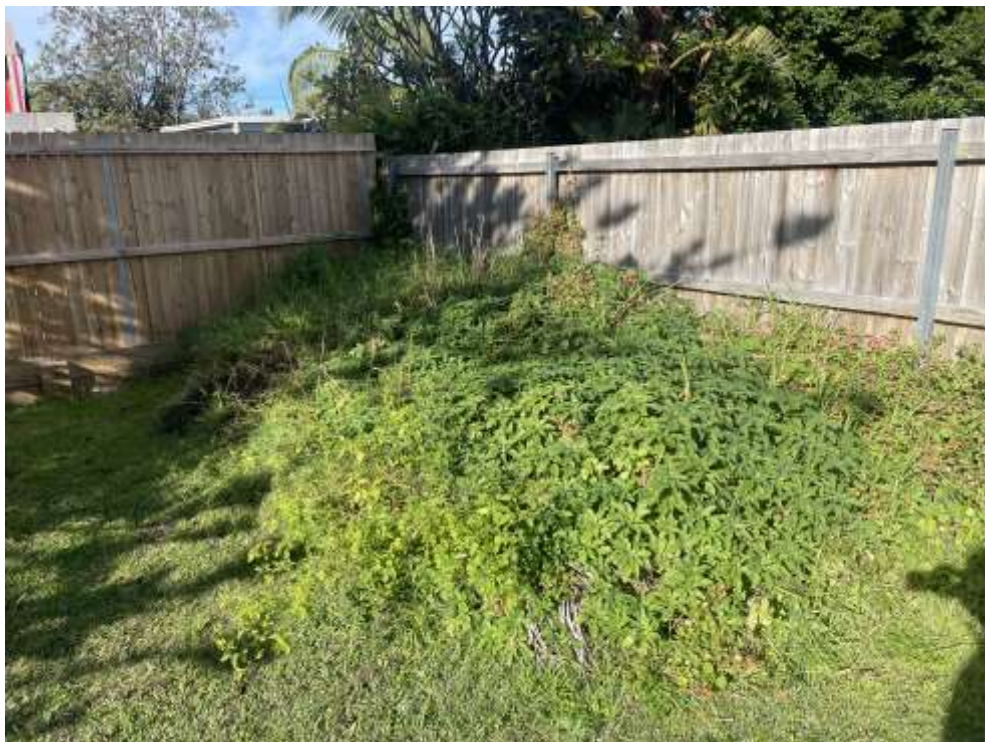
- An unknown stockpile was observed on the south-eastern site boundary, which was covered predominantly by vegetation. Minor bare patches indicate the stockpile consists of silty sand soil, with anthropogenic material such as concrete. Anecdotal information from the tenant suggests it may have been generated by the previous tenant through gardening activities (lawn clippings) (**Photograph 12**);

**Photograph 12:** Image of stockpiled material along south-eastern boundary at Lot 3 DP 6777.

- A Construction Environmental Management Plan (CEMP) for the excavation, waste classification, and handling of all soils from the site should be developed. The CEMP should be prepared in accordance with relevant Northern Beaches Council DCPs and development consent conditions. The CEMP should include provisions for the management of waste soils including, but not limited to:

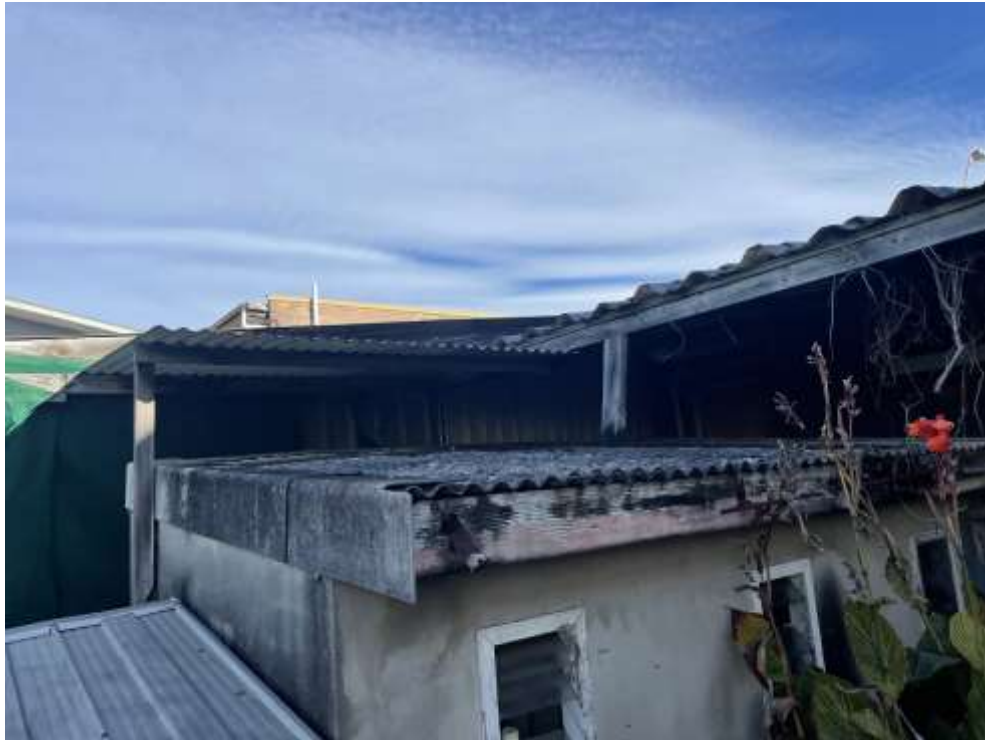
- Brick and concrete pavement was evident under the shed footprints and central section of the site, which was observed to be in fair condition;
- Suspected ACM roofing/gutters/capping and walls were observed on the detached shed on the northern side of the lot. Minor cracks and signs of deterioration were noted (**Photograph 13**);

**Photograph 13:** Image of suspected ACM roofing on the north-western shed at Lot 3 DP 6777.

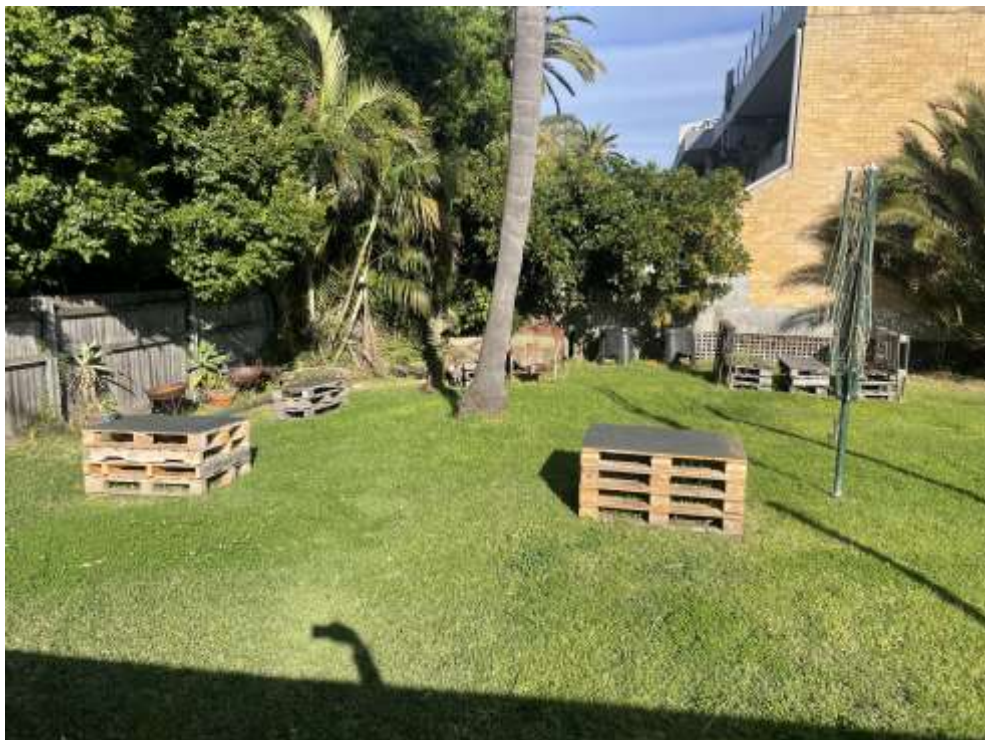
- An overgrown vegetated area was noted on the south-eastern corner of the lot. The ground surface was not visible (**Photograph 16**);
- No visual evidences of infrastructure associated with an underground petroleum storage systems (UPSS) were observed on the lot.

**Photograph 16:** Image of eastern yard area of Lot 4 DP 6777.

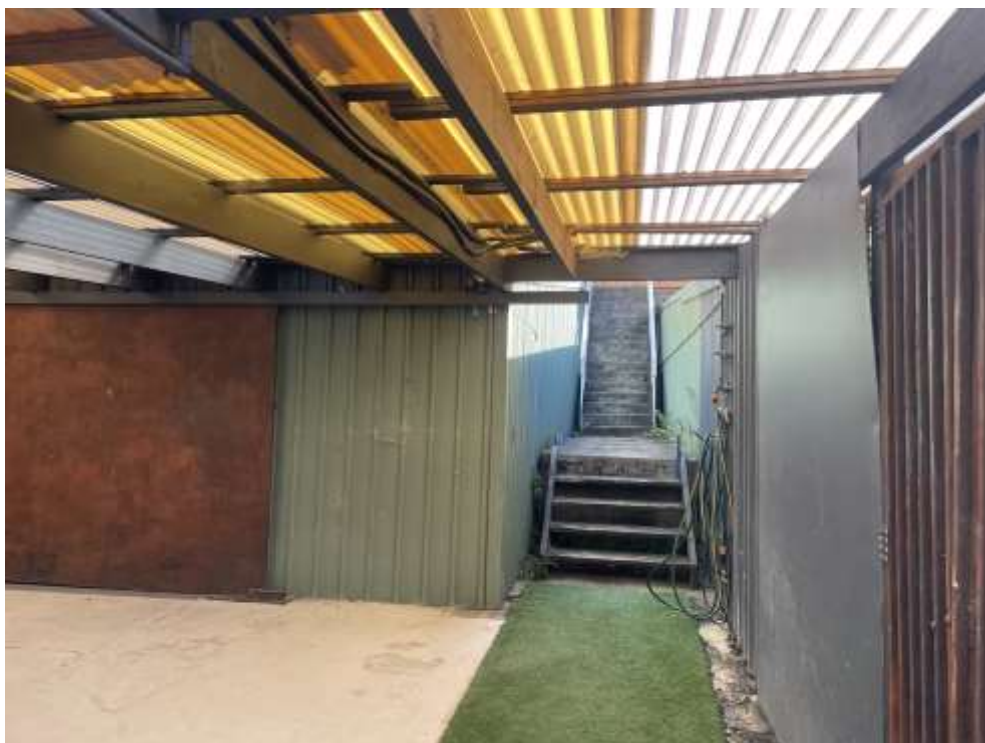
- Furthermore, the western shop front had deteriorated signage indicating that the units were previously occupied by a paint shop;
- Two large metal green sheds were adjacent to the eastern side of the building, and centrally located within the property. These were inaccessible at the time of the inspection (**Photograph 18**);

**Photograph 18:** Image of sheds within Lot 4 DP 6777.
