## **4 Southern Cross Way, Allambie Heights**

### Geotechnical Comments for Section 4.55

## **GEOTECHNICAL INVESTIGATION:**

New House, Granny Flat & Studio at **4 Southern Cross Way, Allambie Heights**

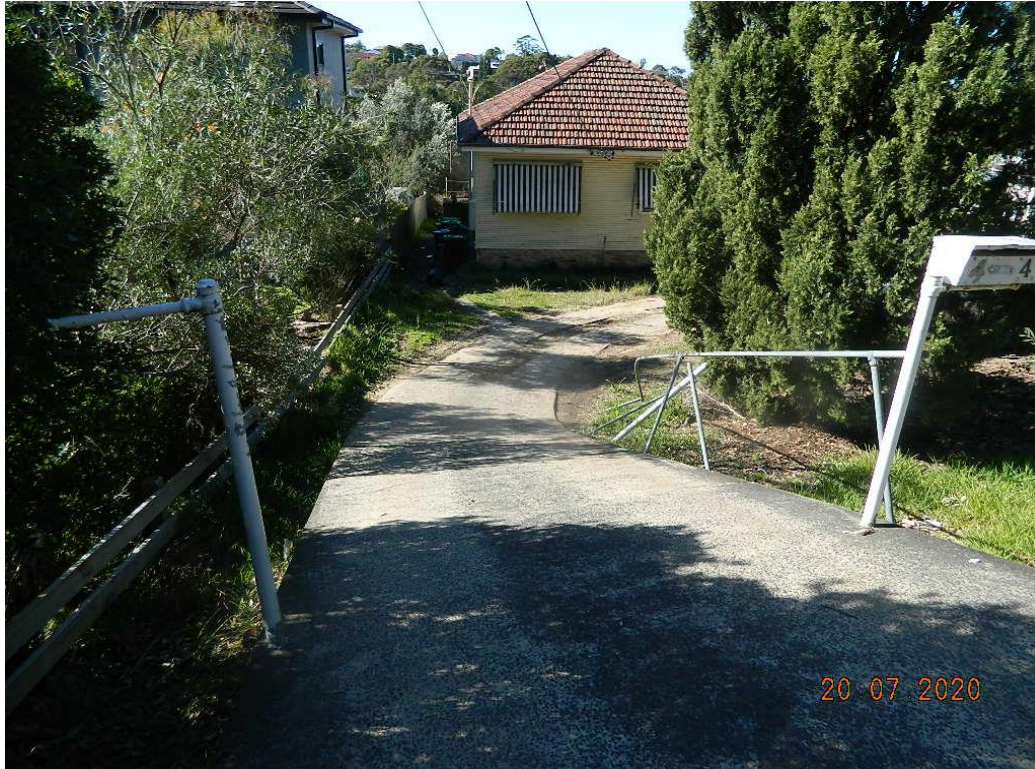
Photo 1

**2.3** At the road frontage a concrete and concrete stripped driveway runs down the slope to a carport beside the existing house (Photos 1 & 2). Sandstone is exposed at the surface under the carport (Photo 3). The part two storey brick and weatherboard clad house is supported by brick walls and brick piers (Photos 4 & 5). The supporting walls and piers stand vertical and show no significant signs of movement (Photo 6). Competent Medium Strength Sandstone bedrock is outcropping on the slope on the downhill side of the property (Photo 7). Stable low sandstone block retaining walls support fill on the downhill side of the house and carport (Photo 8). No signs of slope instability were observed on the property. The adjoining neighbouring properties were observed to be in good order as seen from the street and subject property
