## **REPORT ON GEOTECHNICAL SITE INVESTIGATION**

### **LONG REEF SURF LIFE SAVING CLUB, COLLAROY**

**Northern Beaches Council**

**Project No.: 2017-235**

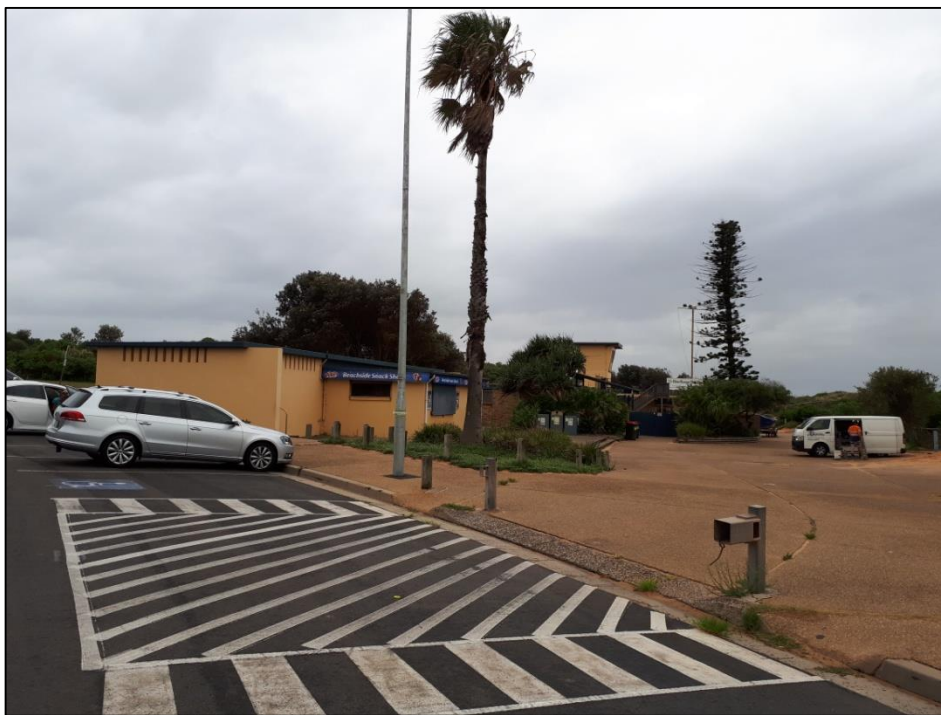
Currently, there is a single storey 1960s style brick Club House on the site with public amenities and shop contained within a separate brick structure, as shown below in Photograph 1:

*Photograph 1: The existing Club House on site, view looking east*

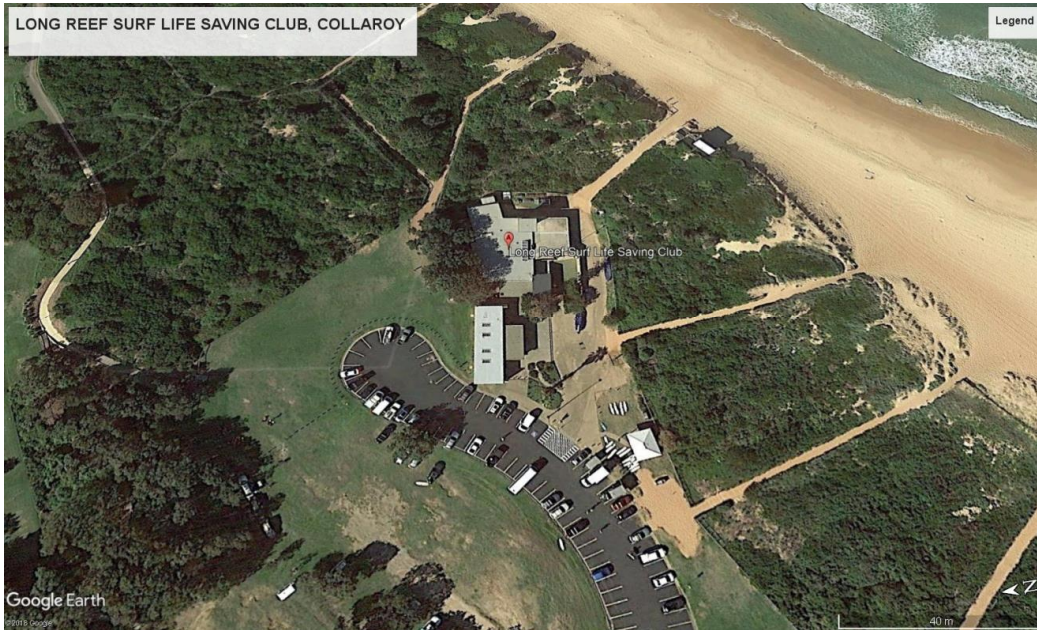
Photograph 2: Aerial view of site, courtesy Google Earth Maps.

The site is located within 200 m of Dee Why Lagoon and 70 m of Long Reef Beach. It is located at the base of a slope pediment that runs from a south east striking ridge that initiates on Collaroy Plateau. It is at about where colluvial slope wash materials, lagoonal and surf beach sediments accumulate above the incised bedrock. The existing site has an average surface slope angle of  $-04^{\circ}/172^{\circ}\text{mN}$ .
