Report Title: Geotechnical Report 1772 Pittwater Road, Bayview

GEOTECHNICAL INVESTIGATION:

New House and Pool at 1772 Pittwater Road, Bayview

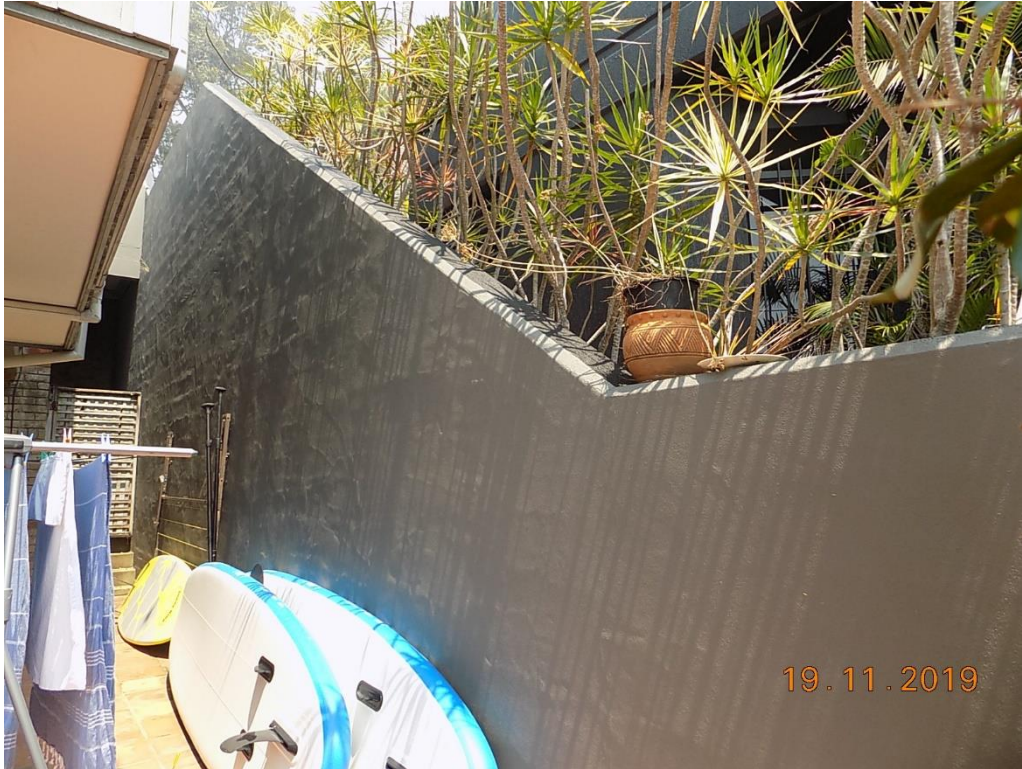
Photo 5

- 2.3** At the road frontage, a concrete driveway runs to a suspended parking platform and lawn area on the uphill side of the property (Photo 1). The platform is supported by steel posts over the old brick driveway (Photo 2). The cut for this sub-floor area is supported by a ~2.0m high stable concrete retaining wall (Photo 3). The part three-storey brick house will be demolished as part of the proposed works (Photo 4). The cut for the house is supported by a ~5.3m high rendered masonry retaining wall that lines the NW common boundary (Photo 5). A gently sloping lawn-

The excavations will reach a maximum depth of ~2.2m deep and will come flush with the NW and upper common boundary. The retaining walls that line these boundaries will be within the zones of influence of the proposed excavations (Photo 5).

Where the retaining walls fall within the zone of influence of the excavation, exploration pits in these locations will need to be put down by the builder to determine the foundation depth and material. The pits are to be inspected by the geotechnical consultant.

If the walls are found to be supported below the base of the proposed excavations, the excavations may commence. If they are not supported below the base of the proposed excavations, the walls will need to be underpinned prior to the excavations commencing.

Underpinning is to follow the underpinning sequence 'hit one miss two'. Under no circumstances is the bulk excavation to be taken to the edges of the walls or piers and then underpinned. Underpins are to be constructed from drives that should not exceed 0.6m in width along brick footings but should be proportioned according to footing type and size. Allowances are to be made for drainage through the underpinning to prevent a build-up of hydrostatic pressure. Underpins that are not designed as retaining walls are to be supported by retaining walls. The void between the retaining walls and the underpinning is to be filled with free-draining material such as gravel.

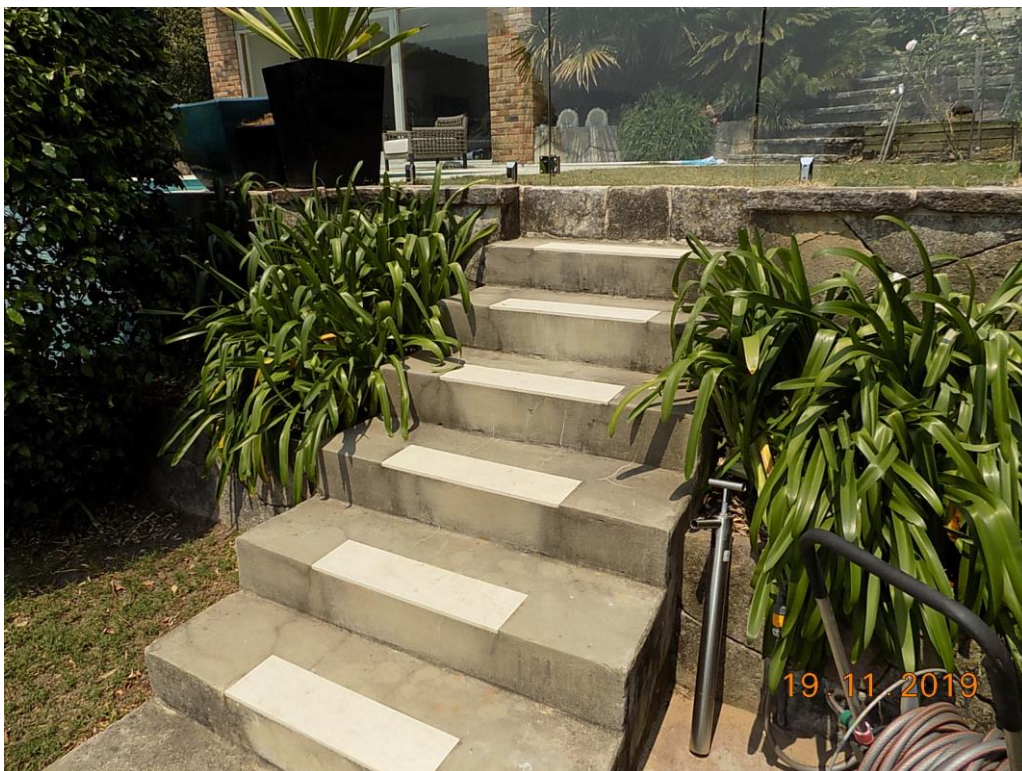
Photo 6

covered fill extends off the downhill side of the house. The fill is supported by a ~1.0m high stack rock retaining wall that will be demolished as part of the proposed works (Photo 6). To the SE of the fill is a pool that will also be demolished as part of the proposed works (Photo 7). Below the fill and the pool, a gently sloping lawn falls to a beach at the waterfront (Photo 8).
