GEOTECHNICAL INVESTIGATION

PROPOSED ALTERATIONS AND ADDITIONS

22 HAY STREET, COLLAROY, NSW

Ref: 31892Yrpt

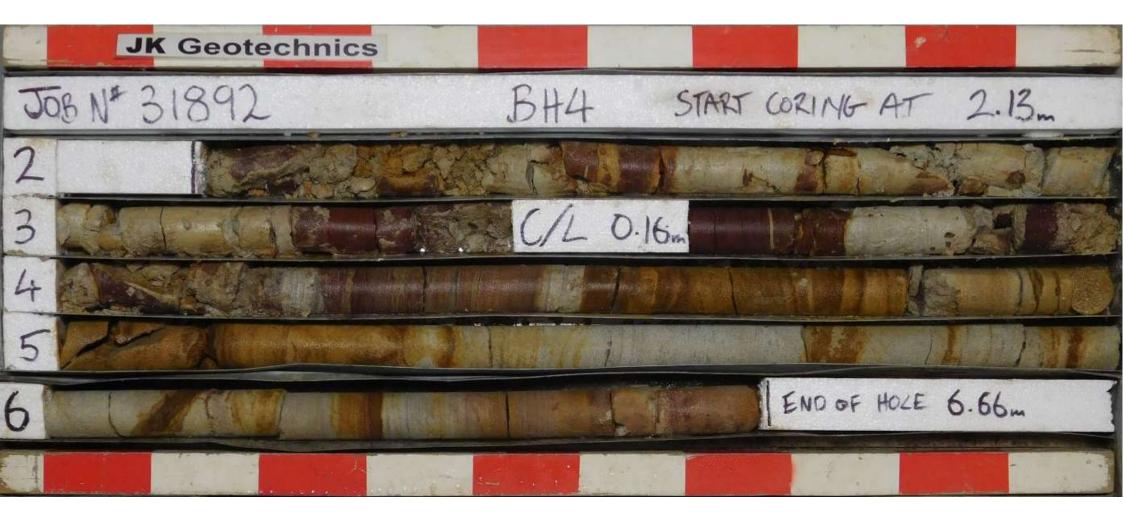
_	_												_
					CORE DESCRIPTION				NT LO				DEFECT DETAILS	1
Water Loss\Level	Barrel Lift	RL (m AHD)	Depth (m)	Graphic Log	Rock Type, grain characteristics, colour, texture and fabric, features, inclusions and minor components	Weathering	Strength	ll li	NDEX I _s (50)	Κ	•	m)	DESCRIPTION Type, orientation, defect roughness and shape, defect coatings and seams, openness and thickness Specific General	Formation
		40 —	- - - - - - - - 2		START CORING AT 2.10m	LIM							- - - - - - -

71.2 ZU18-04-02 Prj. J.K. 9.01.0 ZU18-03-ZU		39-	3-		SANDSTONE: fine to medium grained, light grey mauve, with medium strength iron indurated bands and extremely weathered bands.	HW	VL - L						(2.20m) J, 80°, Ir, XWS 5mm.t (2.36m) XWS, 0°, 120 mm.t (2.52m) J, 90°, Ir, XWS 5mm.t (2.54m) J, 90°, Ir, Fe Ct, I mm.t (2.57m) XWS, 0°, 37 mm.t (2.86m) J, 75°, Ir, Fe Sn (2.87m) XWS, 0°, 370 mm.t (3.87m) XWS, 0°, 370 mm.t (3.88m) J, 85°, XWS 5mm.t	Narrabeen Group
الا ه.د د		_	_		NO CORE 0.16m					_		-	-	╙
TASTER 518626V COLLANOV GPG **C-DRAWING-NESS** VOTATIZOUS 11:31 10:0000 L0008 and in Stati 10st - DGD L00: AR 90'1 & Z.019-04-22 Prj. JR 90'1 J.Z.019-05-20 1000 Million 1000 Milli	ות נסויות	38 37 36	4—		SANDSTONE: fine to medium grained, light grey mauve, with medium strength iron indurated bands and extremely weathered bands. SANDSTONE: fine to medium grained, light grey with orange staining.		L						(3.64m) J, 90°, P, Fe Ct, 1 mm.t (3.74m) XWS, 0°, 160 mm.t (3.97m) J, 90°, Ir, XWS SANDSTONE 5mm.t (4.10m) J, 75°, St, XWS SANDSTONE 5mm.t (4.20m) XWS, 0°, 50 mm.t (4.62m) J, 75°, St, Cn (5.05m) J, 75°, St, Fe Vn (6.12m) J, 45°, P, Fe, 10 mm.t (6.52m) CS, 0°, 40 mm.t	Narrabeen Group

JK 9.01; Z LIB/SLB Log JK CORED BOREHOLE - MAS/EK		35	- - 7 - - - - - - - -		END OF BOREHOLE AT 6.66 m							- 88	- - - - - - - - -

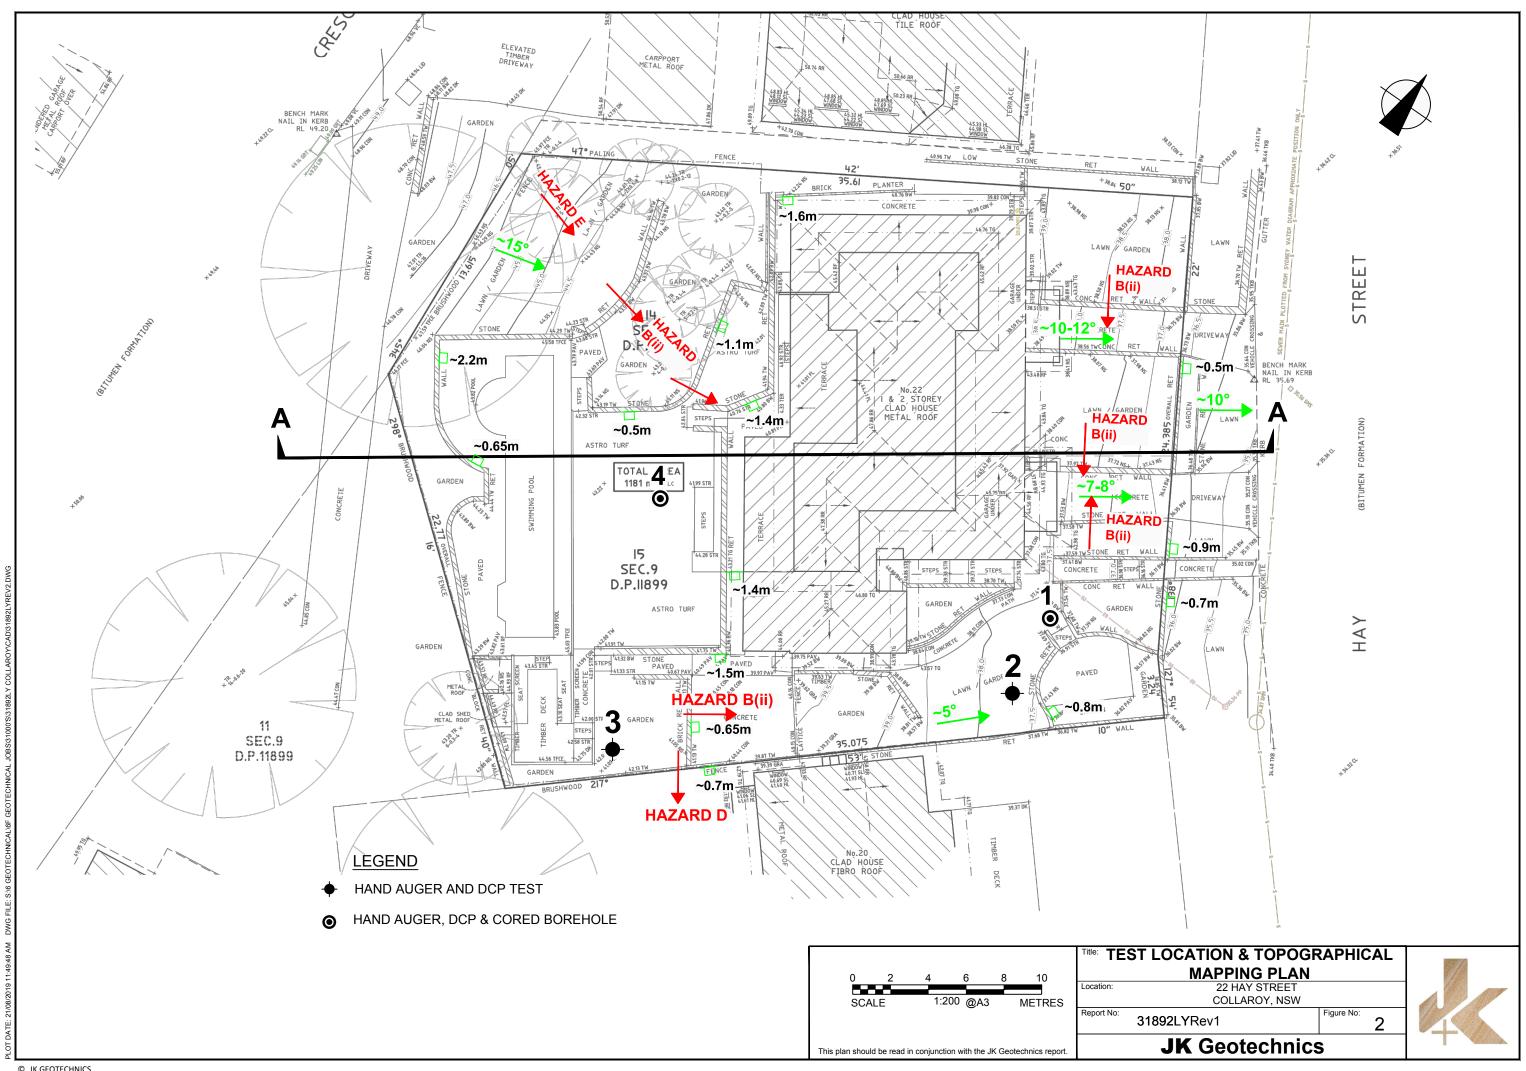
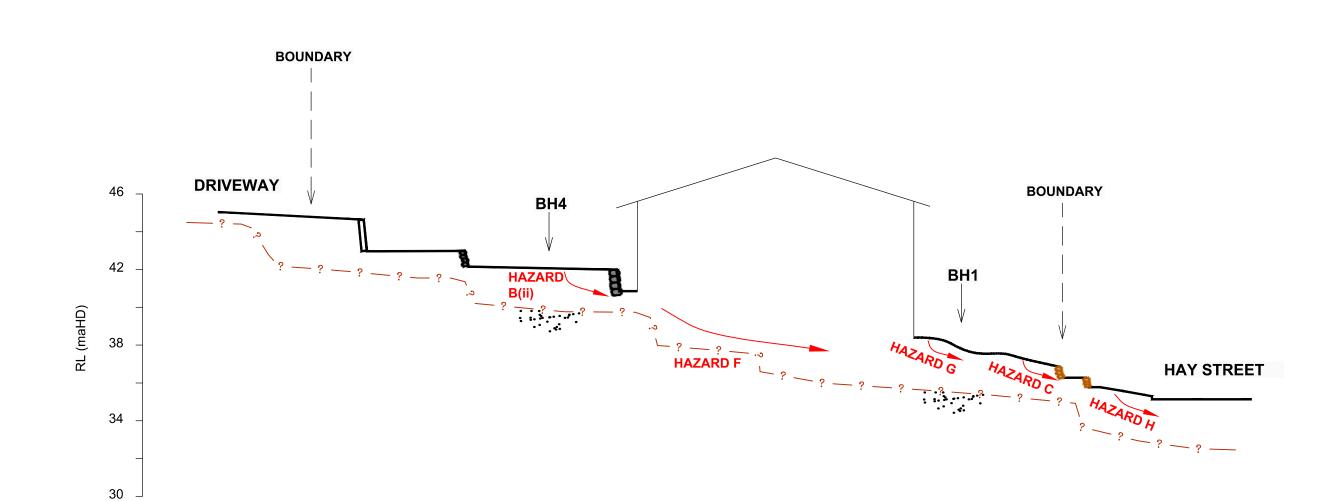
The attached Figure 2 presents a geotechnical sketch plan showing the principal geotechnical features present at the site. Figure 2 is based on the survey plan prepared by CMS Surveyors Pty Ltd (Drawing Name 17755detail, Issue 1, dated 9 May 2018). Additional features on Figure 2 have been measured by hand held clinometer and tape measure techniques and hence are approximate only. Should any of the features be critical, we recommend they be located more accurately using instrument survey techniques. Figure 3 presents a typical cross-section through the site based on the survey data augmented by our mapping observations.

Some of these potential hazards are indicated in schematic form on the attached Figure 2.

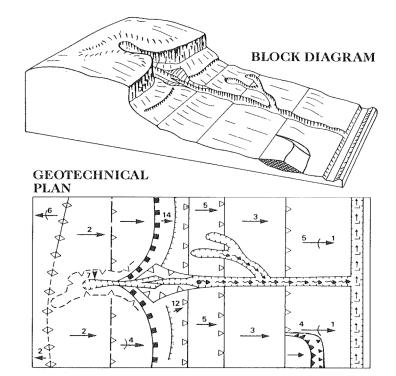
EXAMPLE OF USE OF TOPOGRAPHIC SYMBOLS:

(After Gardiner, V & Dackombe, R.V. (1983), Geomorphological Field Manual; George Allen & Unwin).

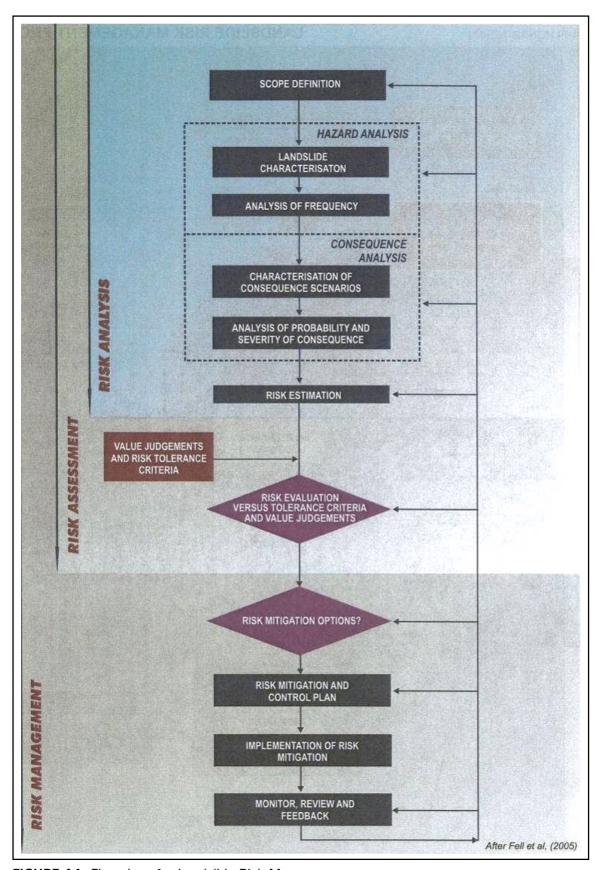
FIGURE A1: Flowchart for Landslide Risk Management.

This figure is an extract from GUIDELINE FOR LANDSLIDE SUSCEPTIBILITY, HAZARD AND RISK ZONING FOR LAND USE PLANNING, as presented in Australian Geomechanics Vol 42, No 1, March 2007, which discusses the matter more fully.

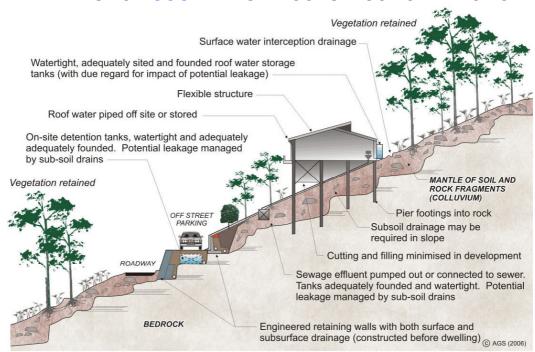
EXAMPLES FOR GOOD HILLSIDE CONSTRUCTION PRACTICE

Roadways and parking areas - are paved and incorporate kerbs which prevent water discharging straight into the hillside (GeoGuide LR5).

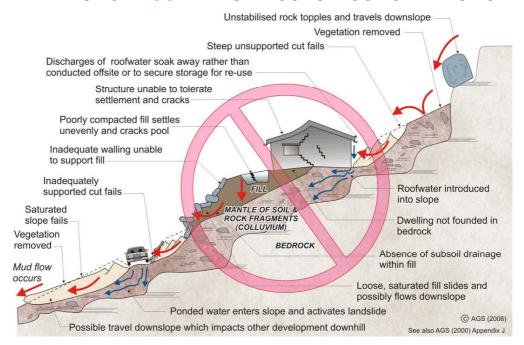
EXAMPLES FOR POOR HILLSIDE CONSTRUCTION PRACTICE

Roadways and parking areas - are unsurfaced and lack proper table drains (gutters) causing surface water to pond and soaks into the ground.
