GEOTECHNICAL INVESTIGATION:

Alterations and Additions at 19 Tor Road, Dee Why

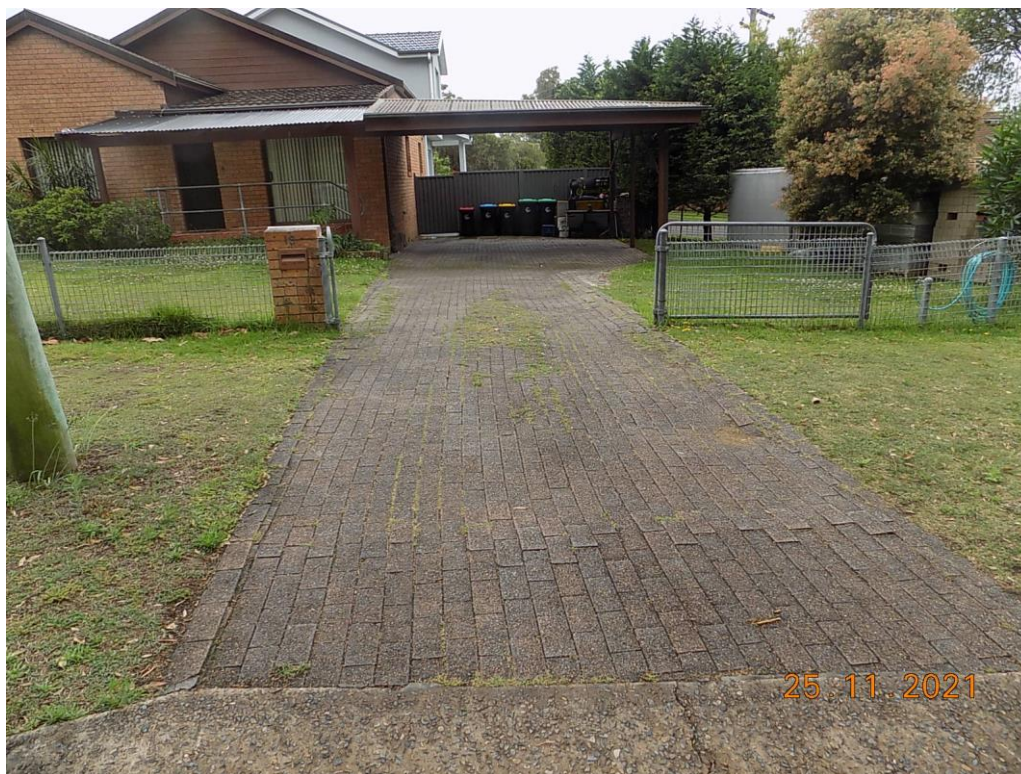
Photo 1

- 2.1** The site was inspected on the 25th November, 2021.
- 2.2** This residential property is on the corner of Tor Road and Stoddart Place. It is on the N side of Tor Road and is on the SW side of Stoddart Place. The property has a NE aspect. It is located on the gently graded lower reaches of a hillslope. The slope above and below the property continues at gentle angles.
- 2.3** At the road frontage to Tor Road, a brick-paved driveway runs to a stable carport attached to the E side of the house (Photo 1). Between both road frontages and the house are gently sloping lawn areas (Photos 2 & 3). The part two-storey brick house is supported on brick walls and brick piers (Photo 4). The external supporting walls show no significant signs of movement and the visible piers stand vertical.

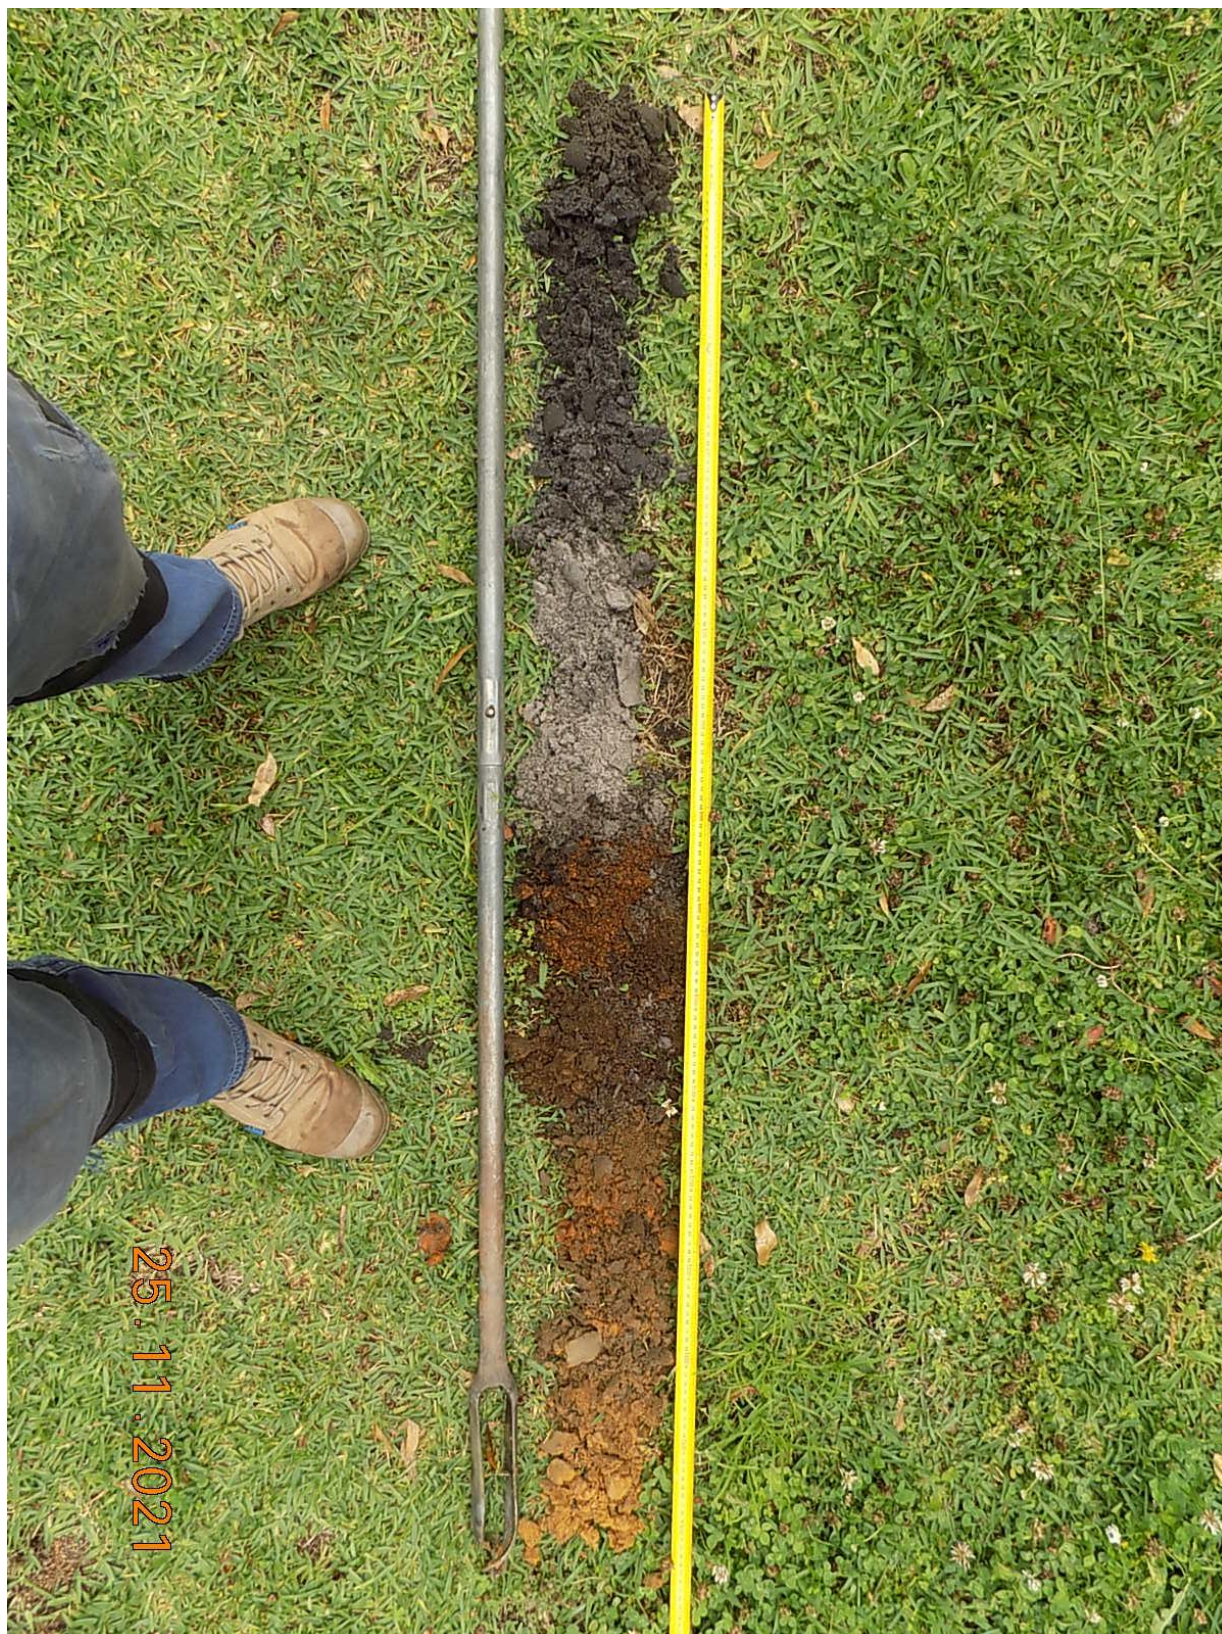
Photo 5: AH1 – Downhole is from left to right.

AUGER HOLE 1 (~RL19.1) – AH1 (Photo 5)

Depth (m)	Material Encountered
0.0 to 0.2	TOPSOIL , sandy soil, dark brown, loose, dry, fine to coarse grained with fine trace organic matter.
0.2 to 0.5	SAND , dark grey, loose, dry, coarse grained.
0.5 to 0.8	SAND , grey, loose to medium dense, dry, coarse grained.
0.8 to 1.4	SAND , grey, dark brown, brown, and orange, medium dense to dense, dry, coarse grained.
1.4 to 1.6	CLAYEY SAND , derived from weathered sandstone, brown, medium dense, dry, coarse grained with a sugary texture.

End of hole @ 1.6m in Medium Dense Clayey Sand. No water table encountered.
