Waterway Impact Assessment

255 Condamine St., Manly Vale, NSW

Report P1605609JR08

December 2021

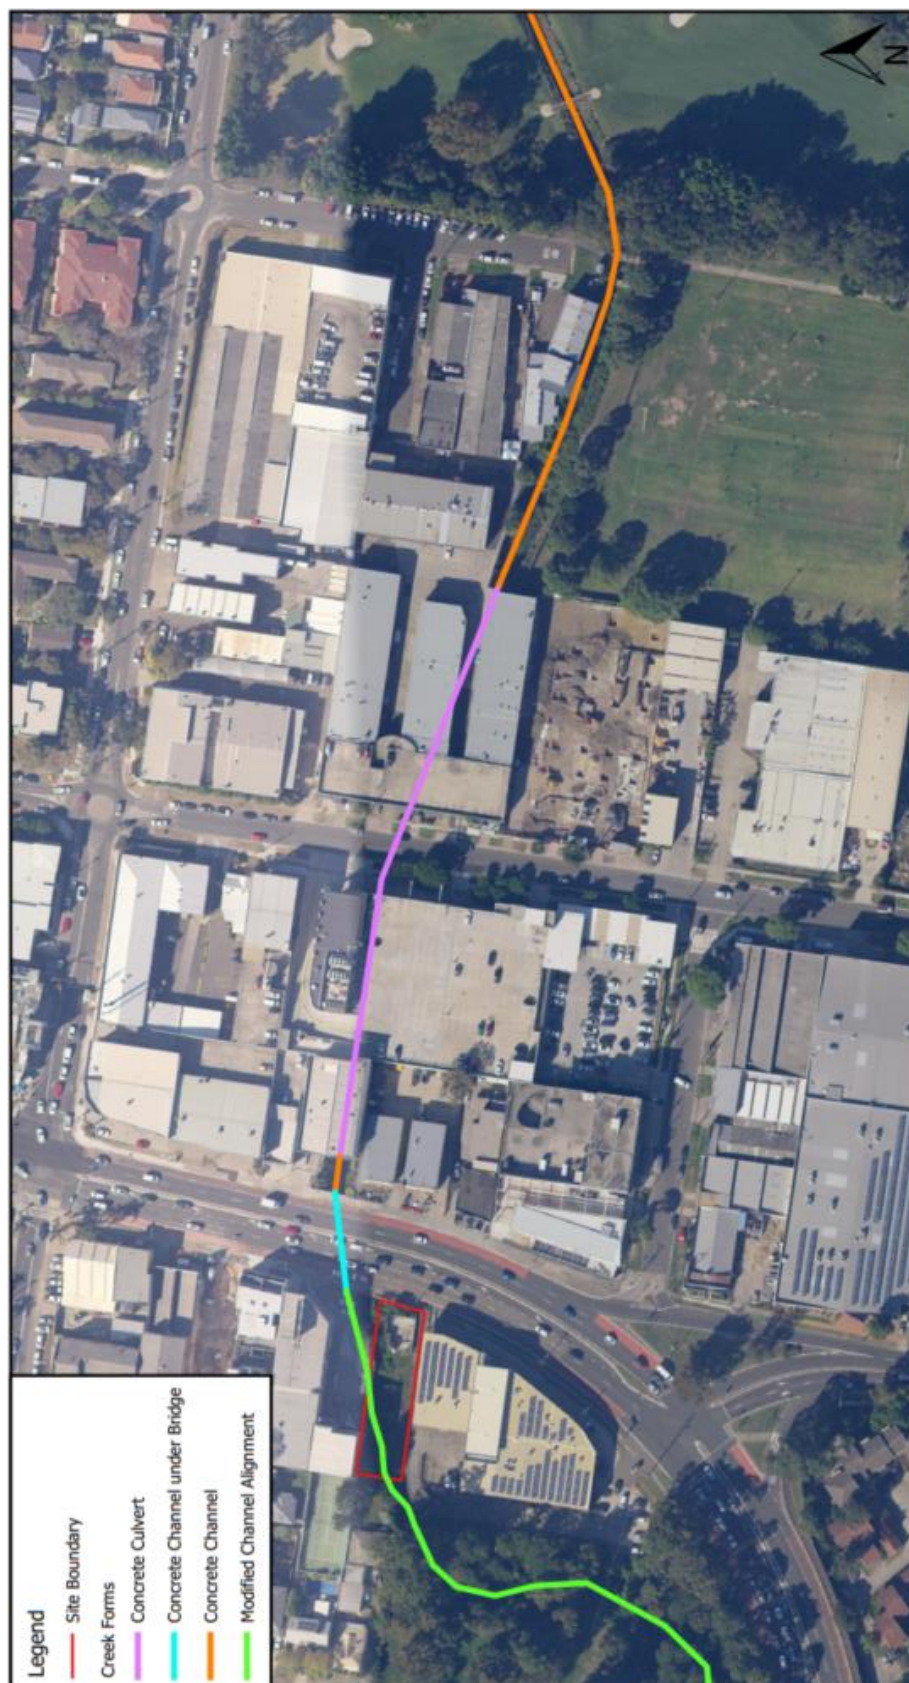
Figure 2: Burnt Bridge Creek channel treatment.

Significant modifications have been made to Burnt Bridge Creek upstream and downstream of the Site, with an overview of channel treatments provided at Figure 2. The following is noted:

1. Burnt Bridge Creek within the site is not a natural channel because the creek has previously been diverted through the site and built as a constructed channel. Downstream of the Site, the channel is bedrock controlled on the bed and concrete lined on the banks under the Condamine Street bridge (refer to Figure 3) and then completely concrete enclosed and piped under 206 Condamine Street and 31 and 28-34 Roseberry Street downslope of the bridge (refer to Figure 2 and Figure 4).
2. Upstream of the Site the channel has been historically realigned (refer to Figure 5 for position of historical alignment), with the northern bank

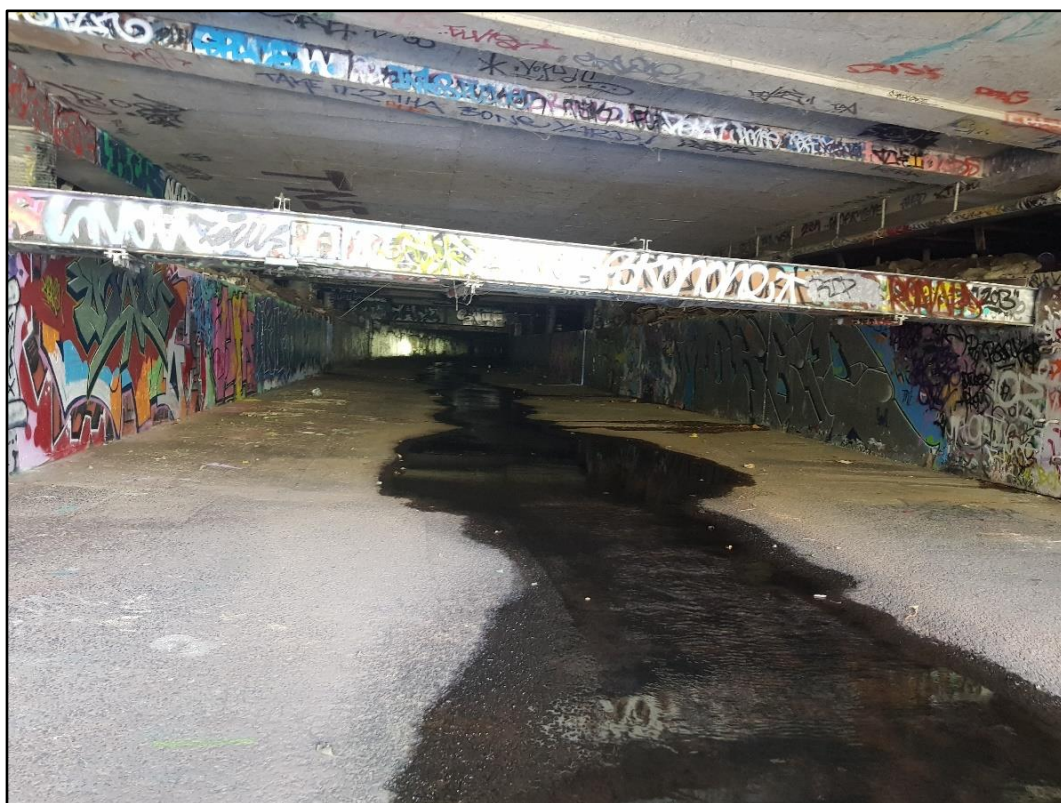
Figure 4: Burnt Bridge Creek culvert below 206 Condamine St.

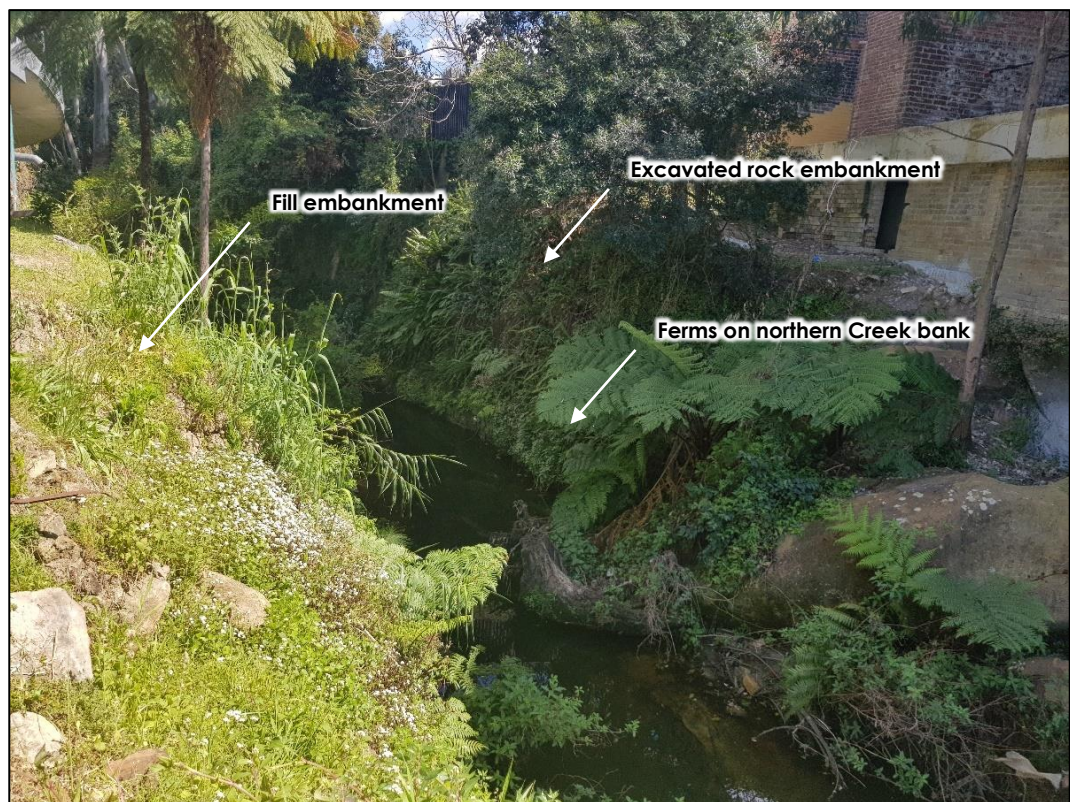
Figure 6: Burnt Bridge Creek immediately upstream of Site.

being cut into rock and soil to form near vertical embankments (refer to Figure 6).

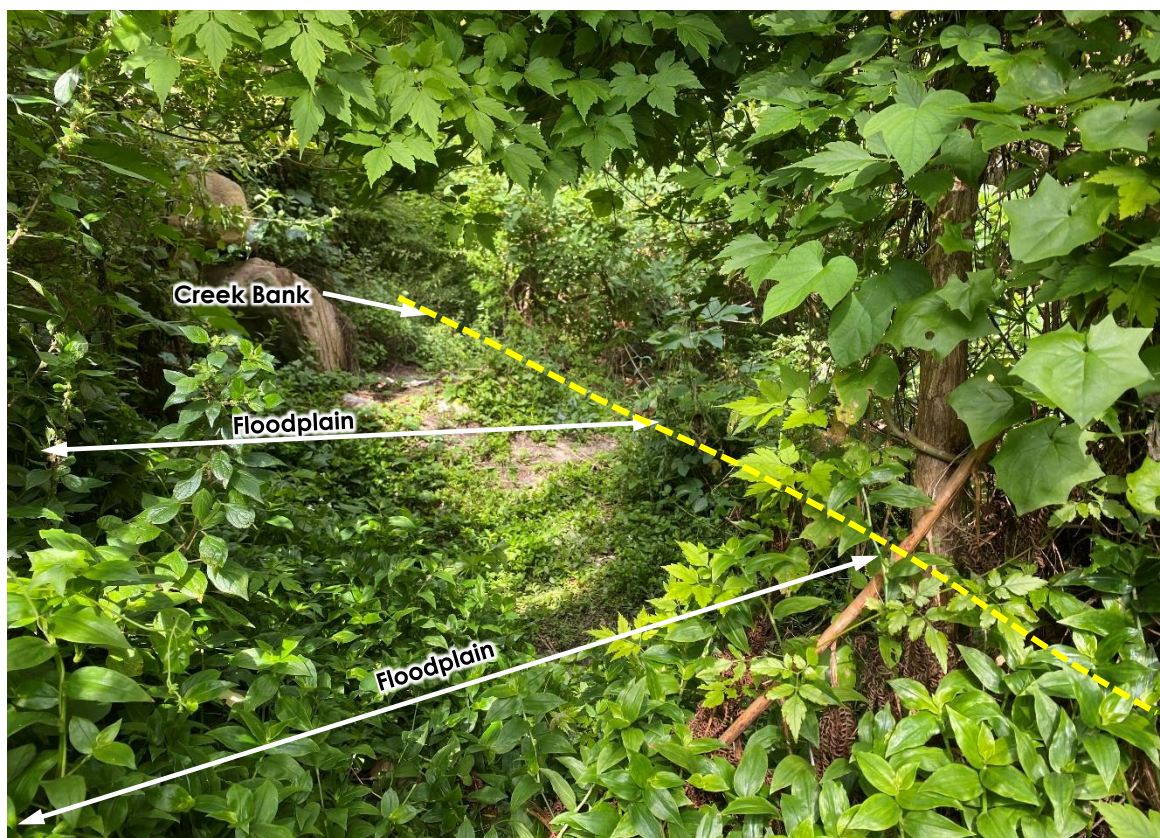
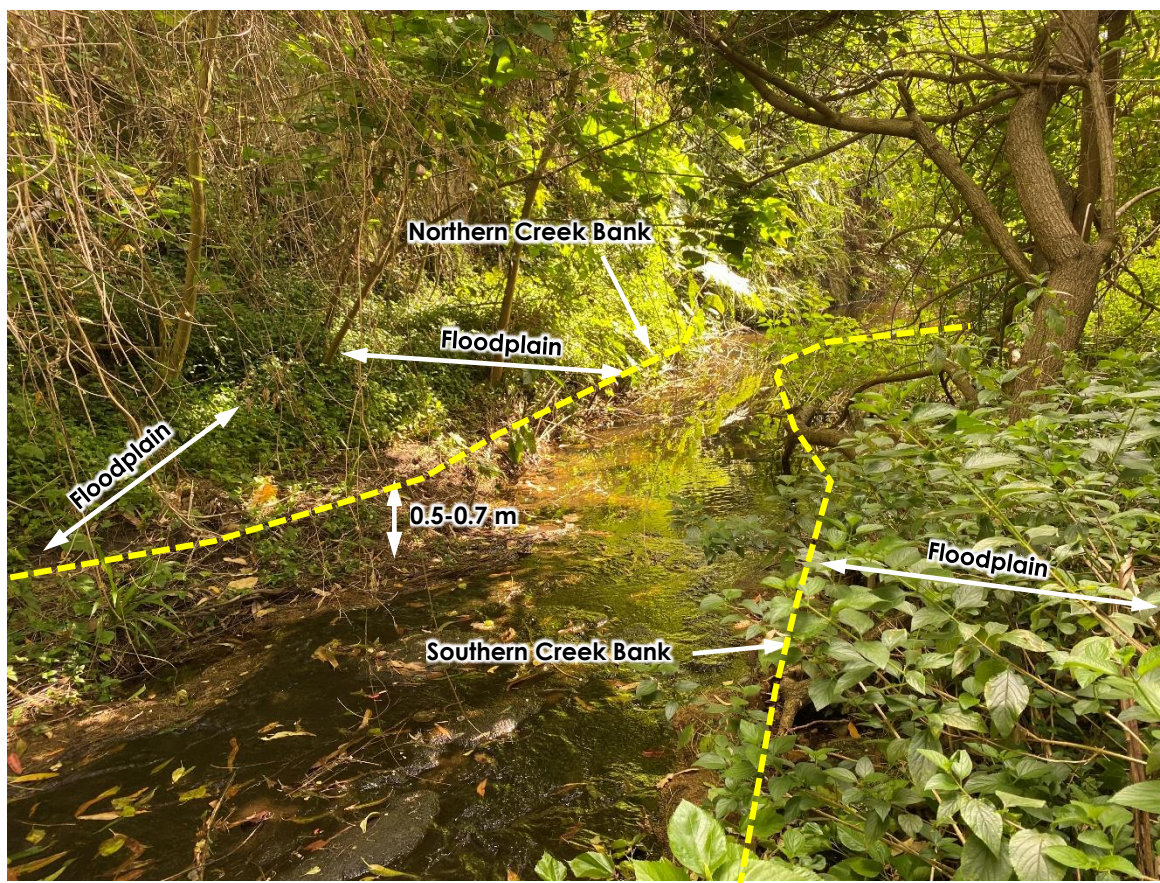
During the 17 November inspection this level was observed as an active floodplain at the western end of the Site and within the adjoining property to the west. The floodplain and creek bank levels are shown in Figure 8, Figure 9 and Figure 10, confirming the following:

1. **Creek bank:** The creek bank is approximately 0.5 - 0.7 m above the permanent water line. The bank is expressed as a clear break in slope between the near vertical slope to the water's edge and the flat grade of the adjoining floodplain. The creek bank was comprised of largely sandy materials held together with plant roots and some clay content.
2. **Floodplain:** There is a distinctly developed floodplain behind the creek bank upslope of the Site. This is variably expressed depending on location, being widest upslope of the site (where it reaches > 5 m width). The floodplain is characterised by sandy sediment which has been

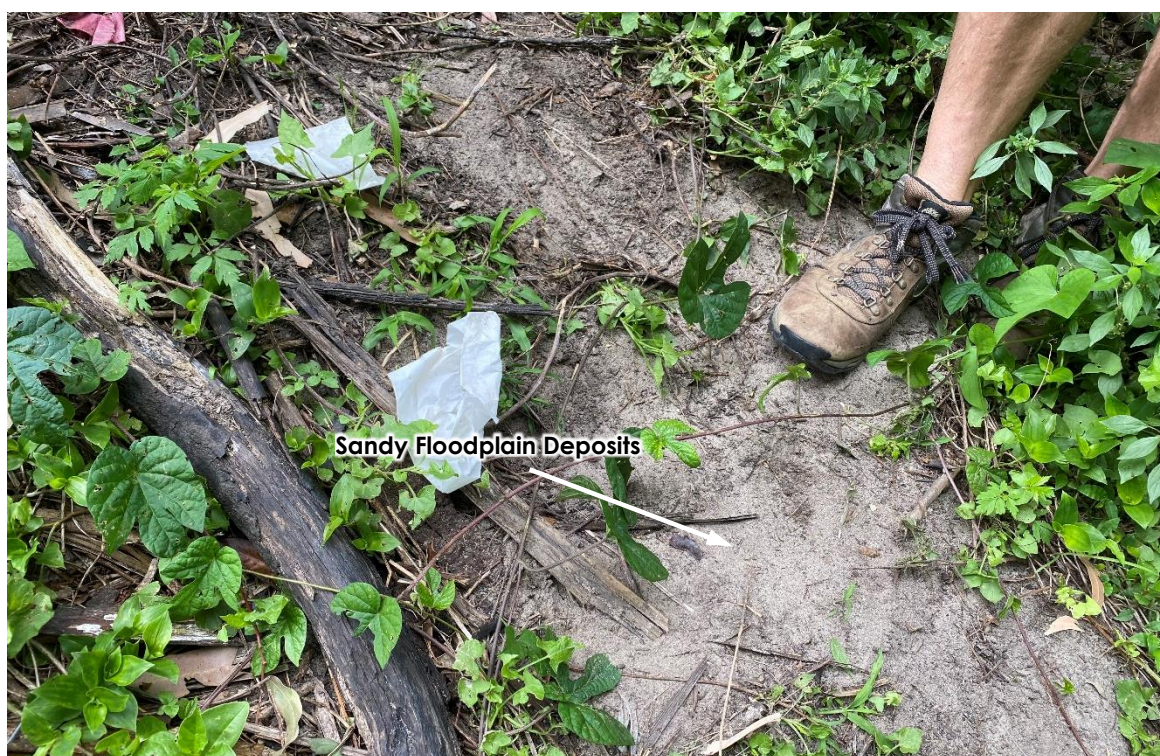
Figure 11: Sandy floodplain sediment on southern bank.

deposited by floods (refer to Figure 11). Floodplain vegetation to the west of the site is well established and consists largely of non-endemic species including trees, understorey and ground cover.

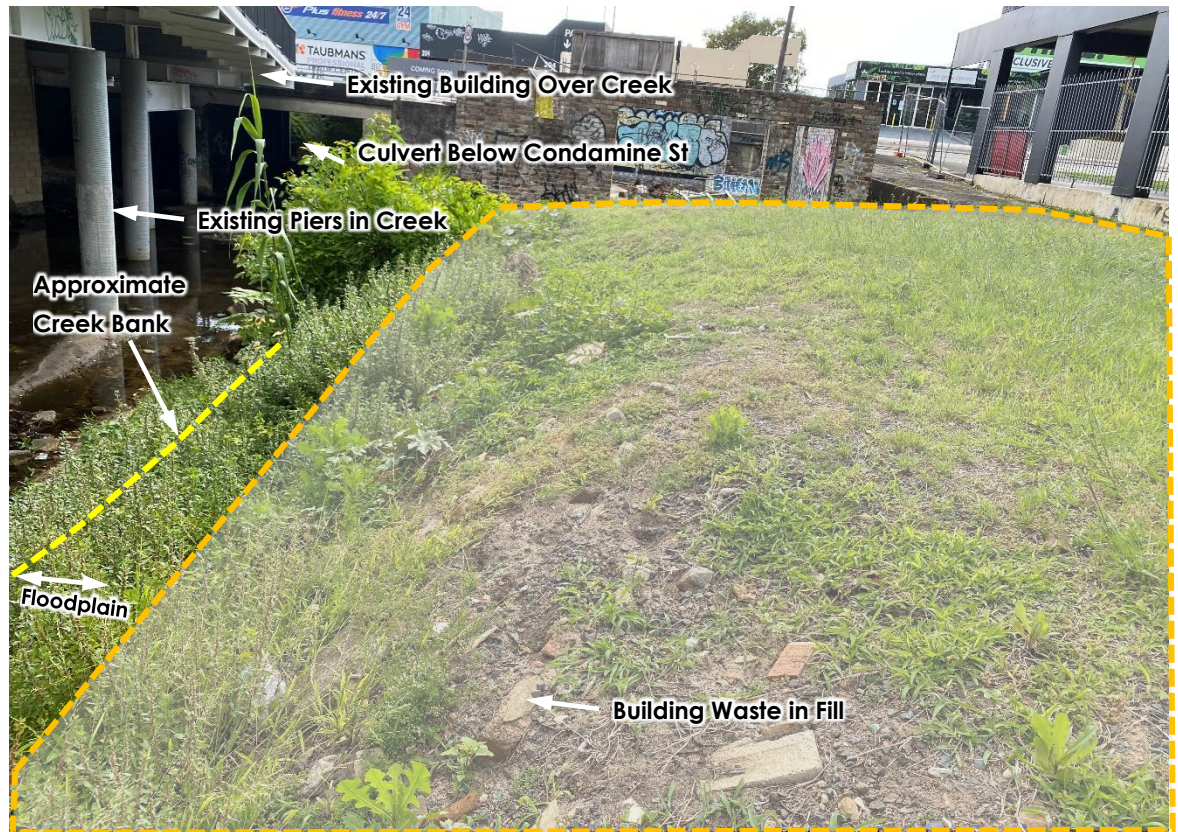
Figure 12: Fill embankment behind creek bank within site looking east.

By contrast, the fill embankment within the site is entirely anthropogenic, containing a range of fill and waste materials (refer to Figure 12 and Figure 13), likely having been placed near to the time that the existing derelict building was constructed.

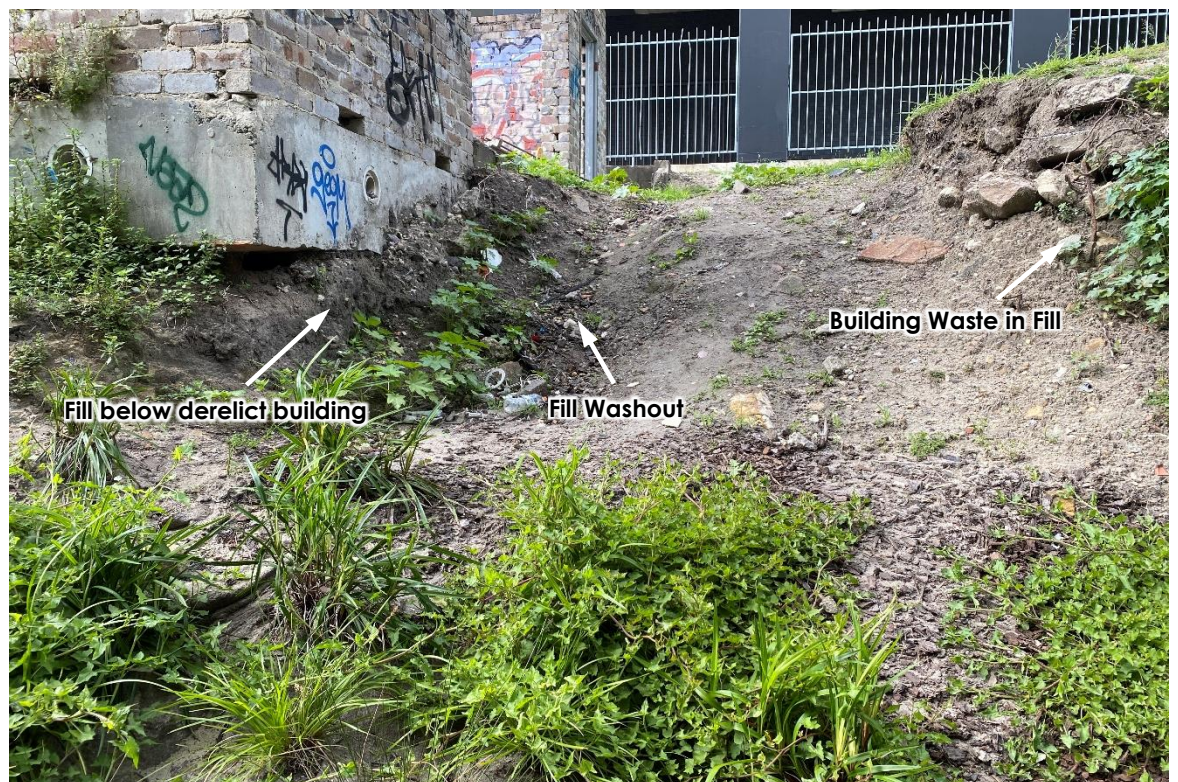
Figure 13: Fill embankment adjacent to derelict building within site.

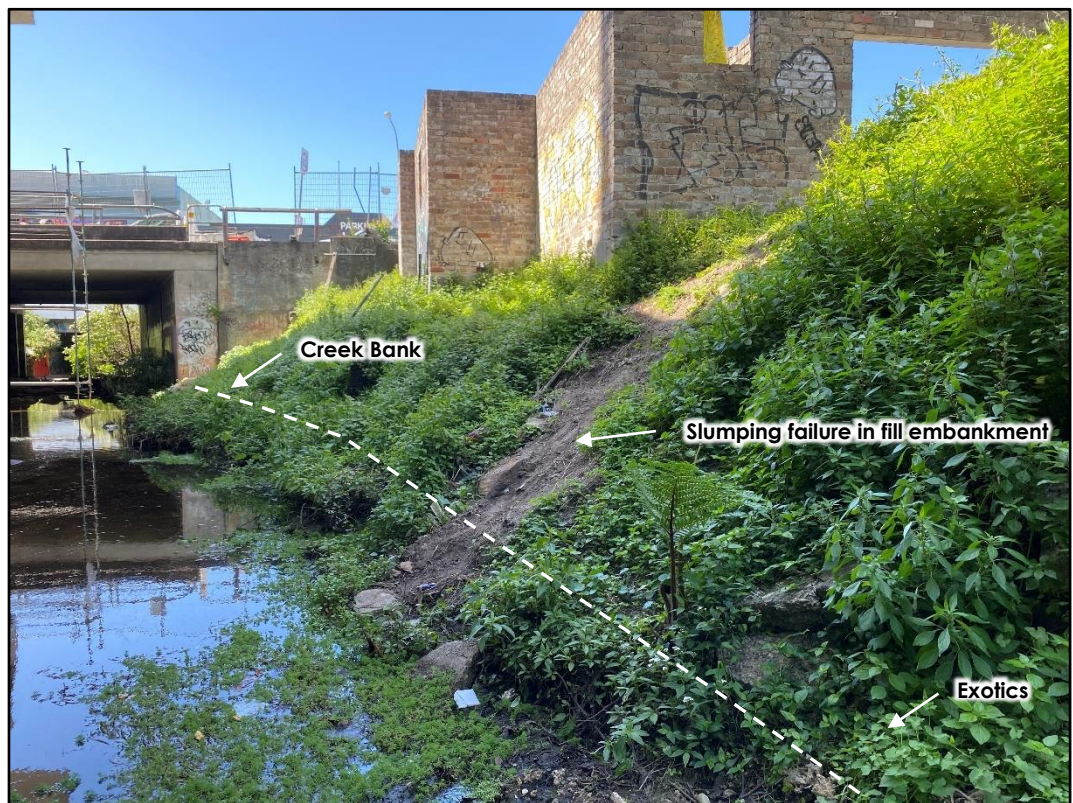
Figure 15: Fill embankment failure with the Site (28/9/2020).

During the 28/9/2020 site inspection the southern fill embankment within the Site was observed to be over steepened and unstable and had been subject to various slippages, both historic and active. In summary:

1. The fill embankment located within the Site adjacent to the southern Creek bank is over-steepened and unstable at a number of locations.
2. In places the fill embankment has failed, and material has been transported downslope to the Creek bank and into the Creek (refer to Figure 15).

Bank stabilisation and reconstruction is required and recommended.

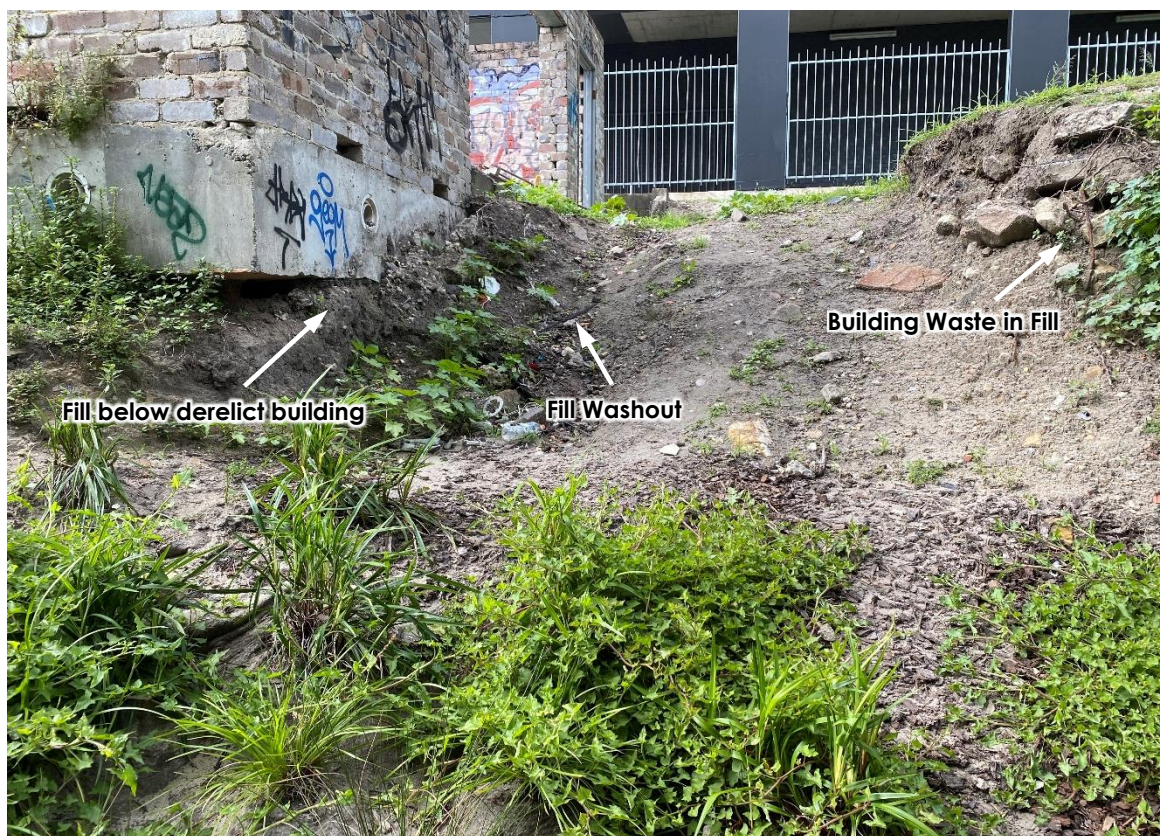
During the 17/11/2021 inspection it was observed that the fill embankment had continued to fail, with evidence of several recent slope failures. These have led to portions of the anthropogenic fill being transported to the creek bank below and into the creek (refer to Figure 16 and Figure 17).

Figure 16: Fill embankment adjacent to derelict building within site (17/11/2021).

Figure 17: Fill embankment failure and waste in creek within site (17/11/2021).

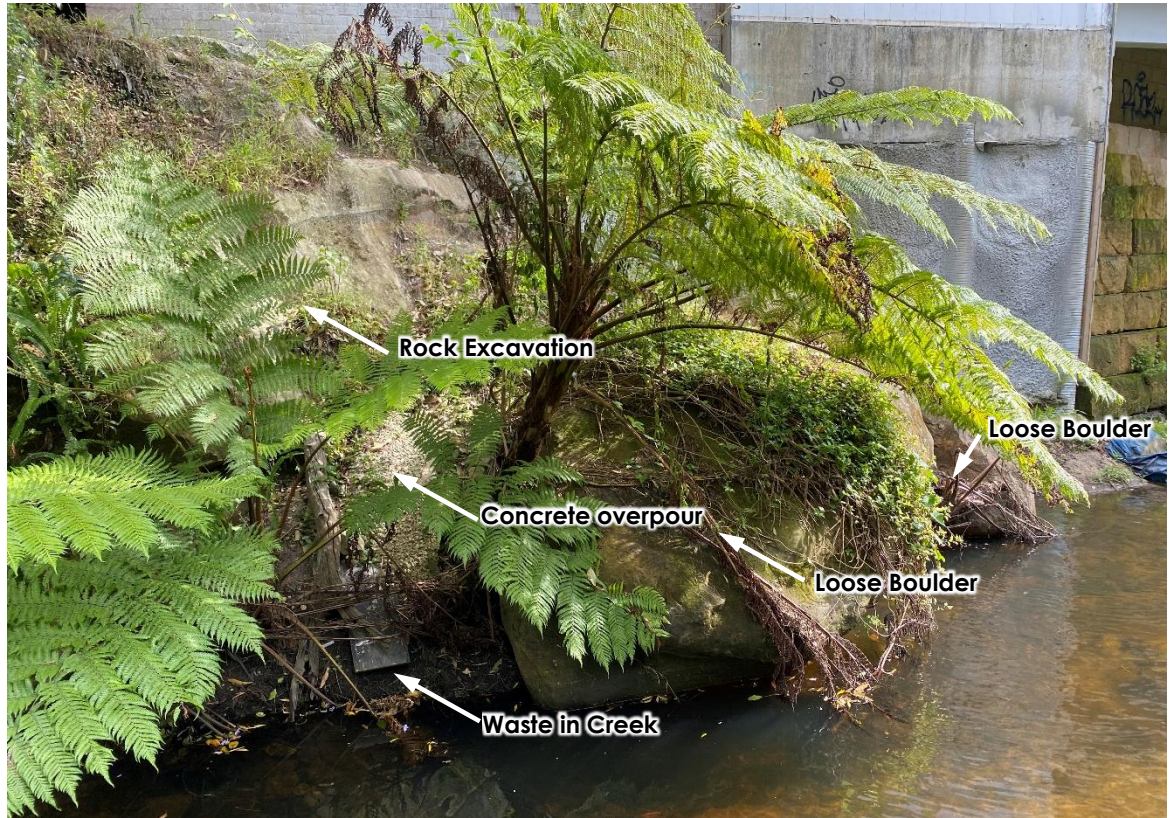
Figure 18: Northern Creek bank and embankment within site (17/11/2021).

1. The bank is not a natural bank but rather has been constructed by soil and rock excavation.
2. The bank is impacted by anthropogenic filling and waste deposition including concrete over pours (refer to Figure 18).
3. The bank is unstable with evidence of recent bank instability (refer to Figure 19 and Figure 20). In particular there has been a boulder slide with movement of two large boulders into the creek, likely caused by erosion of unconsolidated material below and around the boulders. These materials are likely to continue to move into the creek and obstruct flow in coming high flow / flood events, this leading to further bank erosion.

Bank stabilisation and reconstruction is required and recommended.

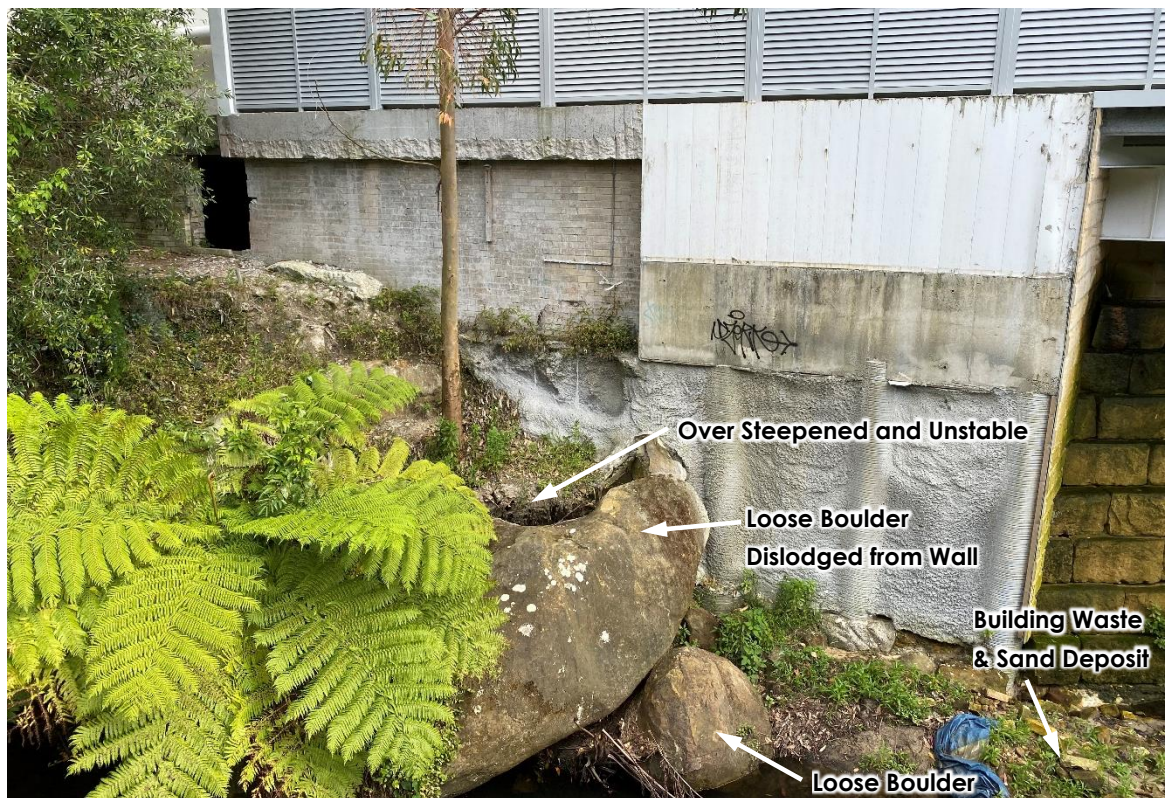
Figure 19: Northern Creek bank and embankment within site (17/11/2021).

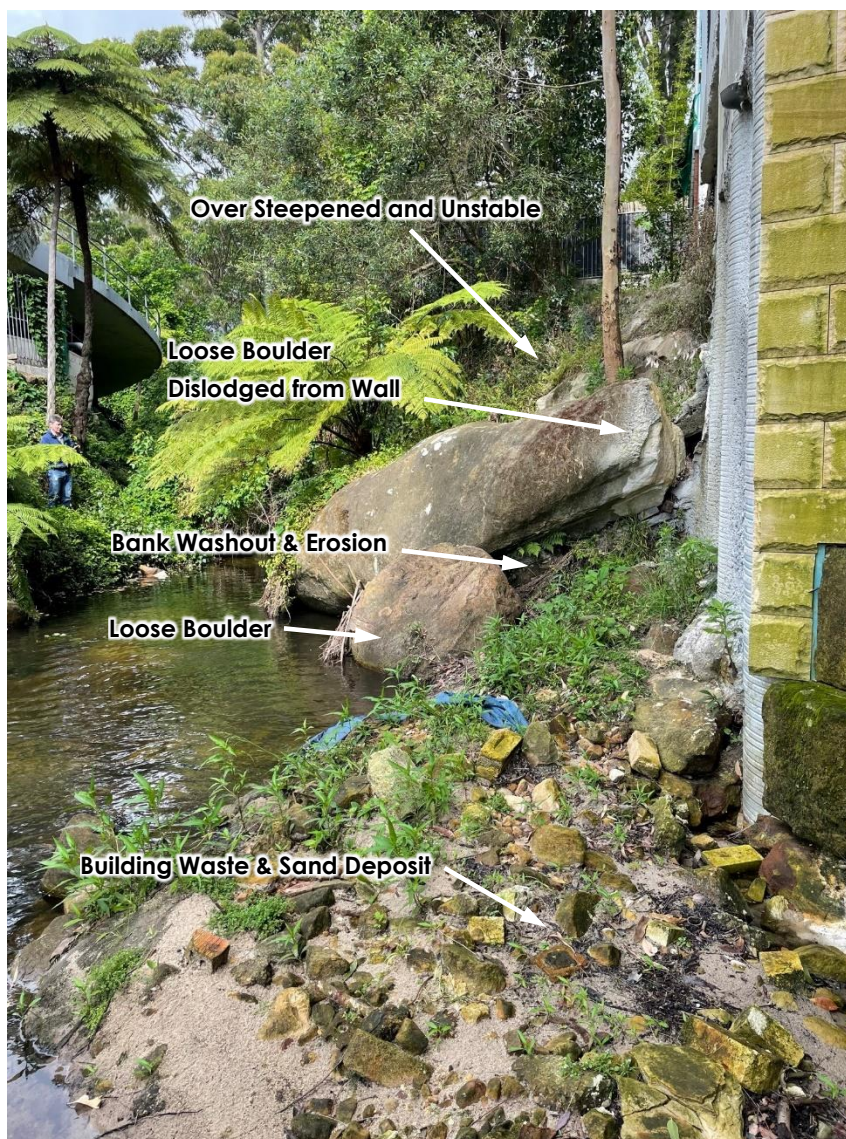
Figure 20: Northern Creek bank and embankment showing failure (17/11/2021).

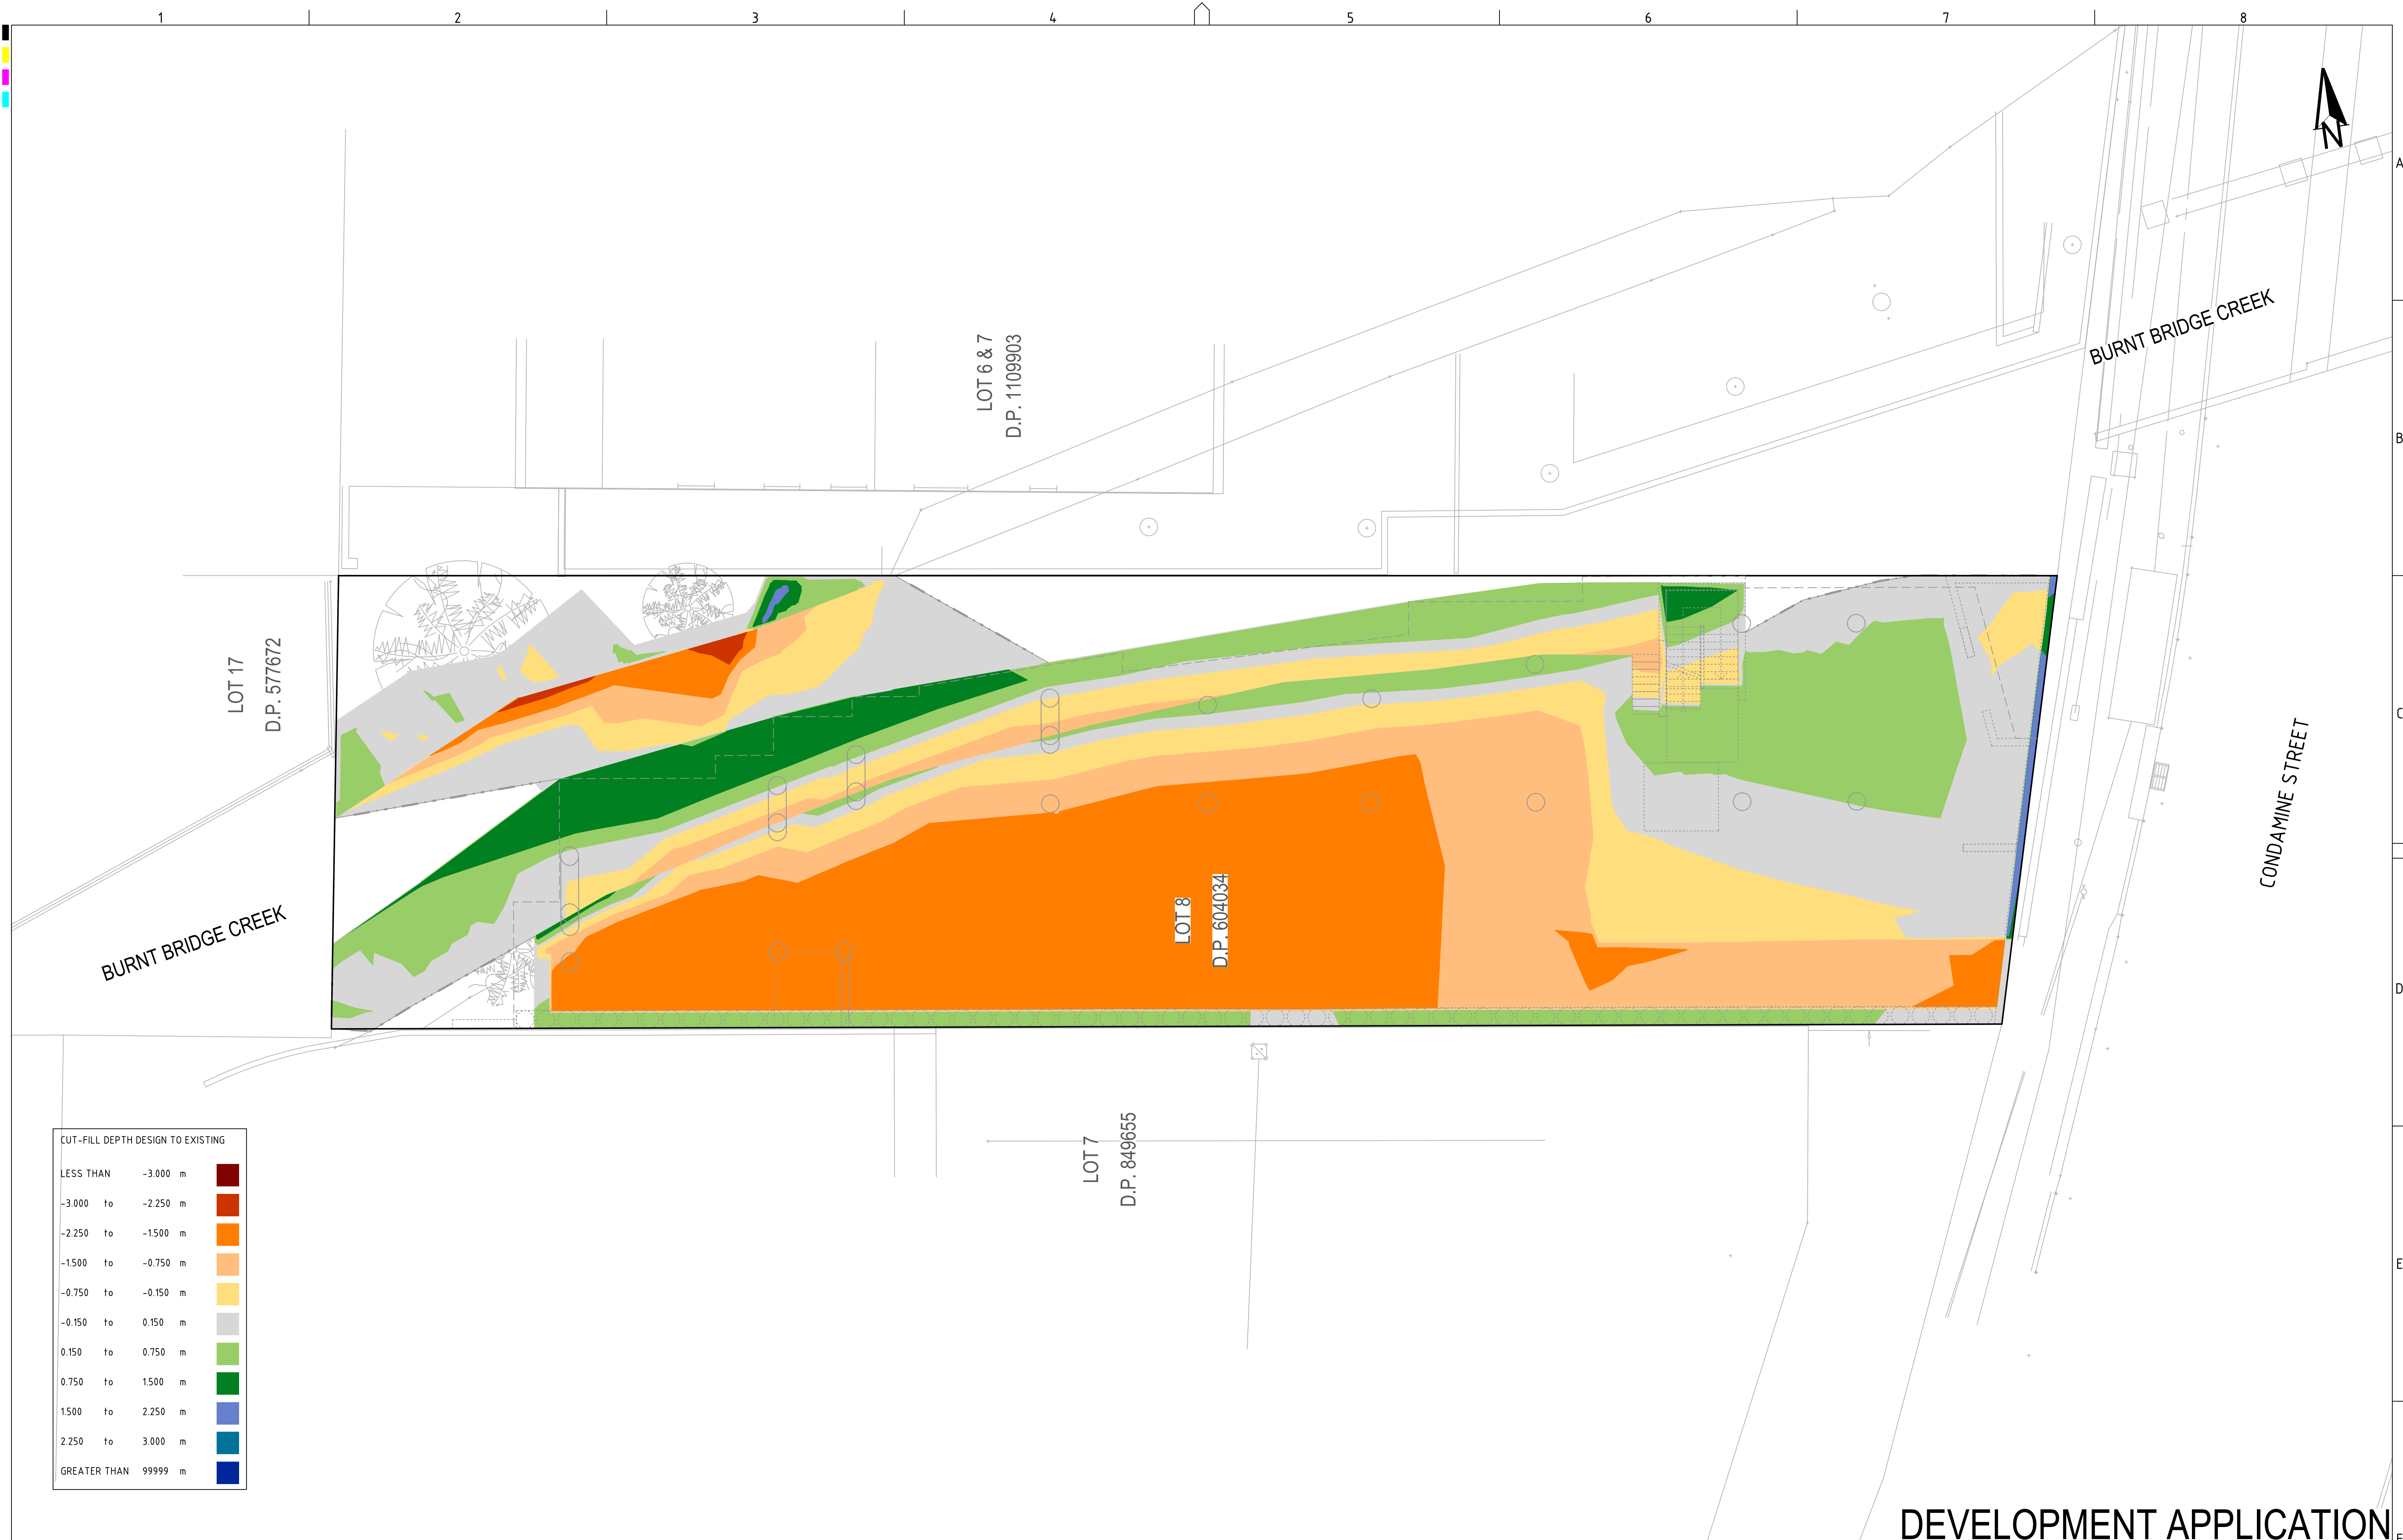
CUT-FILL DEPTH DESIGN TO EXISTING		
LESS THAN	-3.000 m	
-3.000 to	-2.250 m	
-2.250 to	-1.500 m	
-1.500 to	-0.750 m	
-0.750 to	-0.150 m	
-0.150 to	0.150 m	
0.150 to	0.750 m	
0.750 to	1.500 m	
1.500 to	2.250 m	
2.250 to	3.000 m	
GREATER THAN	99999 m

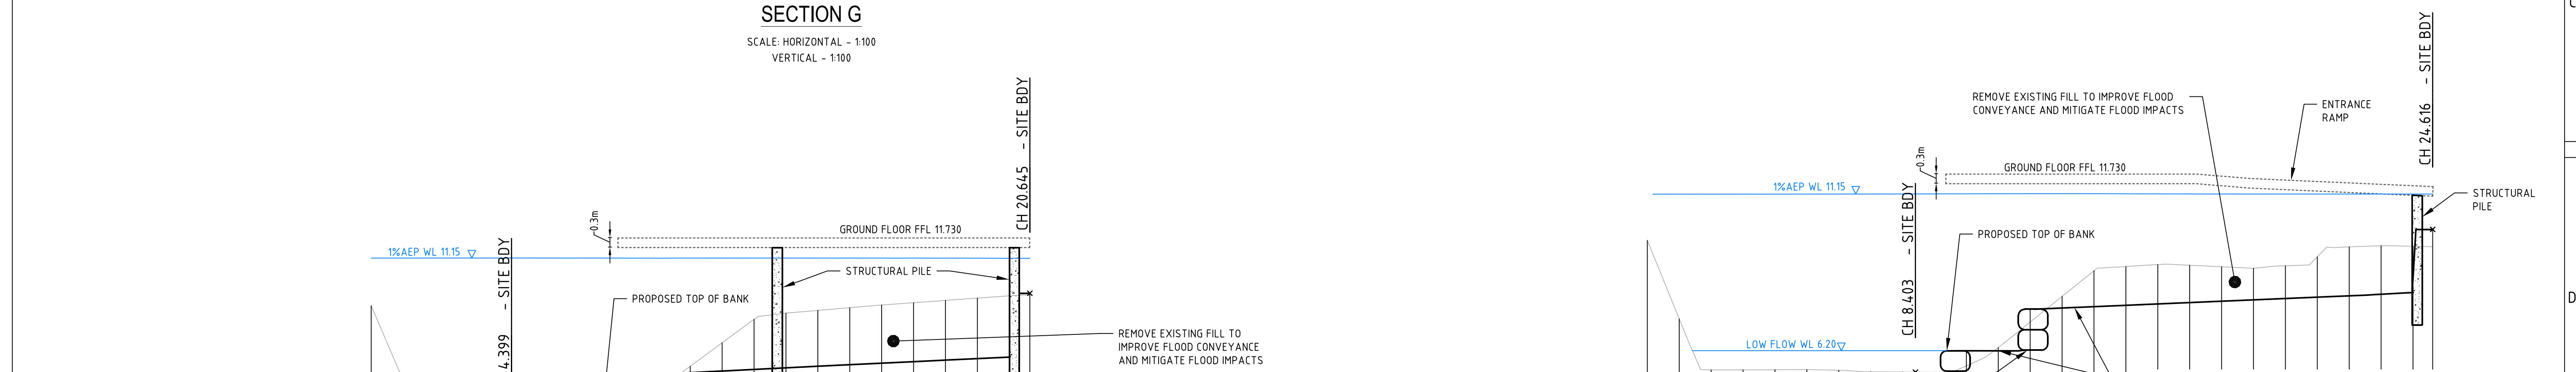
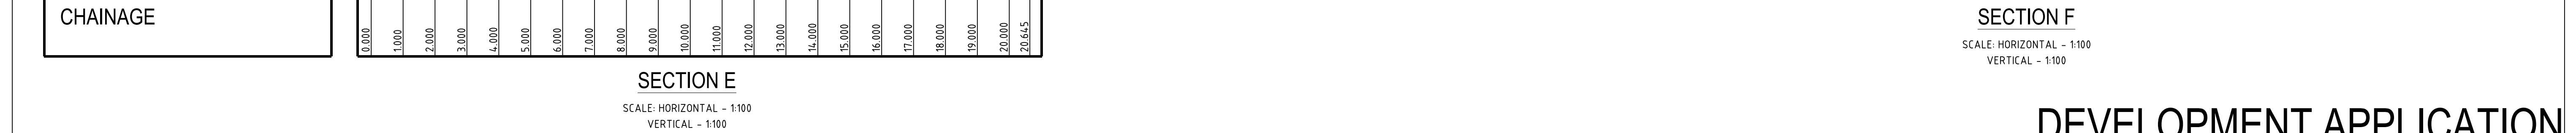
DRAWING ID: P1605609-PS07-R02-C600

SCALE: HORIZONTAL - 1:100
VERTICAL - 1:100
