JAK NEWPORT PTY LTD

Geotechnical Investigation

54-58 Beaconsfield Street, Newport, NSW

E26083.G03_Rev2
29 May 2024

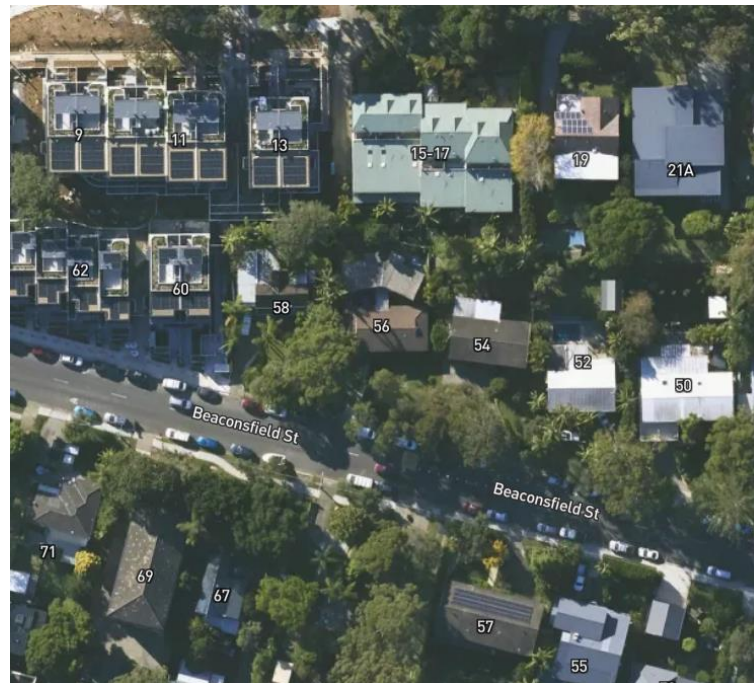
Plate 1: Aerial photograph of the site (source: Metromap, dated 6/5/23)

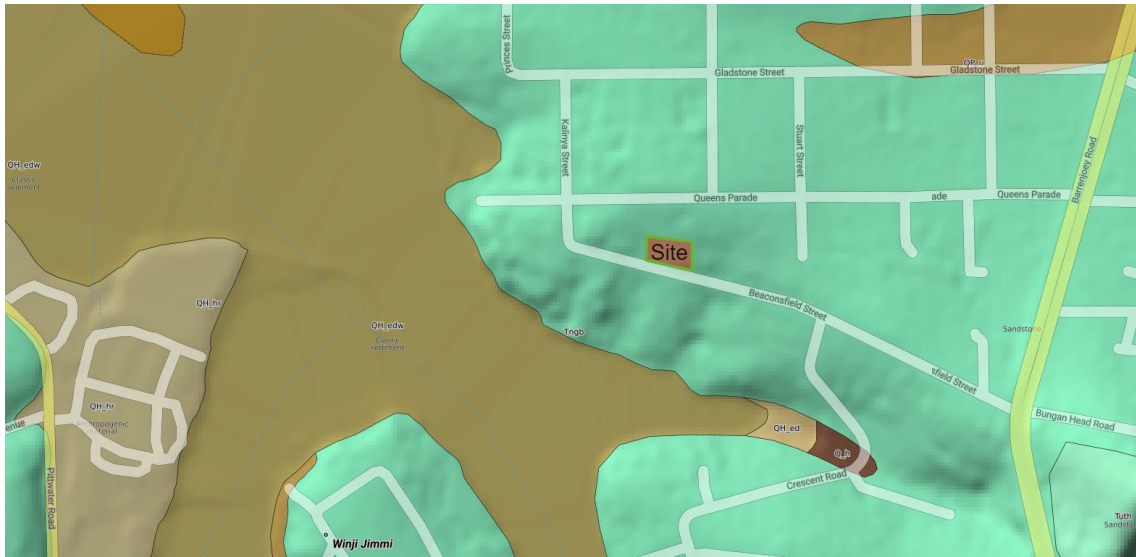
Plate 2: Excerpt of geological map showing location of site.

Attribute	Description
Topography	<p>The site is located on the high north side of the road within gentle to moderately (8-10°), South-West dipping topography with site levels varying from R.L. 16.1m AHD at the South-West site corner to R.L. 23.52m AHD at the North-East site corner.</p>
Regional Geology	<p>Information on regional sub-surface conditions, referenced from NSW Department of Mineral Resources. NSW Seamless Geology Data Package, Catalogue Number: 9232 indicates the site to be underlain by the Buralow Formation (member of the Gosford Subgroup), a fine-grained, micaceous, quartz- to quartz-lithic sandstone; interbedded with siltstone, grey shale and red-brown claystone.</p>

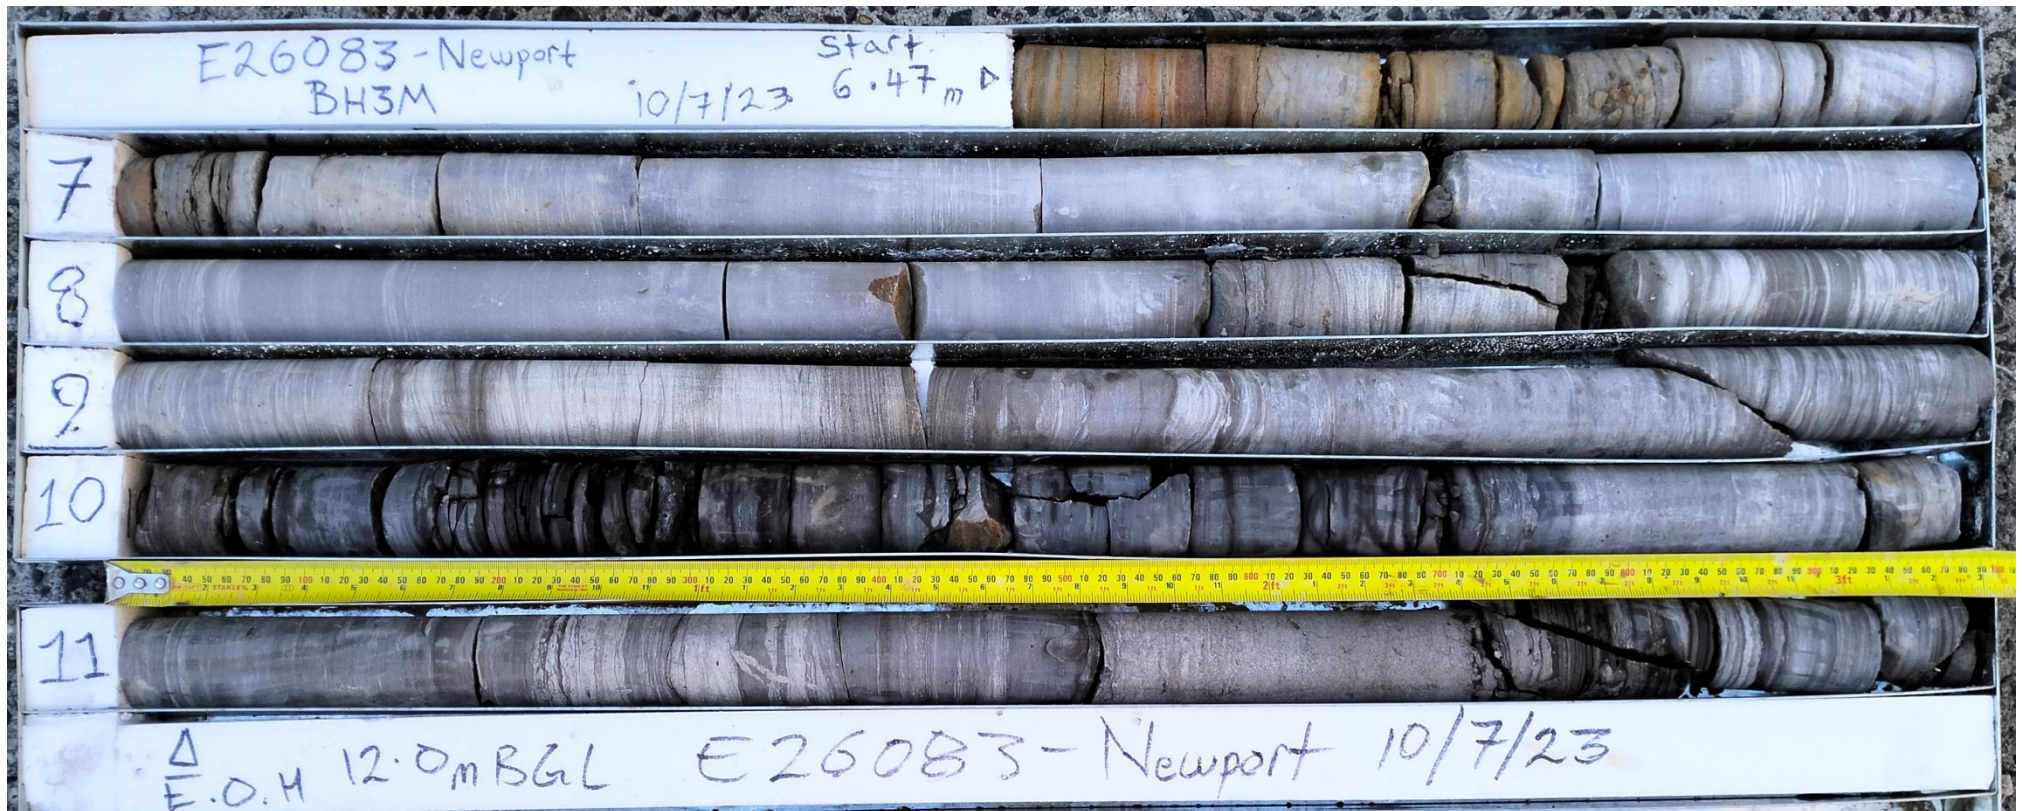
Project	Proposed Residential Development	Depth Range	6.47m to 12.0m BEGL
Location	54-58 Beaconsfield Street, Newport NSW	Contractor	Geosense Drilling Pty Ltd
Position	See Figure 2	Drill Rig	Comacchio Geo 205
Job No.	E26083.G03	Surface RL	≈19.4m AHD
Client	JAK Newport Pty Ltd	Inclination	-90°
		Box	1-2 of 2
		Logged	DD Date 10/7/2023
		Checked	SK Date 10/10/2023
