MARINE HABITAT SURVEY
316 Hudson Parade, Clareville

April 2021

**BIO-ANALYSIS Pty Ltd**

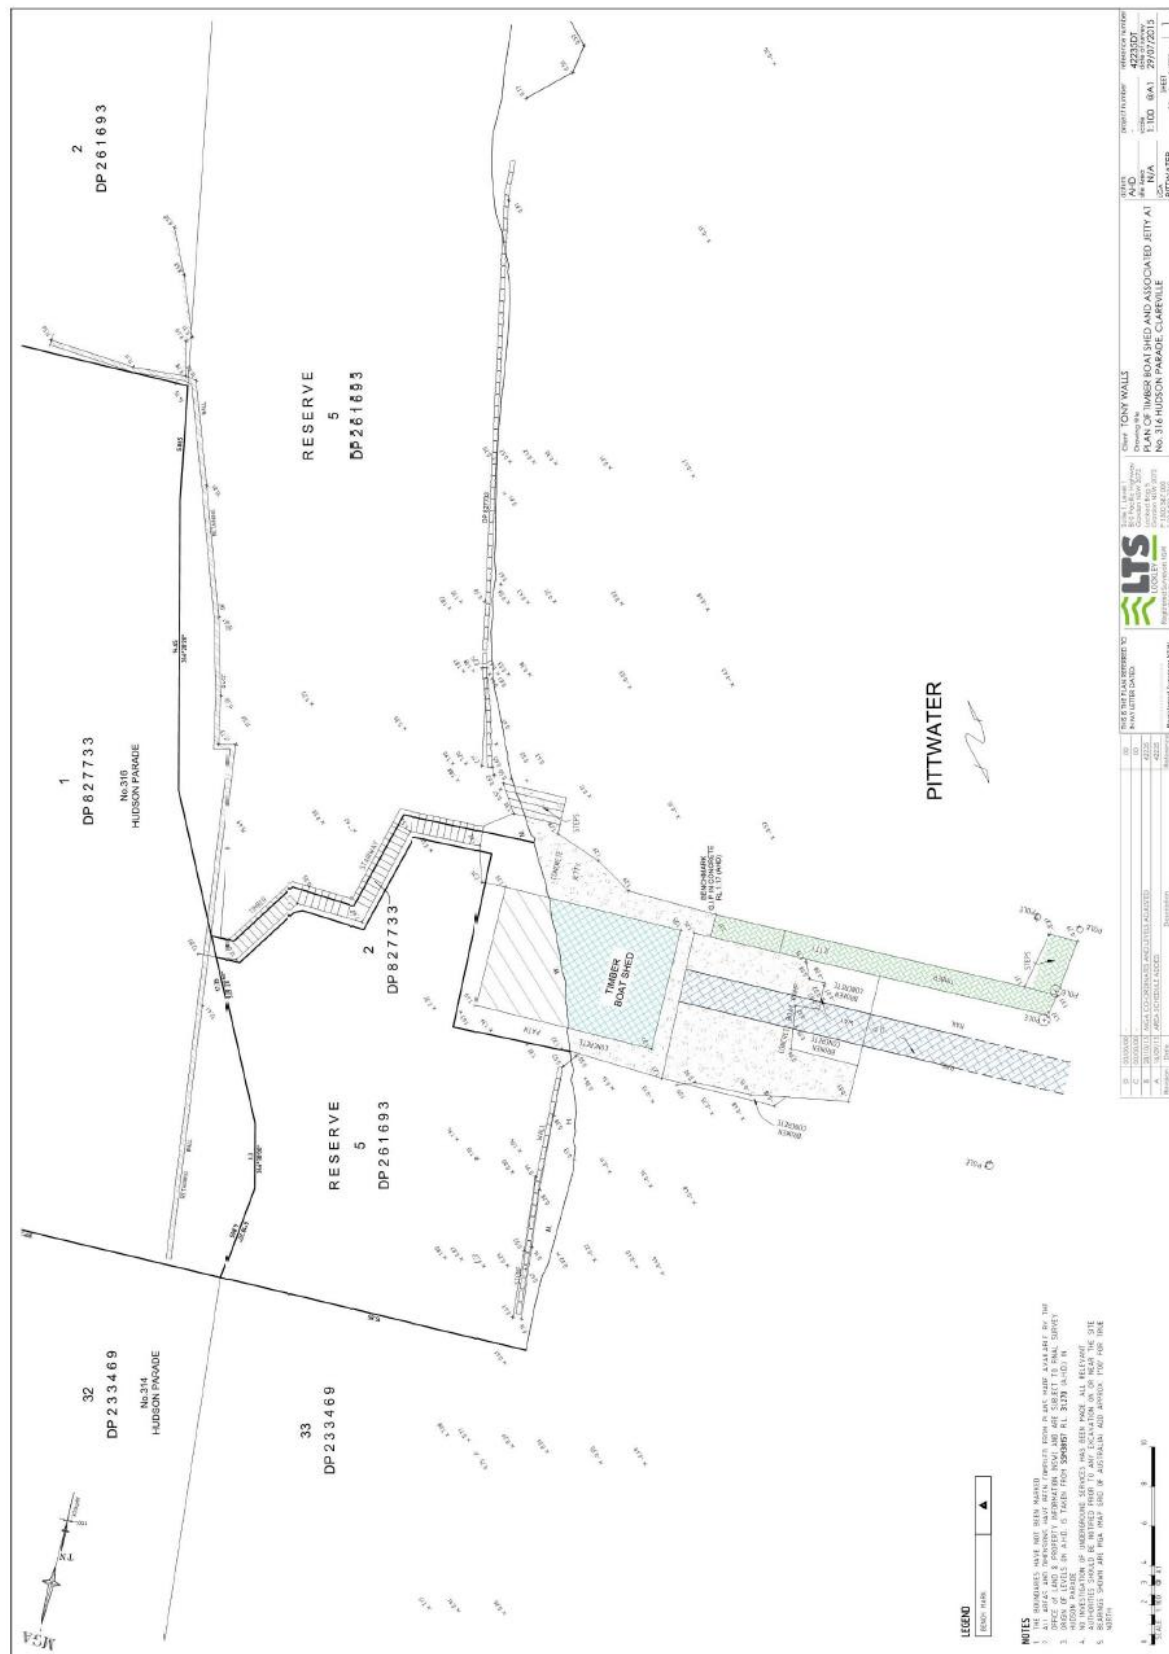
Figure 1a. Plans of the former structures dated from July 2015.
