**GEOTECHNICAL INVESTIGATION**

**116-120 FRENCHS FOREST ROAD & 11  
GLADYS AVENUE, FRENCHS FOREST**

**REPORT GG11138.001A  
21 MARCH 2024**

# Geotechnical Investigation for a proposed residential unit development at 116-120 Frenchs Forest Road & 11 Gladys Avenue, Frenchs Forest

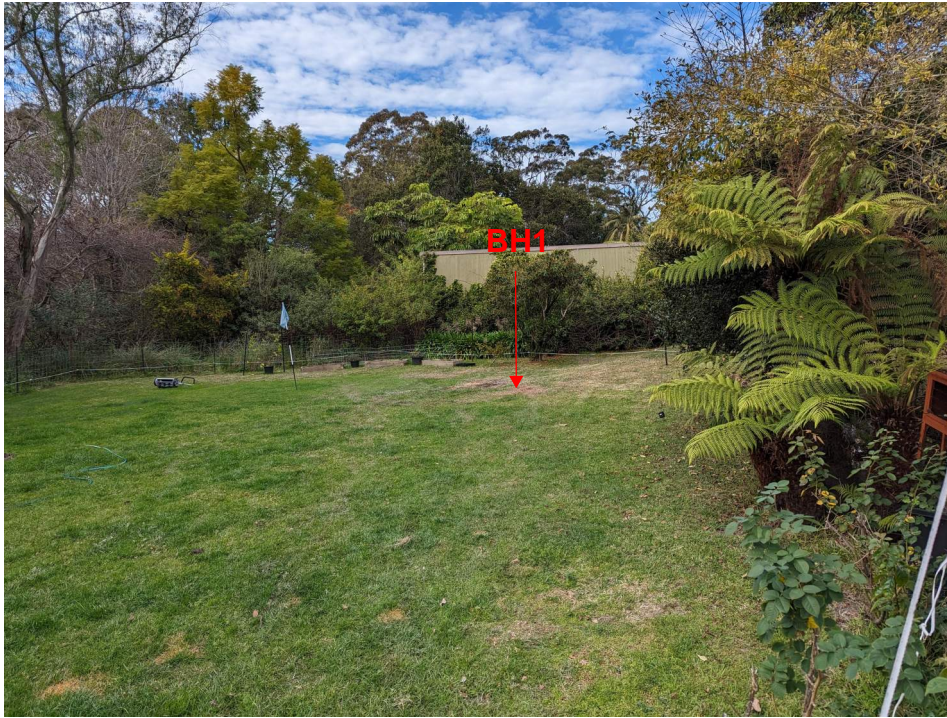
Position of BH1

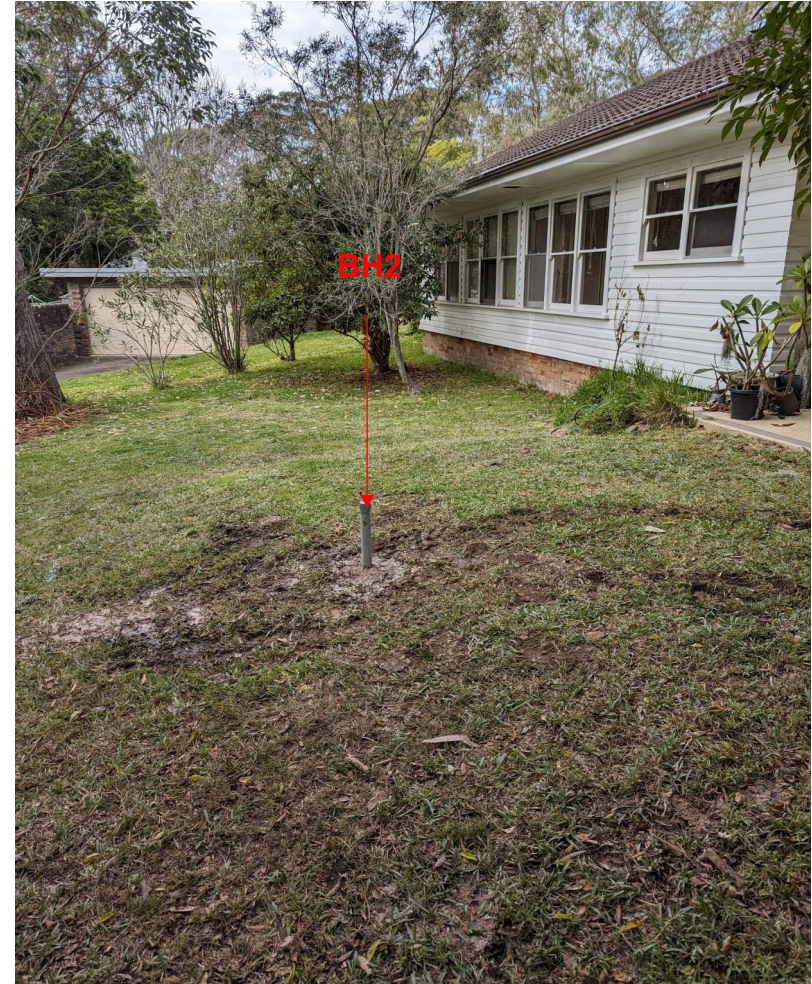
Position of BH2

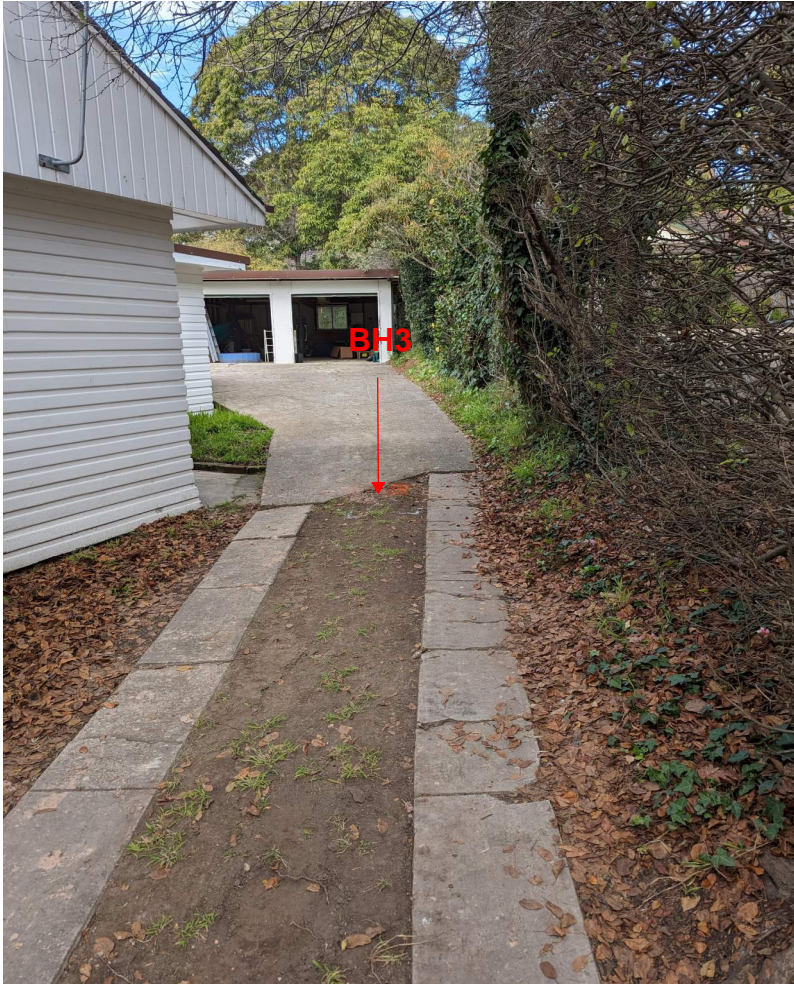
Position of BH3

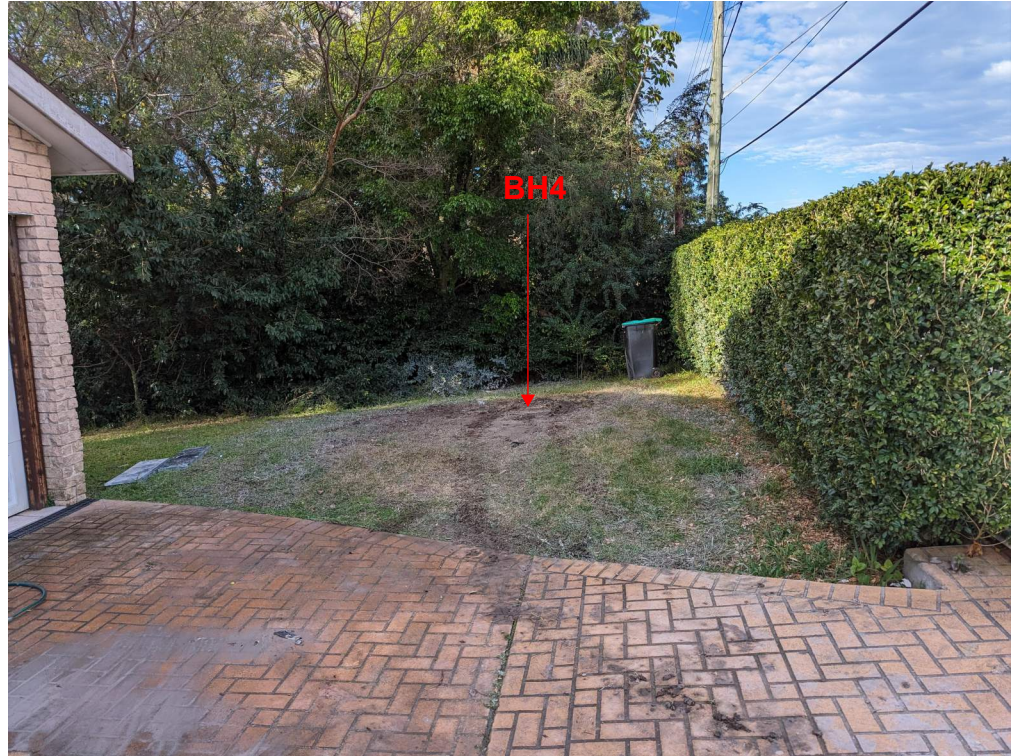
Position of BH4

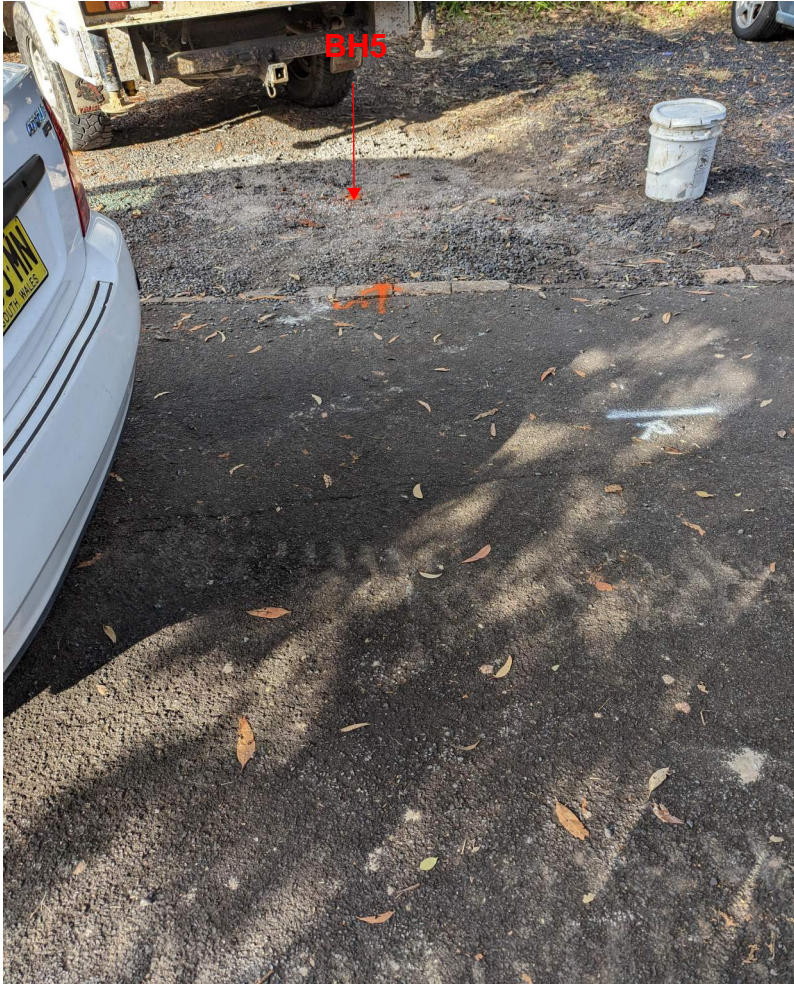
Position of BH5

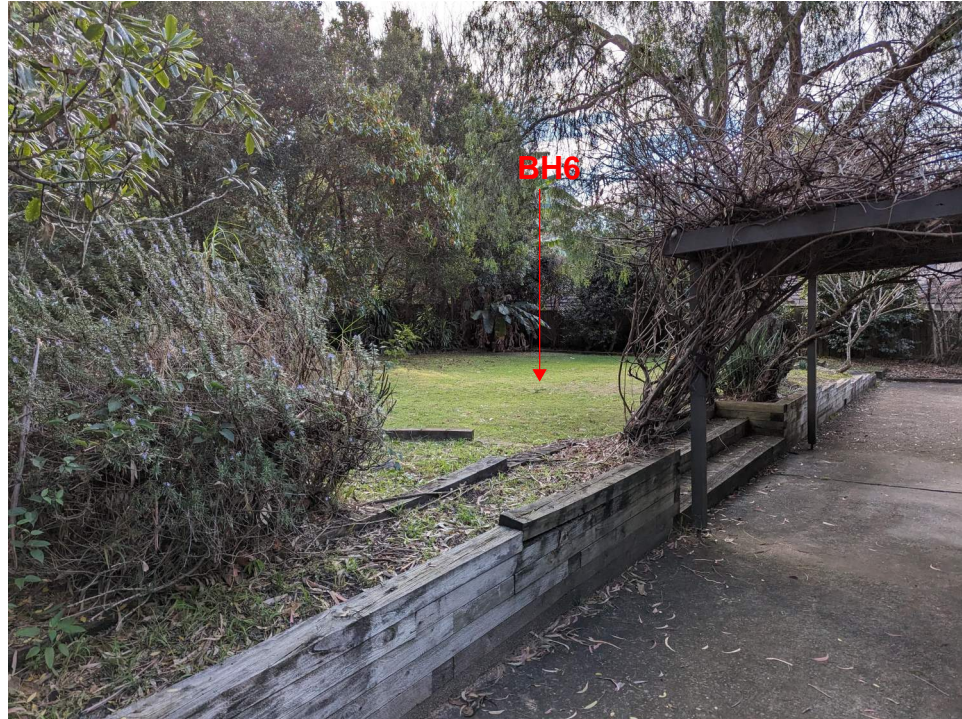
Position of BH6

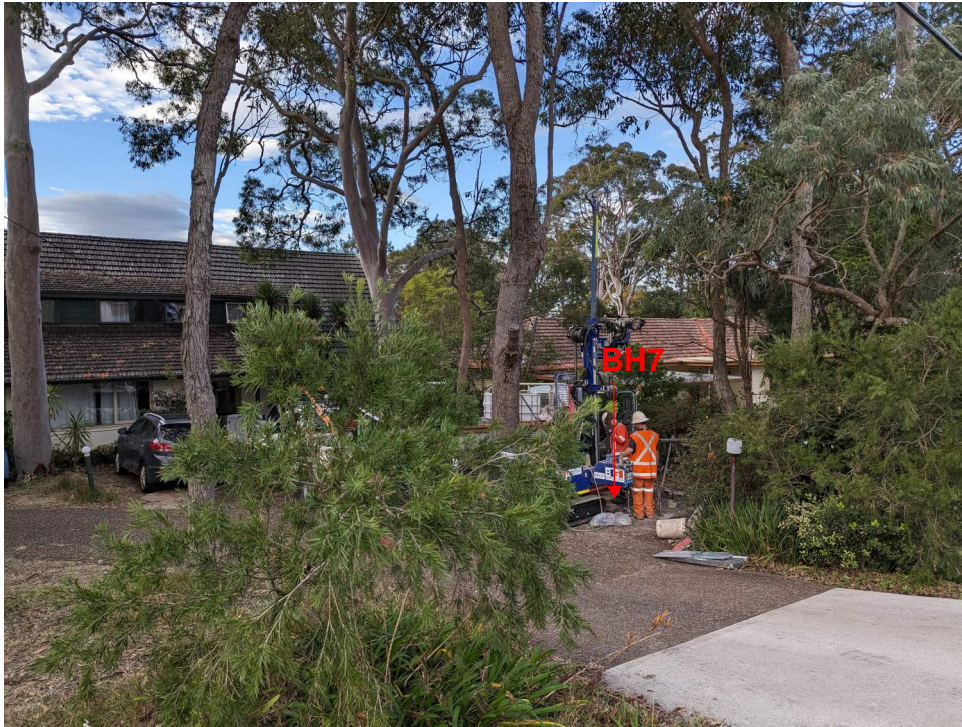
Position of BH7
