REPORT ON PRELIMINARY GEOTECHNICAL SITE INVESTIGATION

PROPOSED NEW DEVELOPMENT

21 WHISTLER STREET, MANLY

Project No.: 2018-141

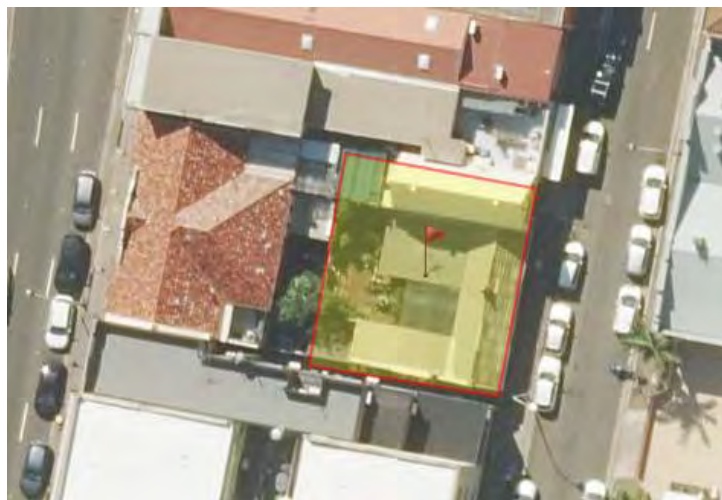
Photograph 1: Aerial photo of site and surrounds

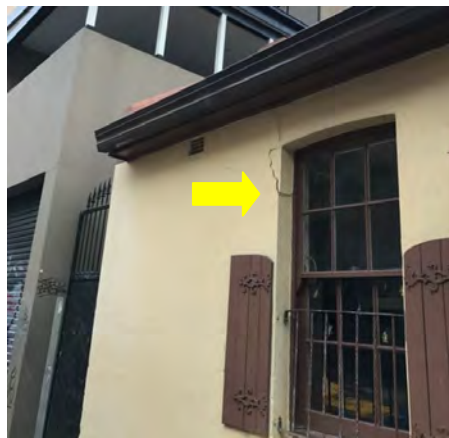
The front of the existing dwelling is positioned directly adjacent to the Whistler Street footpath. Some cracking/distress was observed in the front wall of the dwelling, as seen in Photograph 3 below.

Photograph 3: Observed cracking within the front wall of the dwelling, looking west.

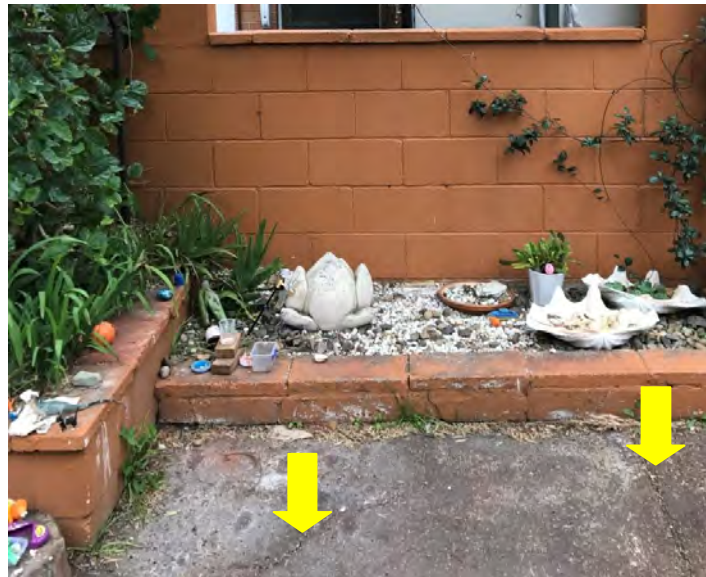
The courtyard area is separated into two sections by a small garden, with the section adjacent to the rear of the property raised approximately 0.40m above the section adjacent to the dwelling. The raised courtyard comprises a concrete/pebble surface whilst the lower courtyard is tiled. The raised concrete/pebble surface courtyard displayed some cracking and possible settling, whilst the lower tiled section did not. Photograph 4 displays some cracking present in the raised courtyard section.

Photograph 4: Cracking in raised courtyard, looking west.

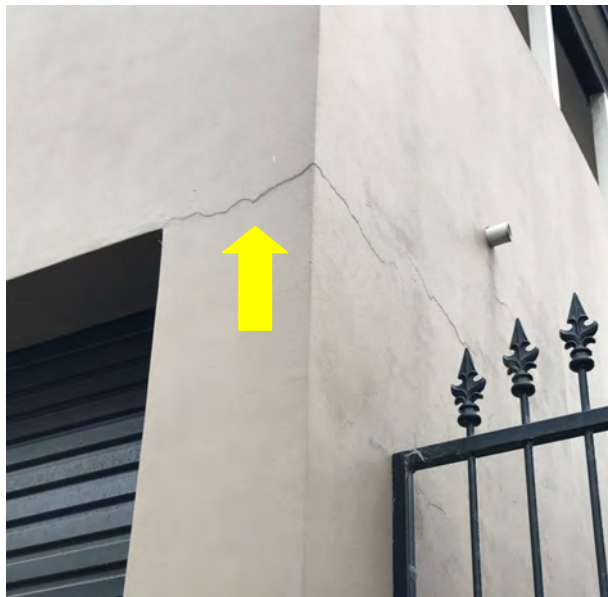
The neighbouring property to the south of the site, No. 33 Belgrave Street, comprises a three storey rendered commercial and unit building approximately 1.0m from the common boundary. The north-east corner of the building displayed some signs of cracking, as seen in Photograph 5 below. The ground surface level within this property appears similar to the site at the boundary with the remainder of the block having a similar topography to the site.

Photograph 5: *Cracking observed in adjacent property (No. 33 Belgrave Street), looking west.*
