**GEOTECHNICAL RISK MANAGEMENT POLICY FOR PITTWATER  
FORM NO. 1 – To be submitted with Development Application**

Address of site 18 Baz Retreat, Warriewood

Report Title: Geotechnical Report 18 Baz Retreat, Warriewood  
Report Date: 13/10/21  
Author: BEN WHITE  
Author's Company/Organisation: WHITE GEOTECHNICAL GROUP PTY LTD

## **GEOTECHNICAL INVESTIGATION:** New Pool at **18 Baz Retreat, Warriewood**

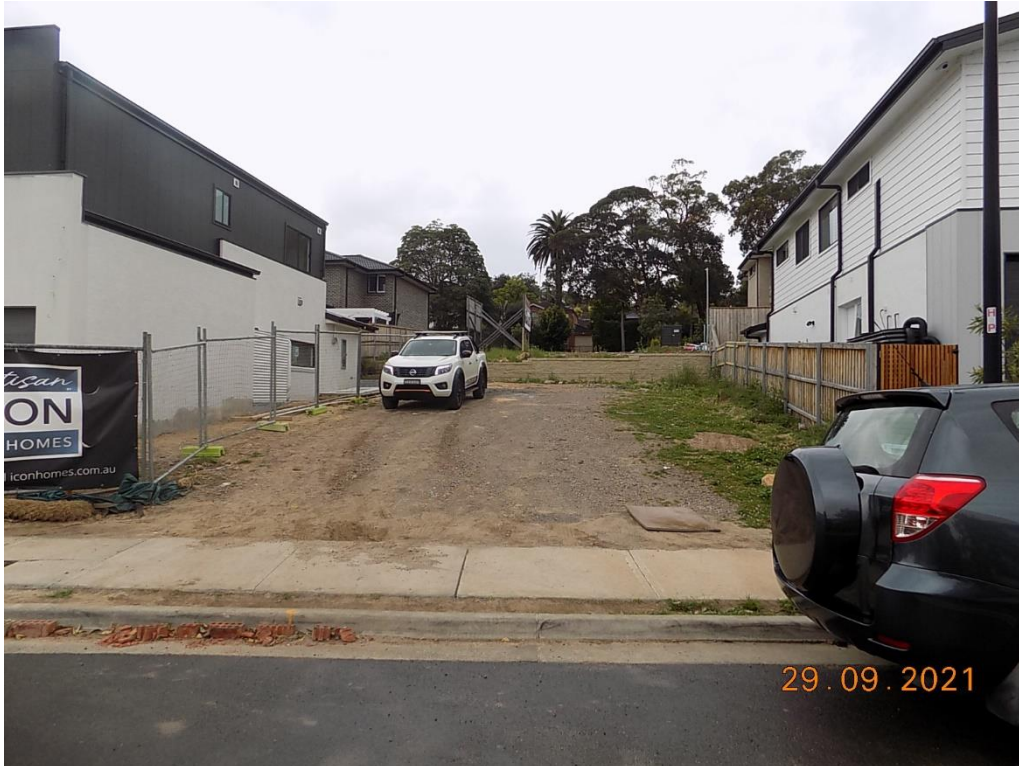
Photo 1

- 2.1** The site was inspected on the 29<sup>th</sup> September, 2021.
- 2.2** This vacant lot is on the high side of the road and has a SW aspect. It is located on the gently graded lower reaches of a hillslope. The slope rises across the property at angles averaging ~5°. The slopes above and below continue at similar angles.
- 2.3** A gently sloping lawn rises across the entire property (Photos 1 & 2). A fill on the neighbouring property above is supported by a stable concrete block retaining wall reaching ~1.0m high (Photo 3).

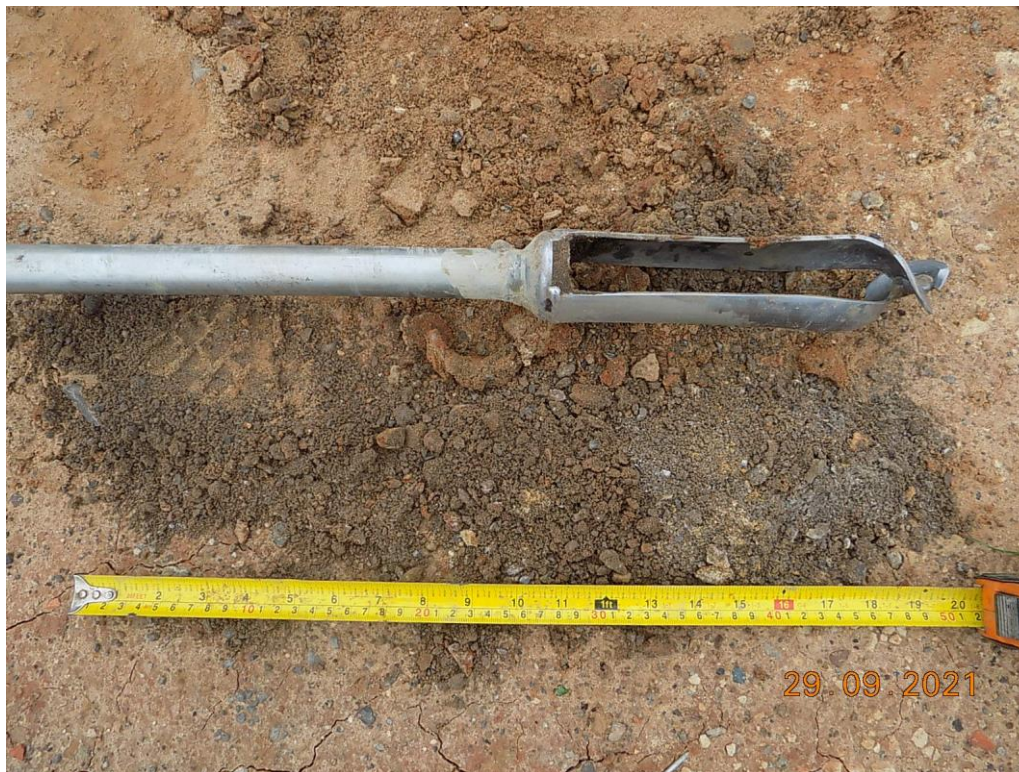
*Photo 3 (Left is top of hole)*

#### AUGER HOLE 1 (~RL11.3) – AH1 (Photo 3)

Depth (m)	Material Encountered
0.0 to 0.3	FILL, disturbed silty soil, brown, dense to very dense, dry, fine to medium grained with fine trace organic matter, rock fragments, and trace clay. AW Geotech describe the fill Clayey Sand fill with sandstone gravel and cobbles.

End of test @ 0.3m. No water table encountered.

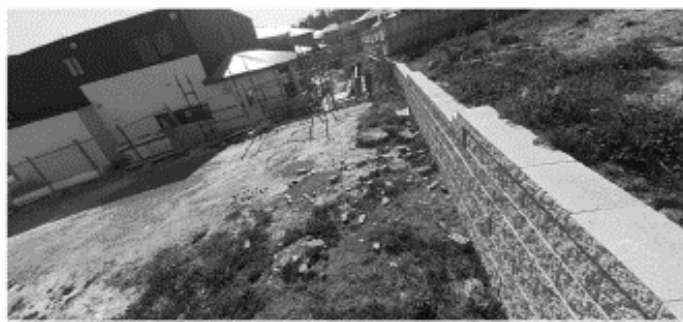
IMAGE 03 - SITE IMAGE OF THE REAR RETAINING WALL

As such, the NW common boundary and the uphill retaining wall will be within the zone of influence of the proposed excavation.

Where the retaining wall above falls within the zone of influence of the excavation, exploration pits in this location will need to be put down by the builder to determine the foundation depth and material. The pits are to be inspected by the geotechnical consultant.

If the wall is found to be supported below the base of the proposed excavation, the excavation may commence. If it is not supported below the base of the proposed excavation, the wall will need to be underpinned prior to the excavation commencing.

Underpinning is to follow the underpinning sequence 'hit one miss two'. Under no circumstances is the bulk excavation to be taken to the edge of the wall and then underpinned. Underpins are to be constructed from drives that should be proportioned according to footing type and size. Allowances are to be made for drainage through the underpinning to prevent a build-up of hydrostatic pressure.

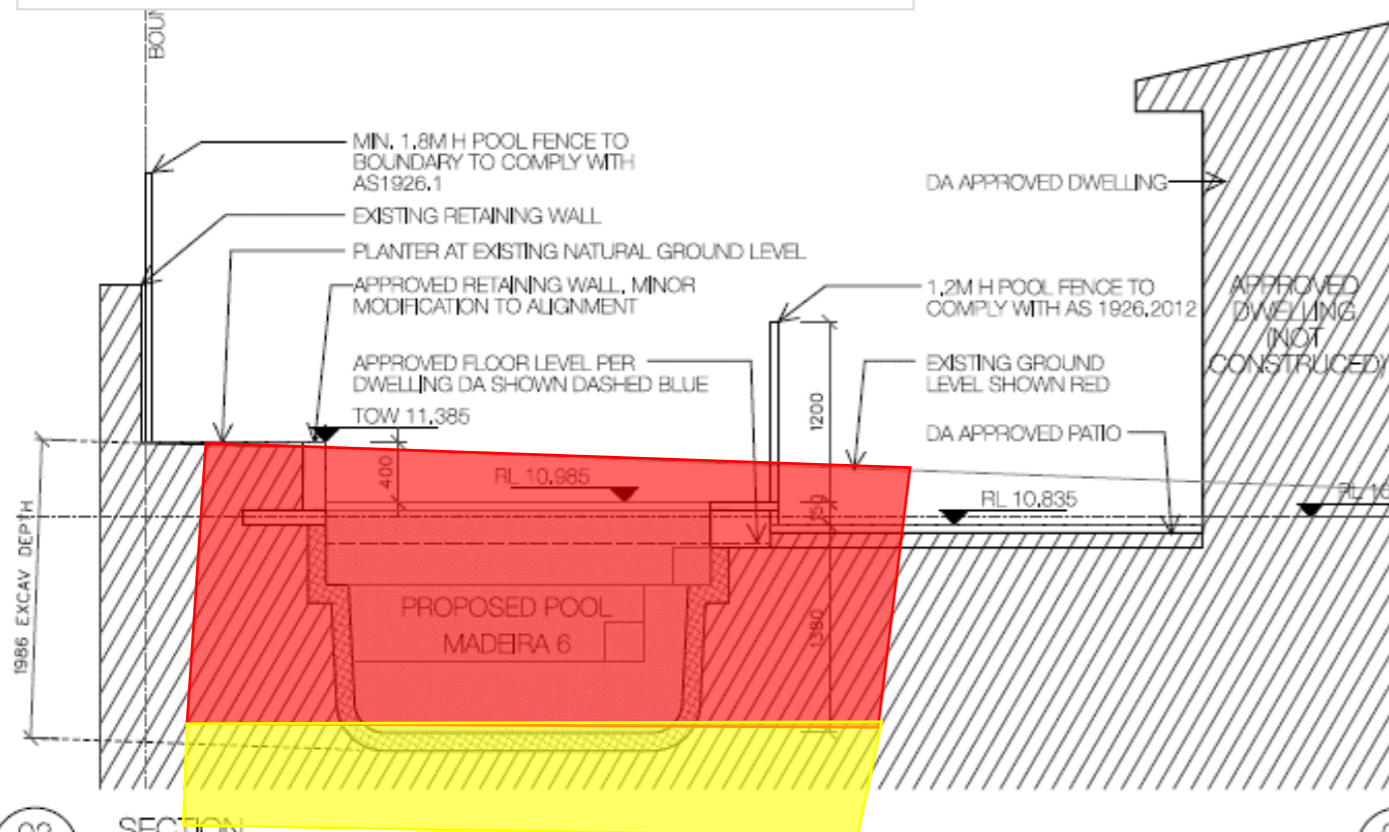
TYPE SECTION – Diagrammatical Interpretation of expected Ground Materials

The entire property is underlain by very well-compacted fill that was encountered to the extent of the testing. Two bore holes were put down on the property by another firm. The bore holes indicate that the fill extends to depths of between ~1.2m and ~1.8m below the current surface before merging into the underlying Very Stiff Sandy Clays. This concurs with the ground testing results carried out by this firm on the adjoining property, No. 20. The Narrabeen Group of Rocks were not encountered during the testing done by us on site, nor was it encountered during the bore holes put down by the other firm. See Type Section attached for a diagrammatical representation of the expected ground materials.

Expected Ground Materials

- Fill
- Topsoil
- Sandy Clay
- Narrabeen Group – Extremely Low Strength Shale
