J3418. 14<sup>th</sup> May, 2021. Page 1.

# **GEOTECHNICAL INVESTIGATION:**

#### Additions and Alterations at **17 Jamieson Parade, Collaroy**

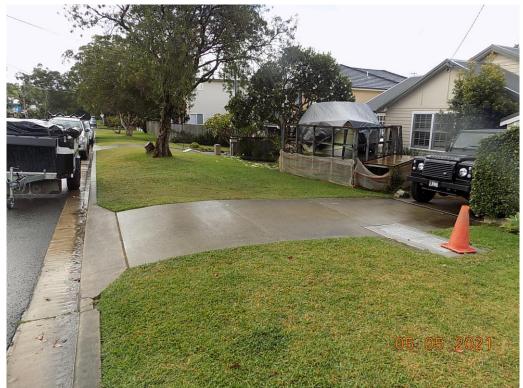
Photo 1

**2.3** At the road frontage, a concrete driveway runs to a timber clad garage on the S side of the house (Photo 1). Between the road frontage and the house is a gently sloping lawn area. The single-storey timber framed and clad house will be demolished as part of the proposed works (Photo 2). Another gently sloping lawn extends off the downhill side of the house to a shed and an outbuilding (Photo 3). Both are to be demolished as part of the proposed works. A garden encompasses the E and N perimeters of the lawn (Photo 4).
