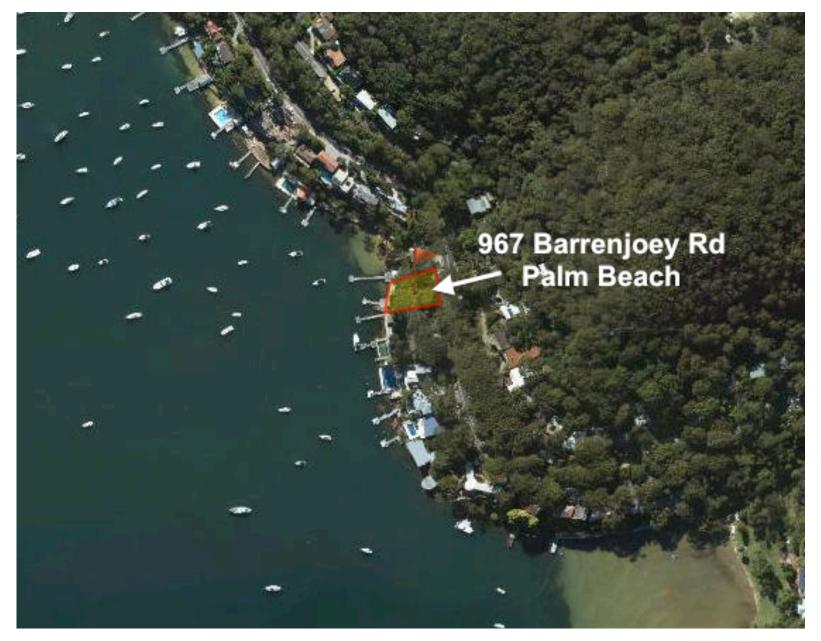
Figure 2

Aerial view showing the existing jetty and similar facilities in the locality

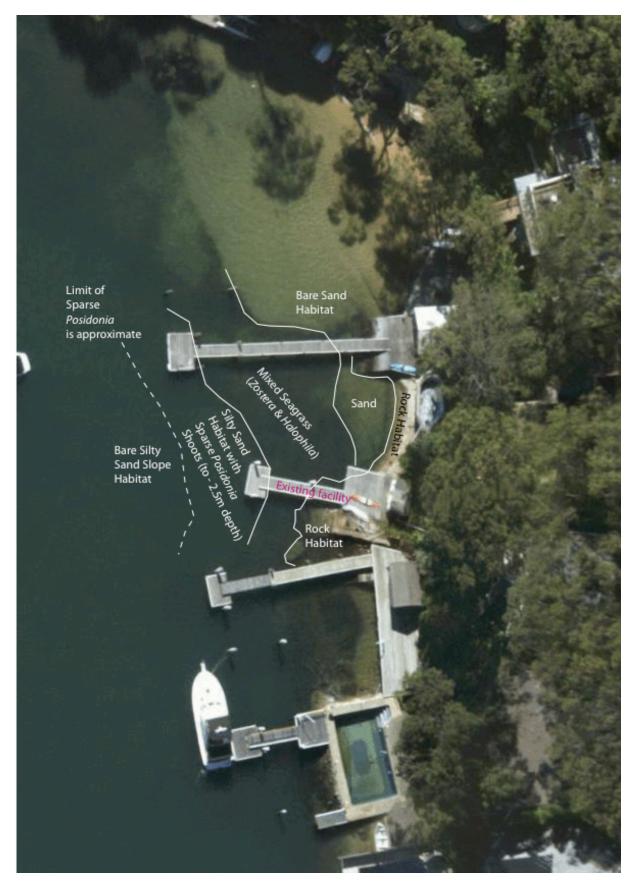
Figure 5 Main aquatic habitats at the subject site on 7 August 2013.

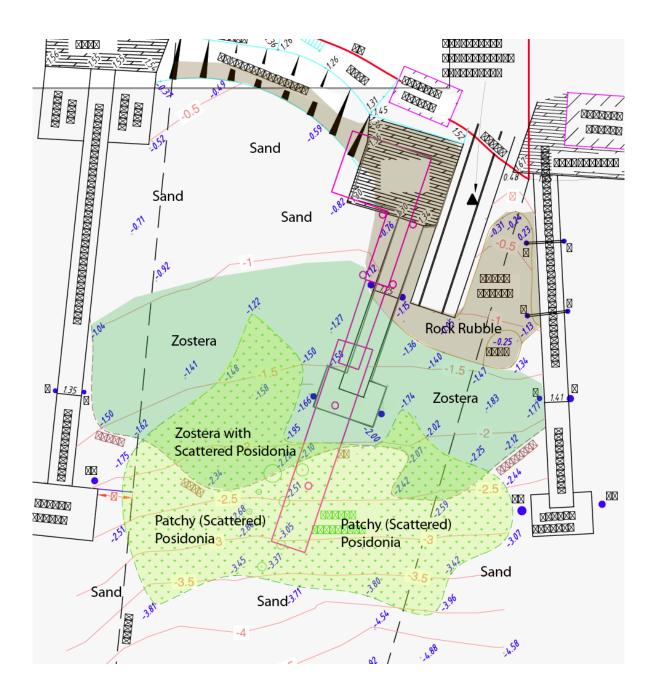
Figure 6 Aquatic Habitats at 967 Barrenjoey Road Palm Beach, surveyed on 9th Jan 2014. Note Green circles under and to the north (left) of the proposed pontoon are surveyed in *Posidonia* patches (see Figure 7).
