Acid Sulfate Soil Management Plan

37 Roseberry Street, Balgowlah NSW 2093

Project No. 24072
Version 2

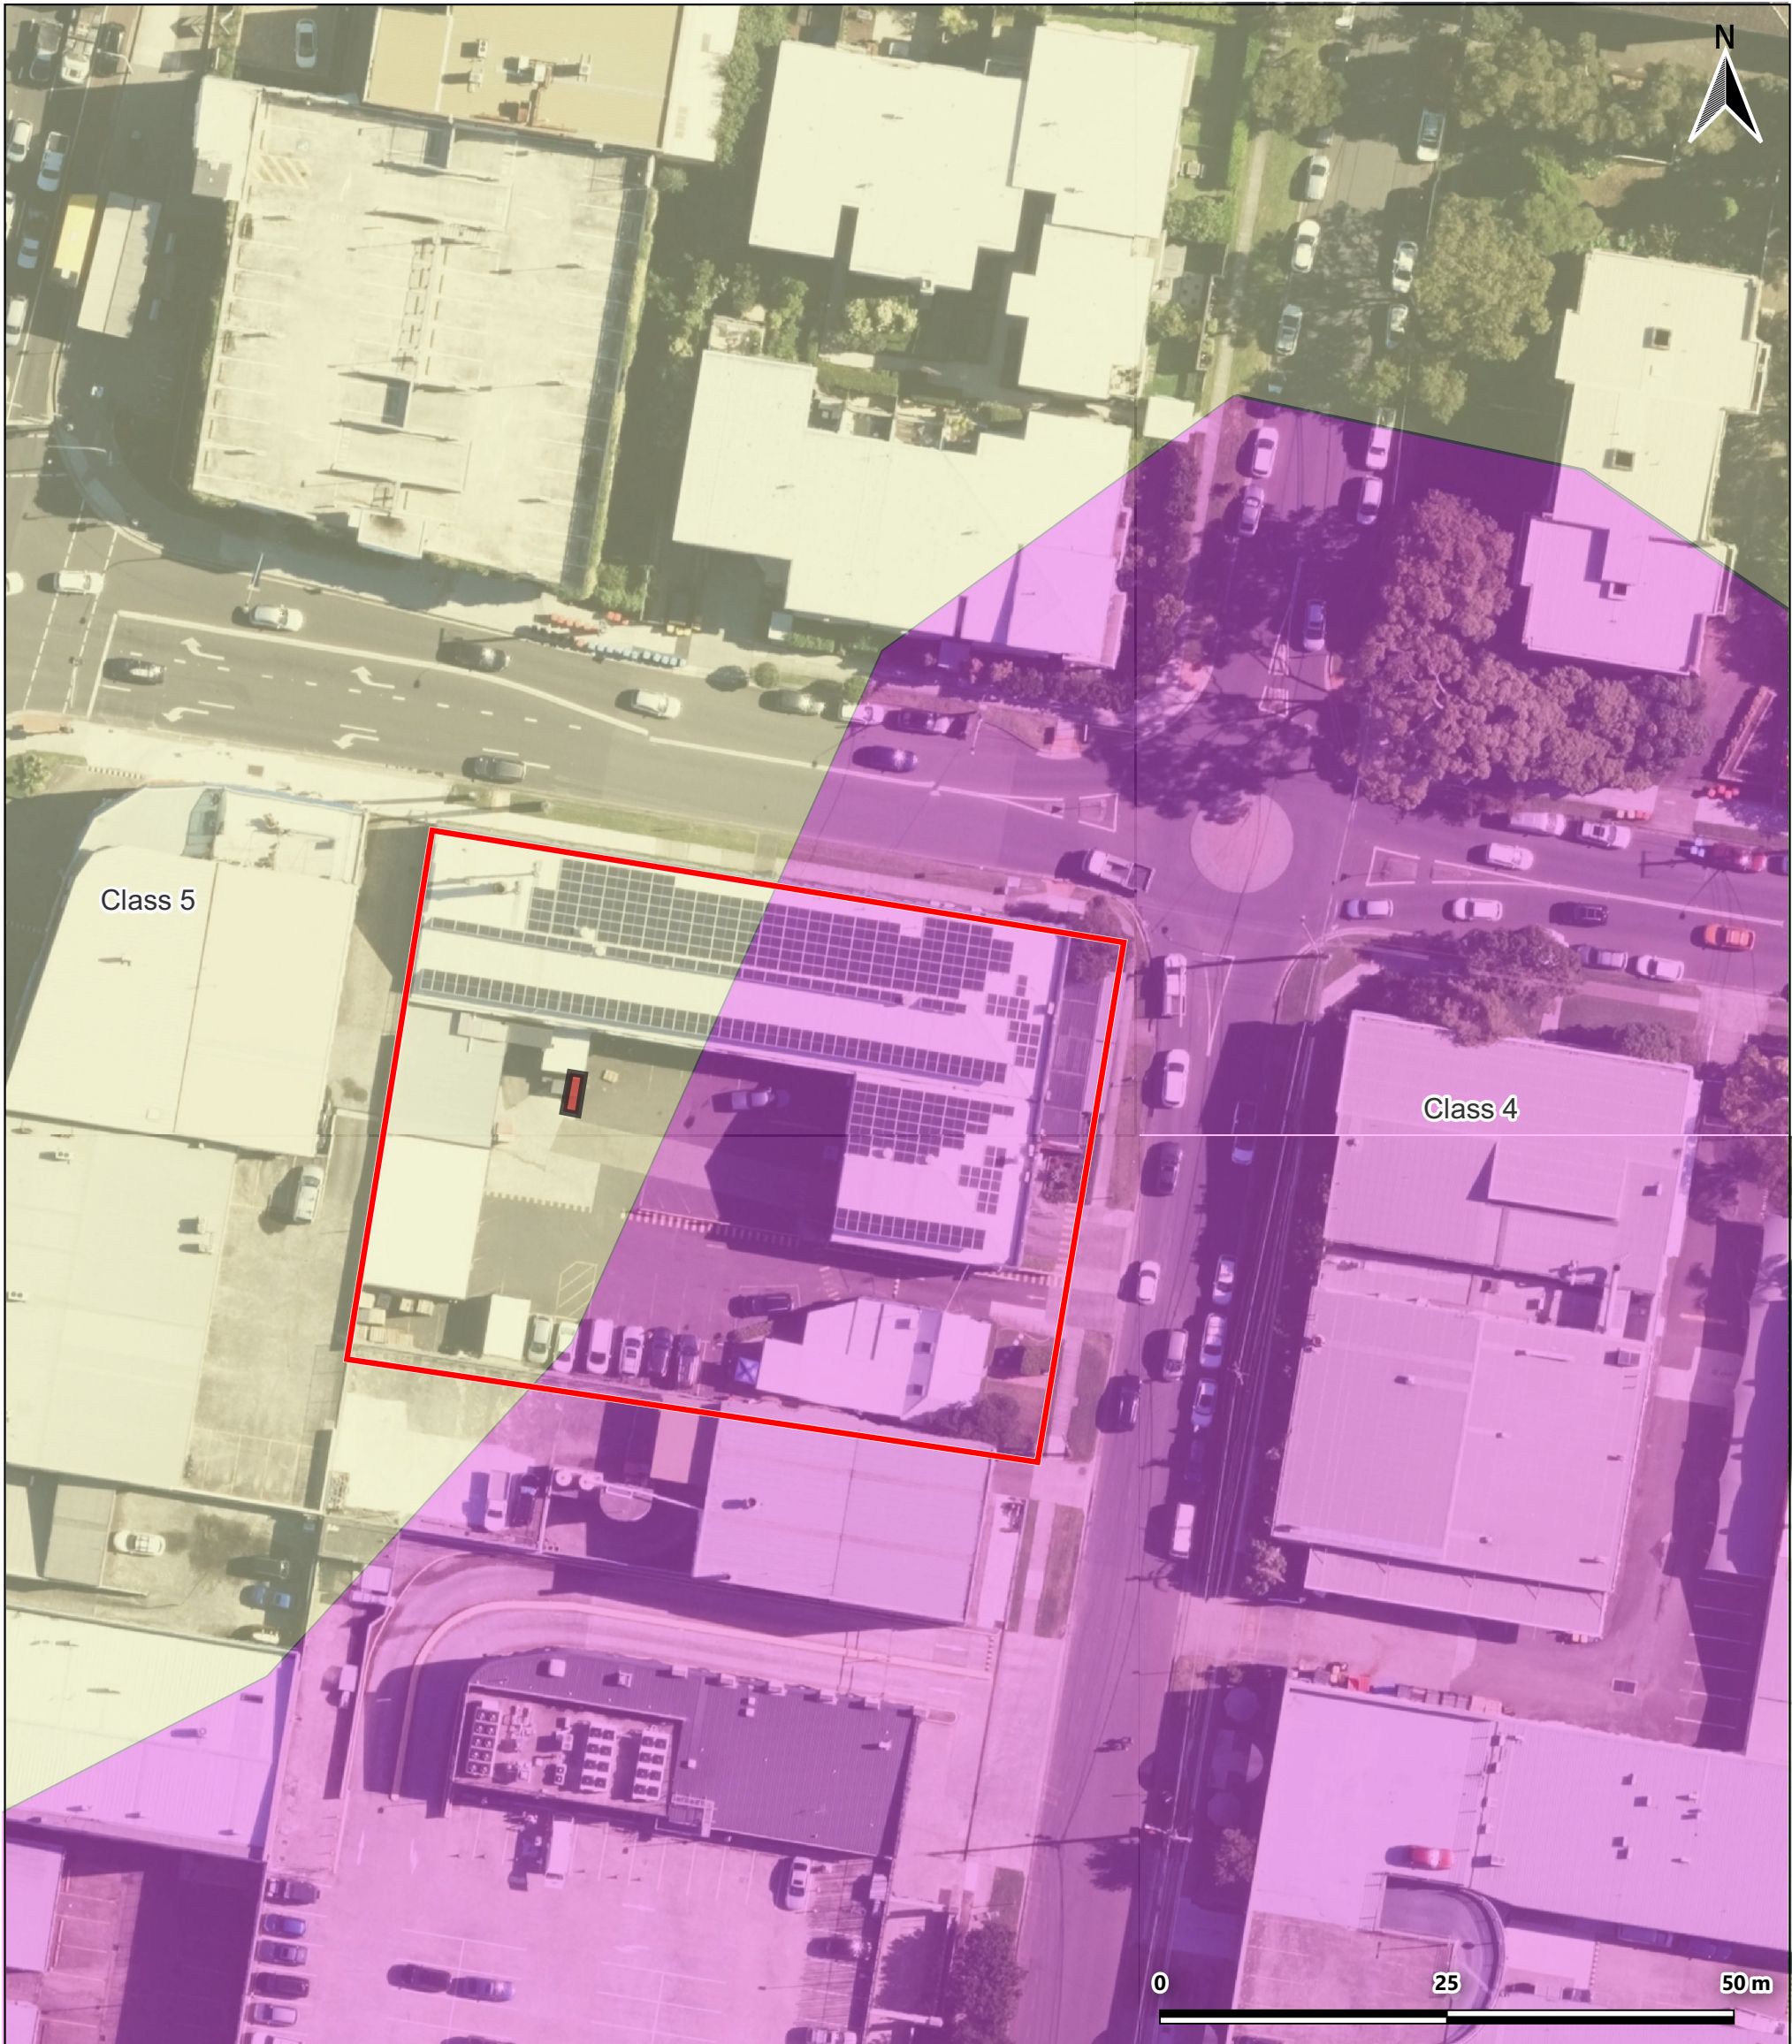
Map 24072_rp03_f02_sitelayout_v01		Legend <div><div><div><div></div></div><div>Site Boundary</div></div><div><div></div></div><div>N/A</div></div> <div><div><div></div></div><div>Possible Trade Waste Location</div></div>
---	--	--

The NSW Department of Planning, Industry and Environment 'eSPADE' NSW Soil and Land information portal identifies the site as being within an area of low probability of ASS occurring less than 3 m below the natural ground surface (L4). The soil landscape is described as consisting of level to gently undulating swales, depressions and infilled lagoons on quaternary sands. This corroborates with data detailed above in **Table 2-1** from Manly LEP mapping, which is presented in **Figure 2, Appendix A**.
