J3685. 3rd September, 2021. Page 1.

GEOTECHNICAL INVESTIGATION:

New Unit Block at 18 Alexander Street, Collaroy

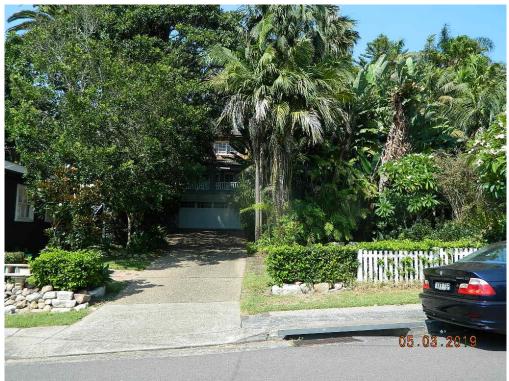
Photo 1

- 2.3 At the road frontage, a concrete driveway runs to a garage beneath the house (Photo 1). A free-standing studio is located beside the driveway (Photo 2). This will be demolished as part of the proposed works. A gravel driveway runs up the slope to a car parking space on the E side of the studio (Photo 3). The area between the road frontage and the house is otherwise densely vegetated (Photo 4). The house will also be demolished as part of the proposed works (Photo 5). A stable timber retaining wall reaching a maximum height of ~1.0m terraces the slope on the E side of the house and

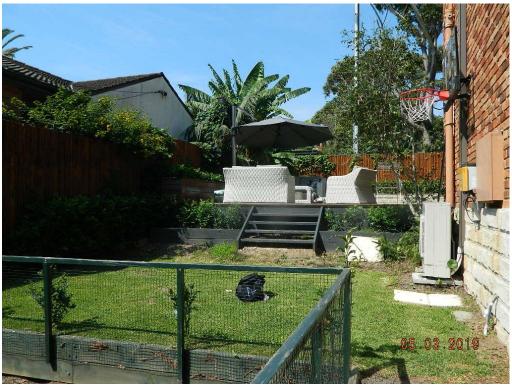
Photo 6

will be demolished as part of the proposed works (Photo 6). A near level lawn area rises from the uphill side of the house to a stable ~0.5m high sandstone block retaining wall along the uphill boundary (Photo 7). A recently constructed pool in the SW corner of the property will also be demolished as part of the proposed works (Photo 8). No signs of movement were observed on the grounds. The adjoining neighbouring properties were observed to be in good order as seen from the road and the subject

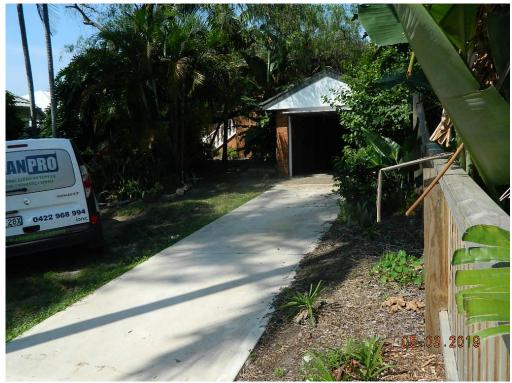
Photo 9

HAZARDS	Hazard One	Hazard Two		
ТҮРЕ	The proposed excavation collapsing onto the worksite and impacting on the E neighbouring property before retaining walls are in place.	The proposed excavation undercutting the neighbouring house to the E, causing failure in the supporting walls of the neighbouring house (Photos 9 & 10).		
LIKELIHOOD	'Likely' (10 ⁻²)	'Possible' (10 ⁻³)		
CONSEQUENCES TO PROPERTY	'Medium' (30%)	'Medium' (15%)		
RISK TO PROPERTY	'Moderate' (2 x 10 ⁻⁴)	'Moderate' (2 x 10 ⁻⁴)		
RISK TO LIFE	6.5 x 10 ⁻⁴ /annum	8.3 x 10 ⁻⁵ /annum		
COMMENTS	This level of risk to life and property is 'UNACCEPTABLE'. To move the risk levels to acceptable levels, the recommendations in Section 13 are to be followed.	This level of risk to life and property is 'UNACCEPTABLE'. To move the risk levels to acceptable levels, the recommendations in Section 13 are to be followed.

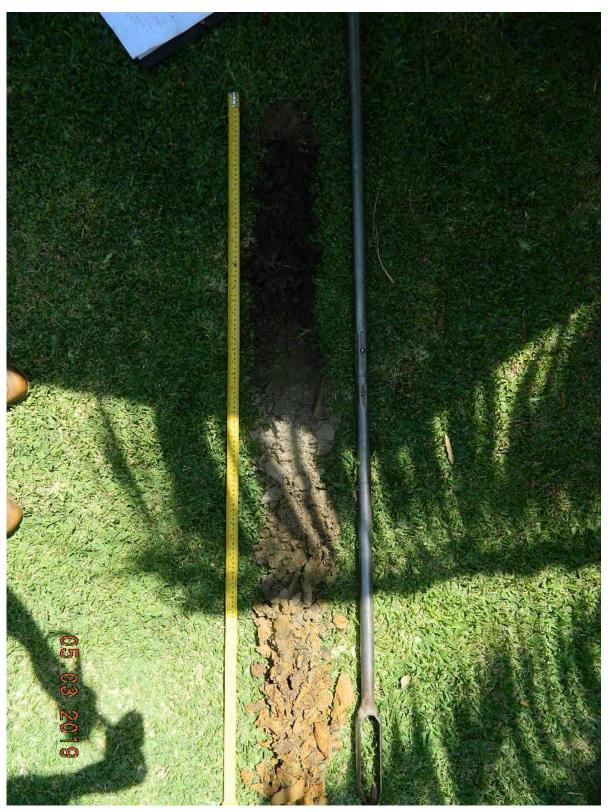
AUGER HOLE 1 (~RL12.4) – AH1 (Photo 11)

Depth (m)	Material Encountered
0.0 to 0.1	FILL , disturbed sandy soil, light brown, loose, fine to medium grained, organic matter, dry.
0.1 to 0.6	SANDY SOIL , dark brown, rock fragments, fine to medium grained, loose, dry.
0.6 to 0.8	SAND, light grey, loose, fine to medium grained, dry.
0.8 to 0.9	SAND, light tan, loose, fine to medium grained, dry.
0.9 to 1.3	SANDY CLAY , orange with yellow and grey mottling, firm to stiff, fine to medium grained, dry.
1.3 to 1.4	SANDY CLAY , orange with yellow and grey mottling, stiff, fine to medium grained, dry.

End of test @ 1.4m in sandy clay. No water table encountered.

Photo 11: Auger Hole 1: The base of auger hole is at the base of the image.
