# Geotechnical Landslide Risk Assessment

1112 - 1116 Barrenjoey Road, Palm Beach NSW

**Report No:** E25203.G14\_Rev2

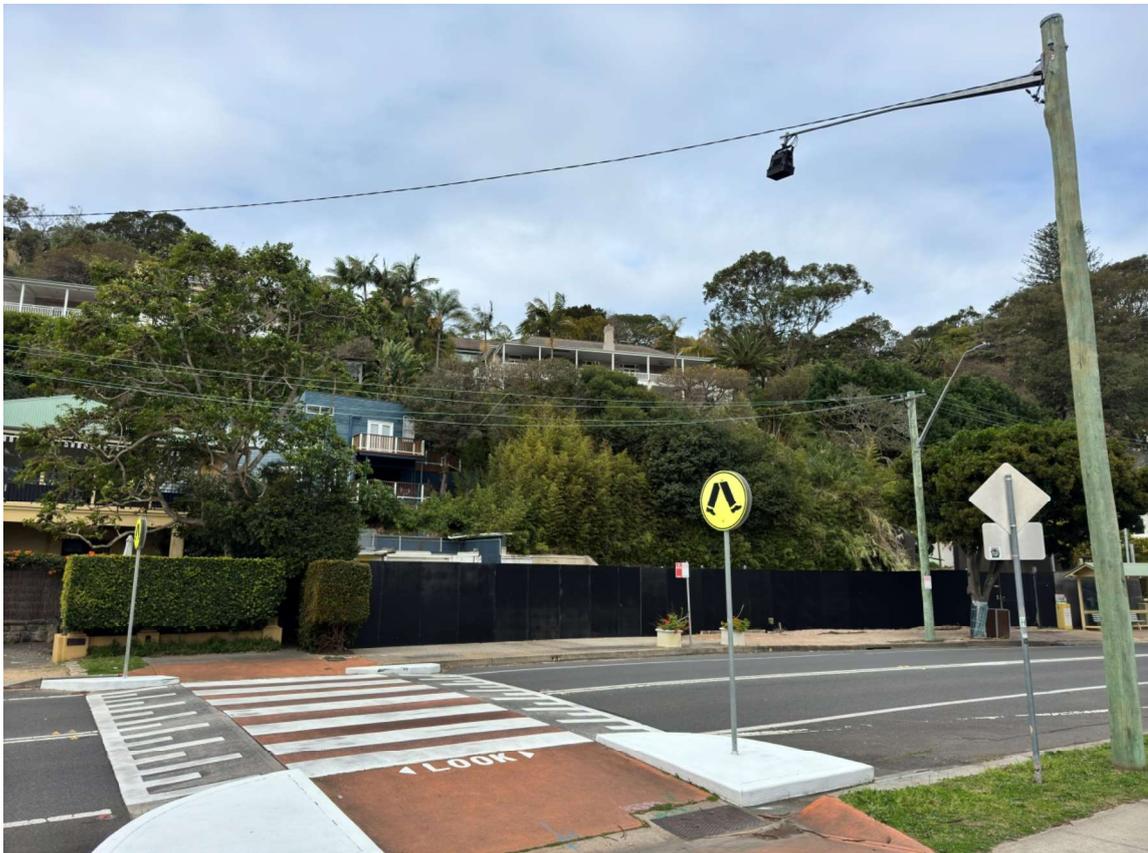
**Plate 3:** View of the site looking SE from Barrenjoey Rd

The current site conditions at the front half of the site are shown in **Plates 3 – 6** below.

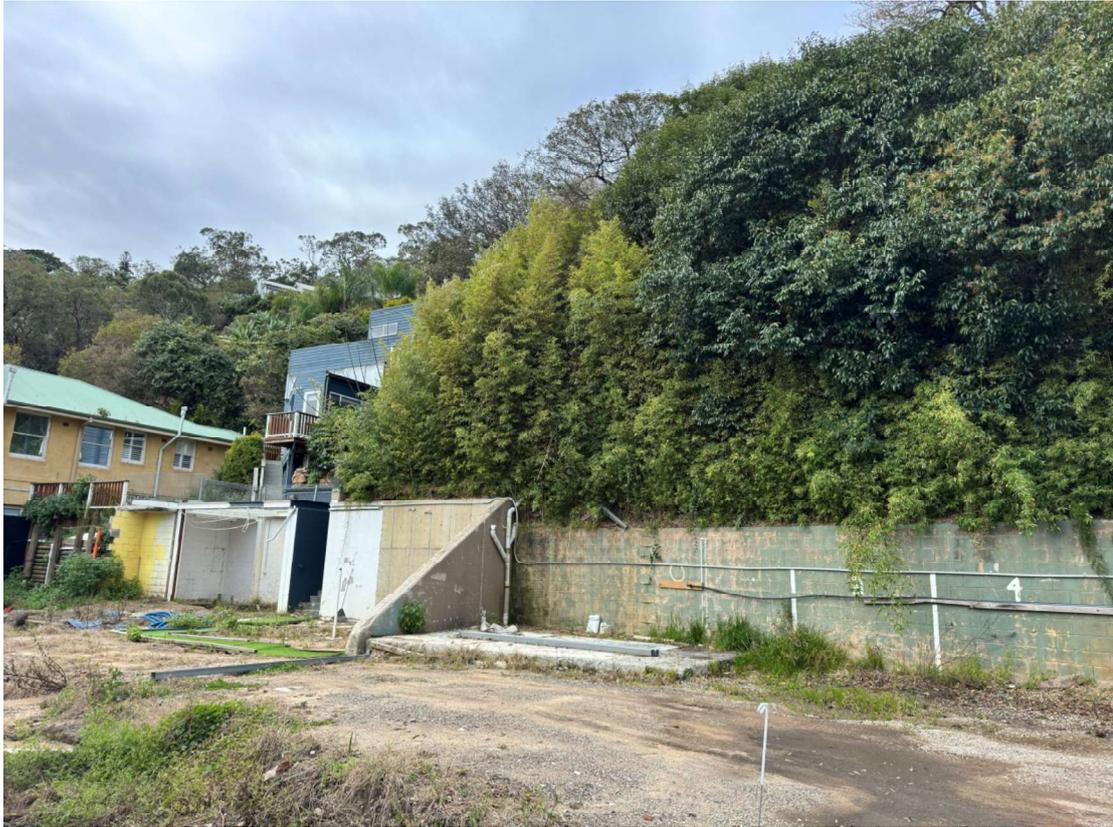
**Plate 4:** Interior view at front half of the site, looking to NE.

The excavation into the toe of the slope is supported by the 2.5m high block wall, **Plates 4 & 5**.

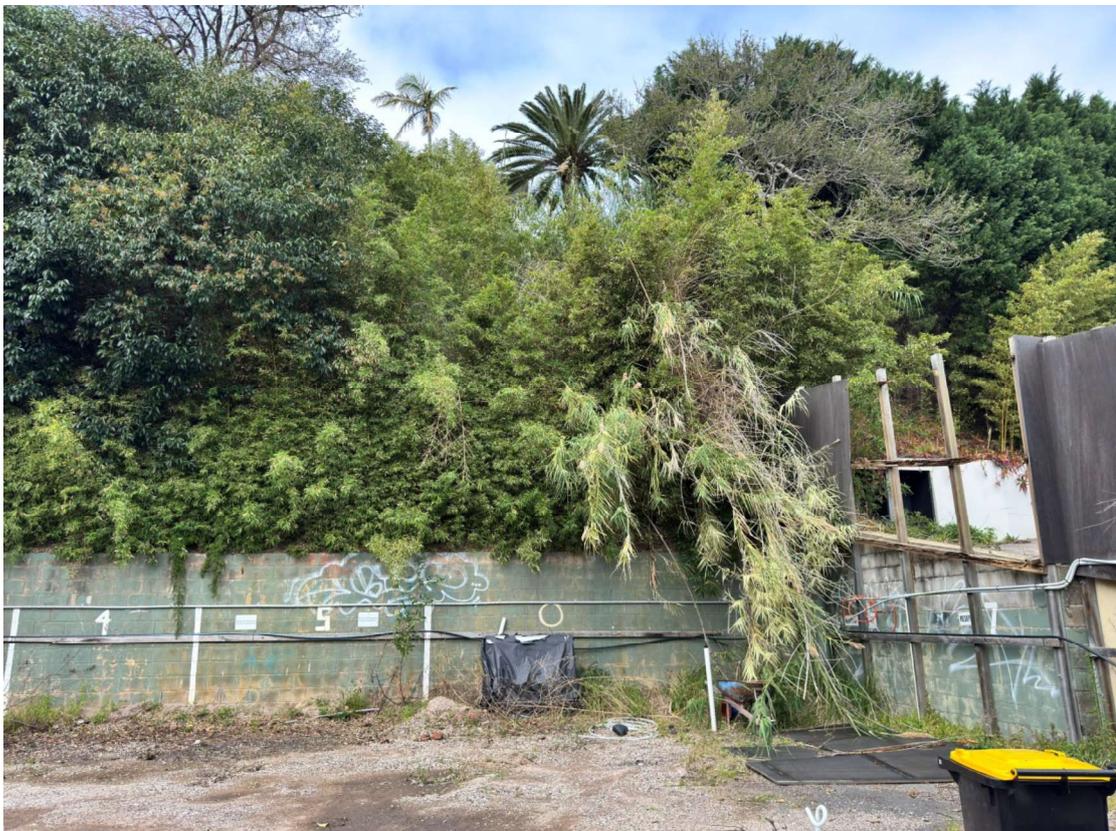
**Plate 5:** Interior view at front half of the site, looking to east.

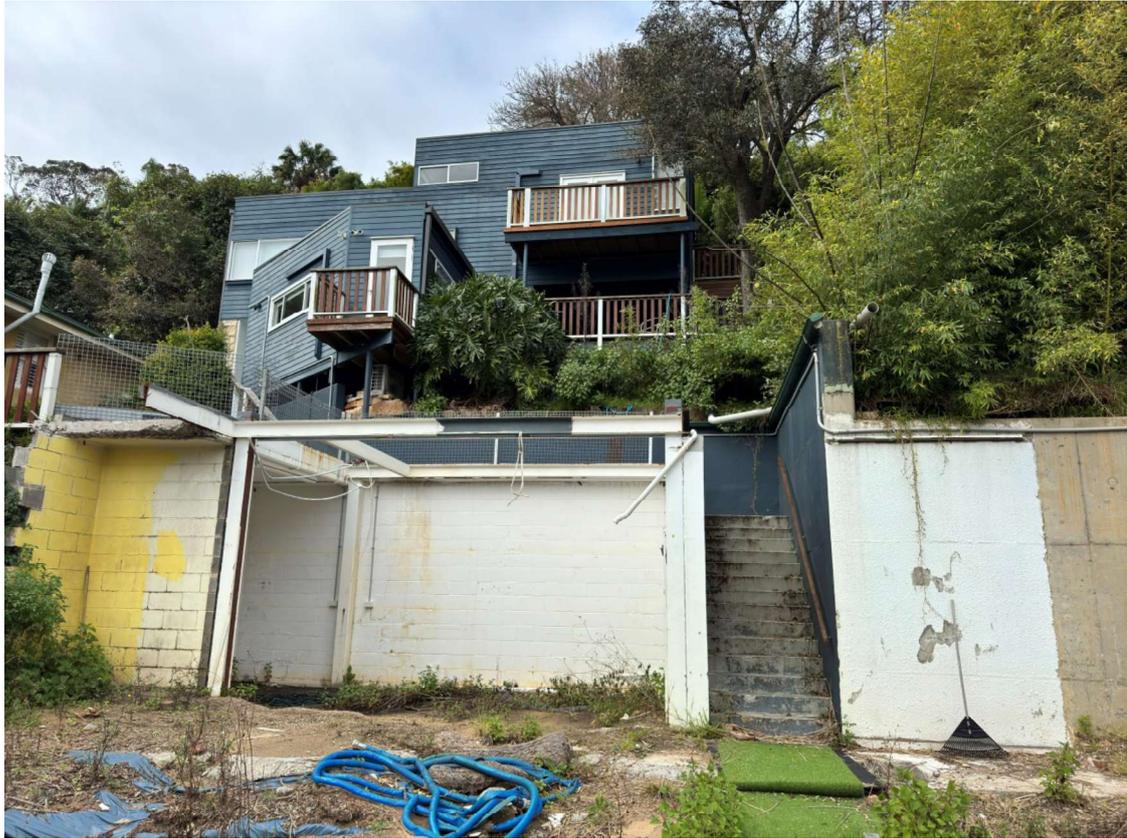
**Plate 6:** View east at northern side, partly demolished remains with remaining dwelling uphill.

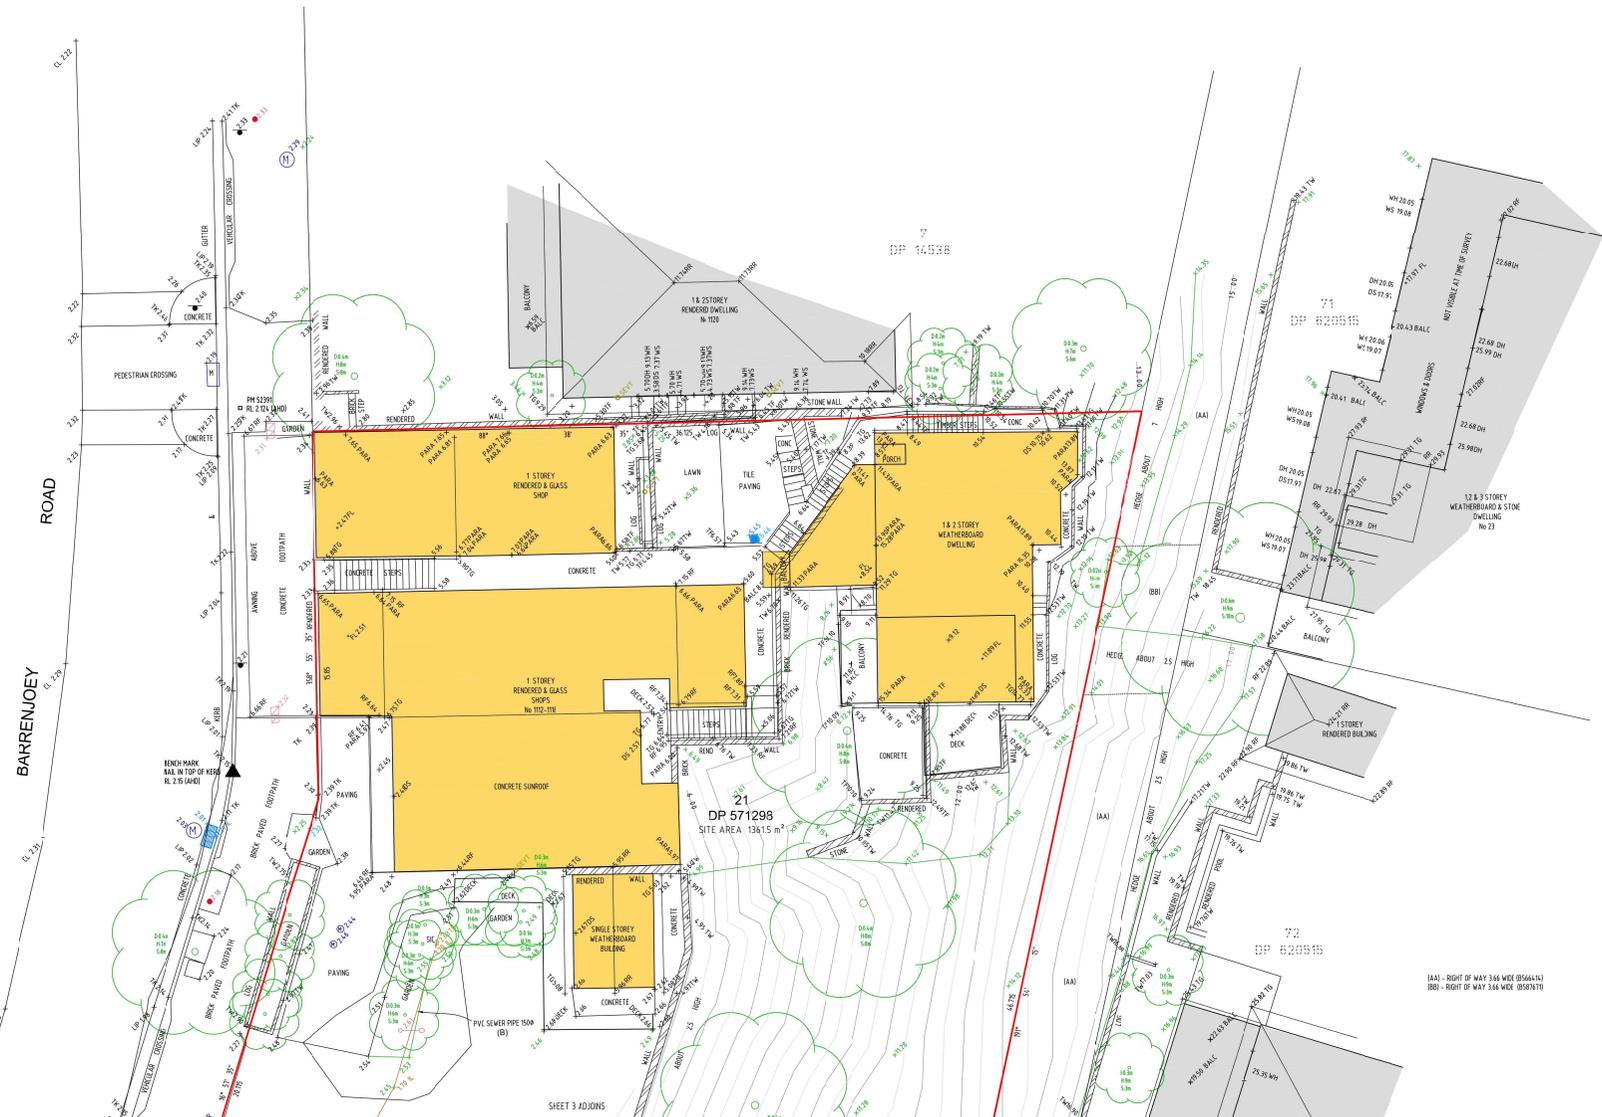
Figure:  
**2.1**  
 Project: E25203.G14

**Palmdev Pty Ltd**  
 Landslide Risk Assessment  
 1112-1118 Barrenjoey Road, Palm Beach NSW  
 Survey Plan, Sheet 1 of 2

Survey details of the site are provided in **Figure 2** herewith.

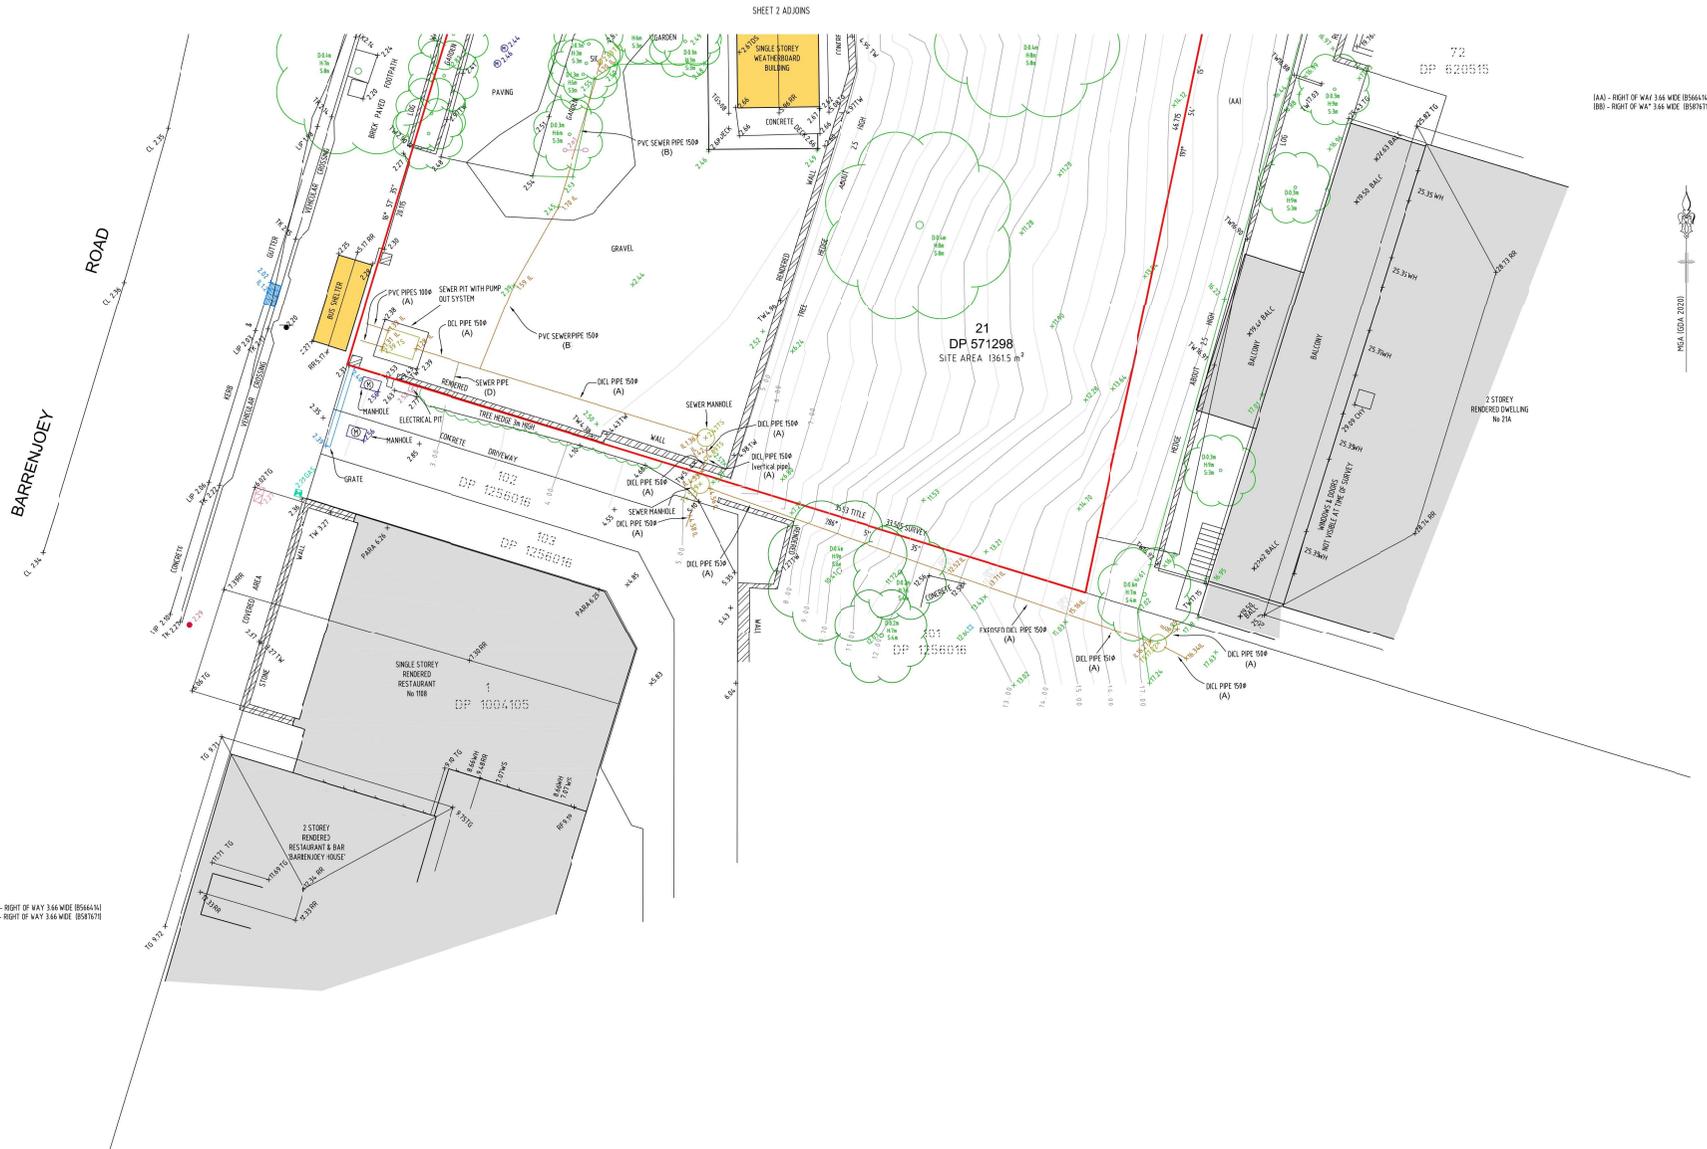
Figure:  
**2.2**  
 Project: E25203.G14

**Palmdev Pty Ltd**  
 Landslide Risk Assessment  
 1112-1118 Barrenjoey Road, Palm Beach NSW  
 Survey Plan, Sheet 2 of 2

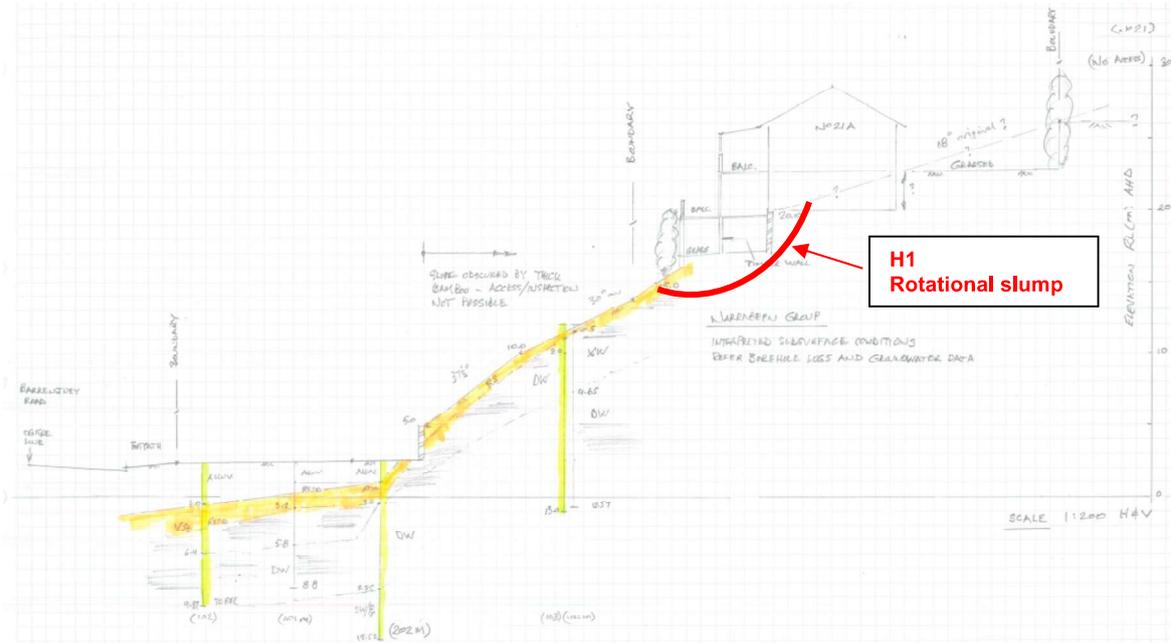
- **Hazard H1** - *rotational slump failure of the steep slope above the proposed excavation.*

The slope above the property boundary at the rear of 1112 – 1116 Barrenjoey Rd, also above the proposed excavation, is susceptible to failure from several trigger mechanisms:-

**Plate A1:** Hazard H1 definition.

Potential hazards or slope/structure failure mechanisms considered feasible are shown in **Plate A1** and **Plate A2**, and are discussed below.

Damage to property occasioned from a slope failure of this type and scale could affect No.21A and No.23 Palm Beach Rd at a range of consequence levels as treated below in **Table A1(a)**. The spatial relationship between the proposed excavation and each of the two uphill properties is shown on the slope section presented in **Plate A1**.

A cross section for No.23 Palm Beach Rd was not included, as the risks associated with that property are dealt with under Hazard H1 as for No.21A Palm Beach Rd. See also **Plate A1**.

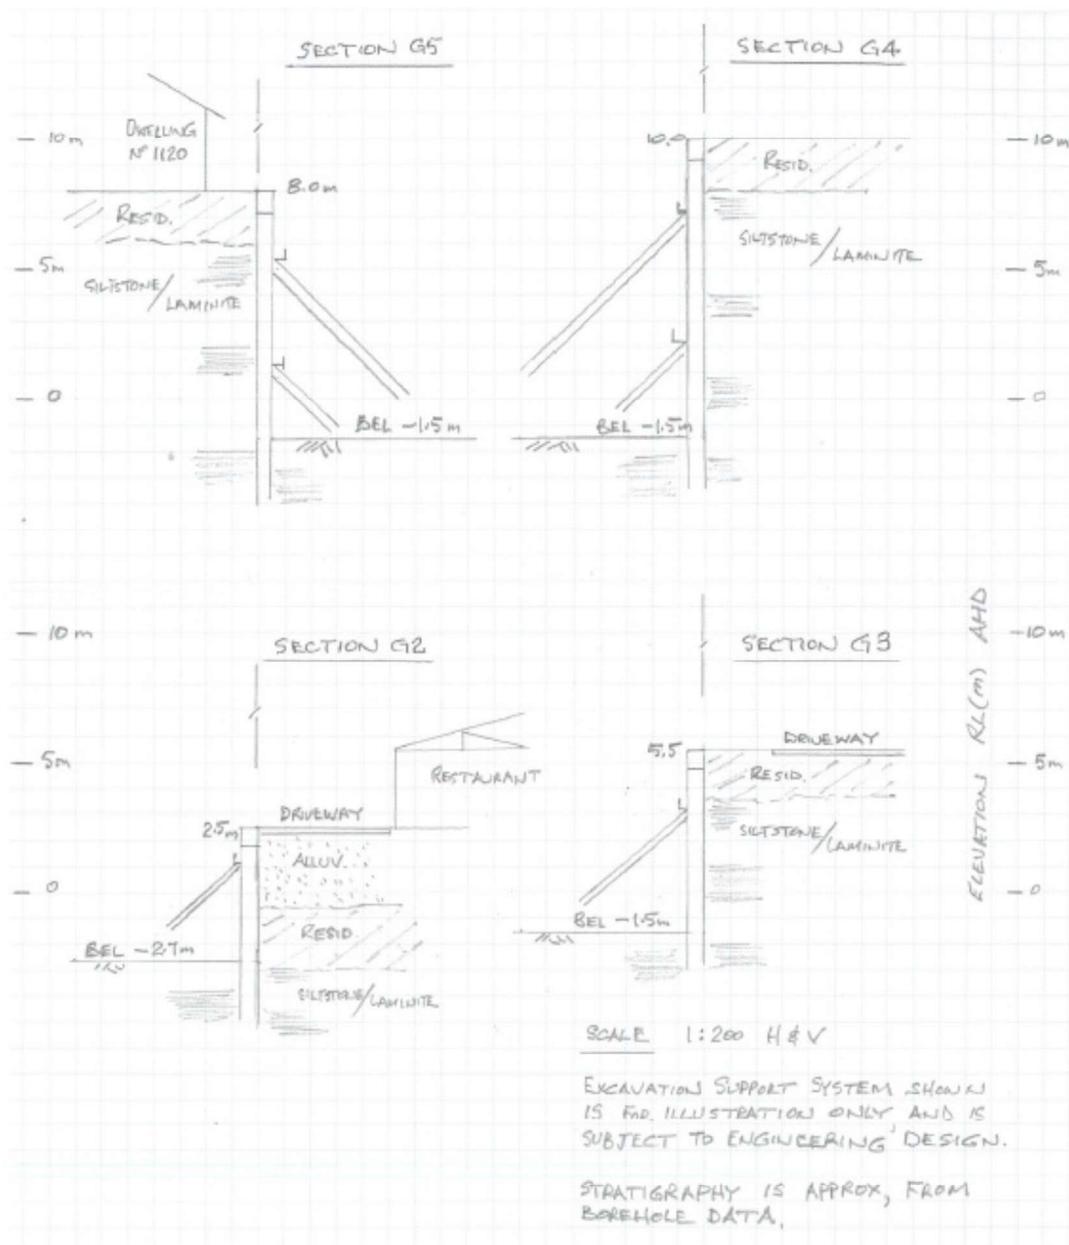
The hazard assessed is a movement or failure of the pile wall excavation support system. Two scenarios are assumed:-

**Plate A2:** Hazard H2, excavation geometry, Sections G2 – G5.  
[Section locations shown on **Plate A3**]

Analysis Case	Section No.	Excavation Depth (Wall Height)	Adjoining Development
H2(i)	G2	5.2m	Driveway (access to battle-axe properties) and Restaurant ("Barrenjoey House")
H2(ii)	G3	7.0m	Driveway (access to battle-axe properties)
H2(iii)	G4	11.5m	Undeveloped slope (Lot 101) above "Barrenjoey House"
H2(iv)	G5	9.5m	House on No.1120 Barrenjoey Rd

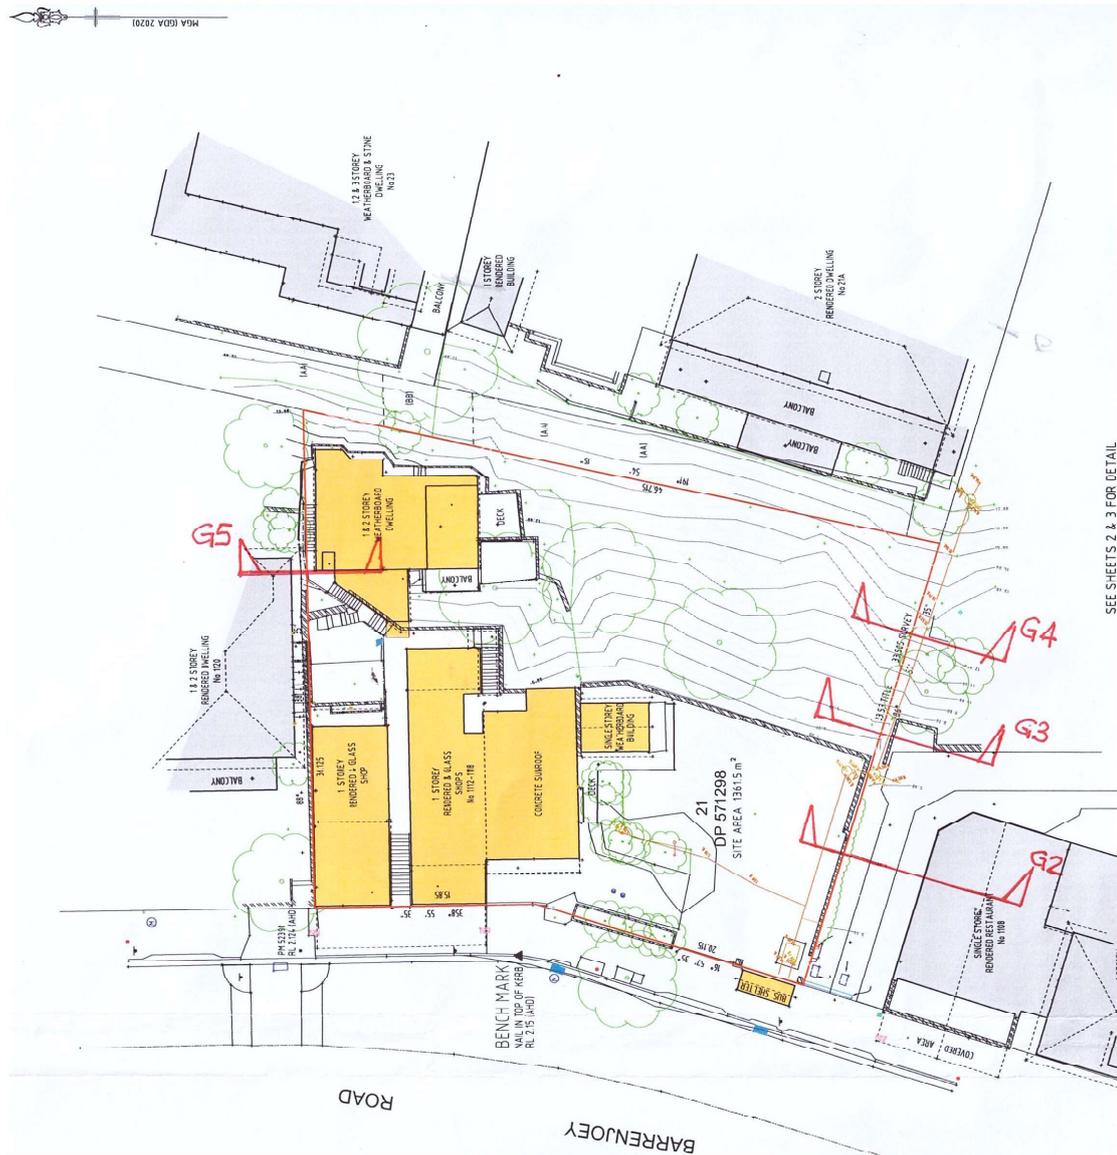
**Plate A3:** Section Locations (Base Survey Plan by Beveridge Williams).

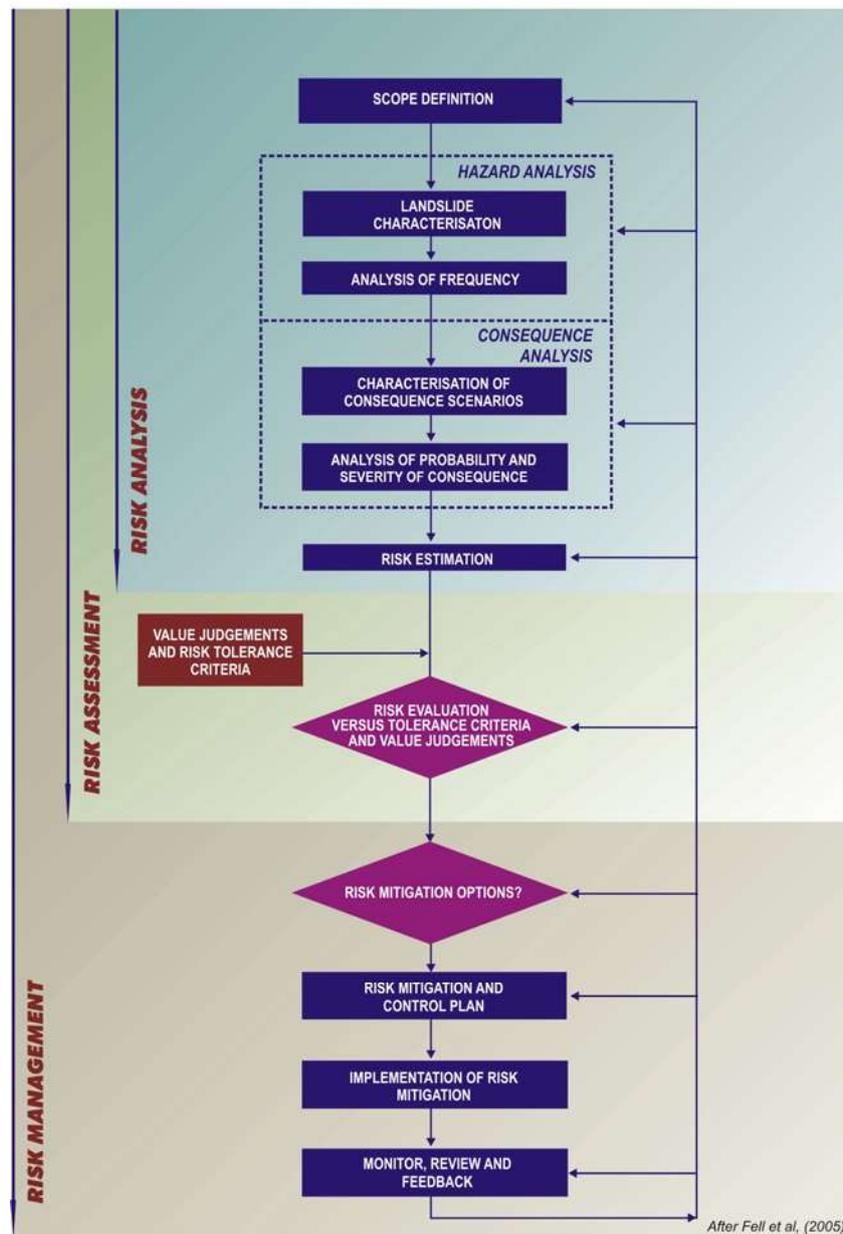
Figure 1.

The Framework for LRM presented in Figure 1 is similar to the flow chart in AGS (2000). However, it has been simplified in presentation and has been amended slightly from AGS (2000) to reflect the inclusion of Frequency Analysis as part of Hazard Analysis (in accordance with the abovementioned definition of hazard and as defined in AGS 2000).
