GEOTECHNICAL INVESTIGATION:

New House and Pool at **24 Beach Road, Collaroy**

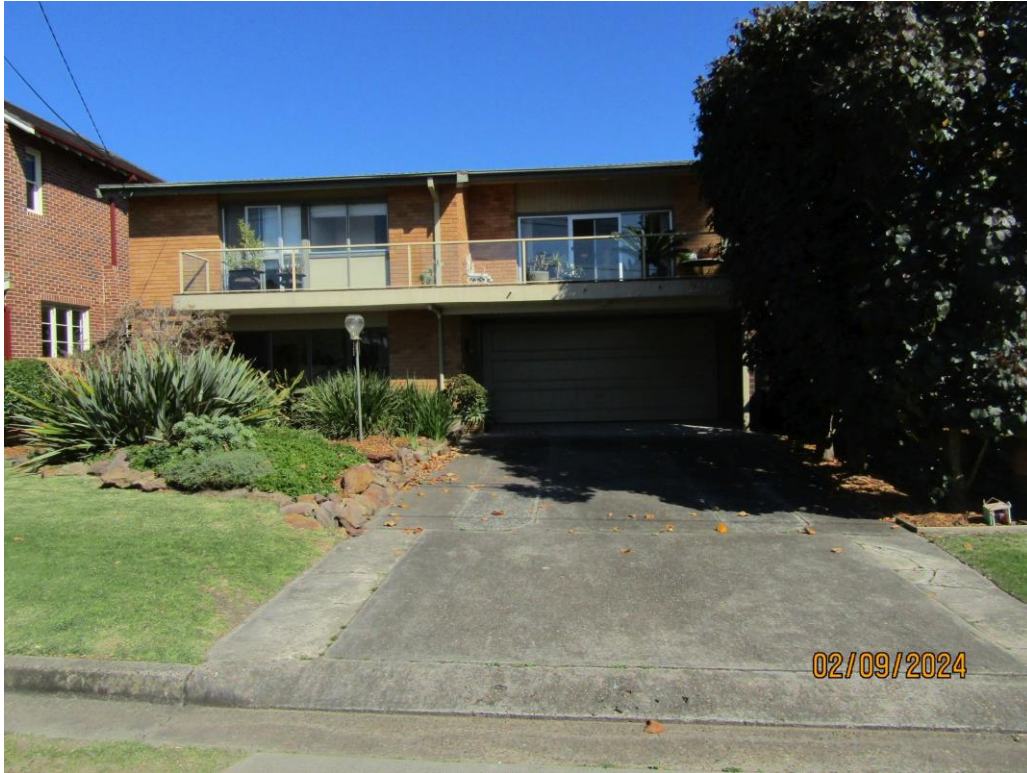
Photo 1

- 2.3** At the Beach Road frontage, a concrete driveway runs to a garage on the ground floor of the house (Photo 1). The part two storey house with garage is supported on brick walls and columns (Photos 1 & 2). The external supporting walls show no significant signs of movement and the supporting columns stand vertical. Near level lawn and garden areas extend off the E and W sides of the house. A concrete driveway accessed from Cliff Road runs to a parking area at the W side of the house

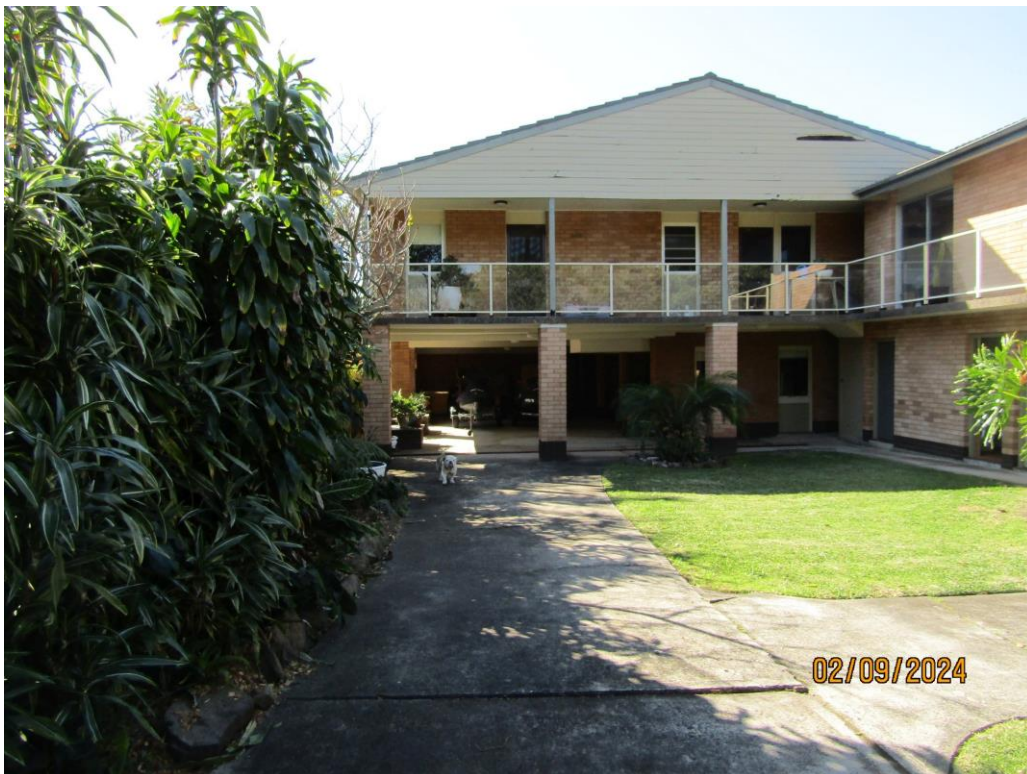
Photo 2

(Photo 2). The adjoining neighbouring properties were observed to be in good order as seen from the street and subject property.

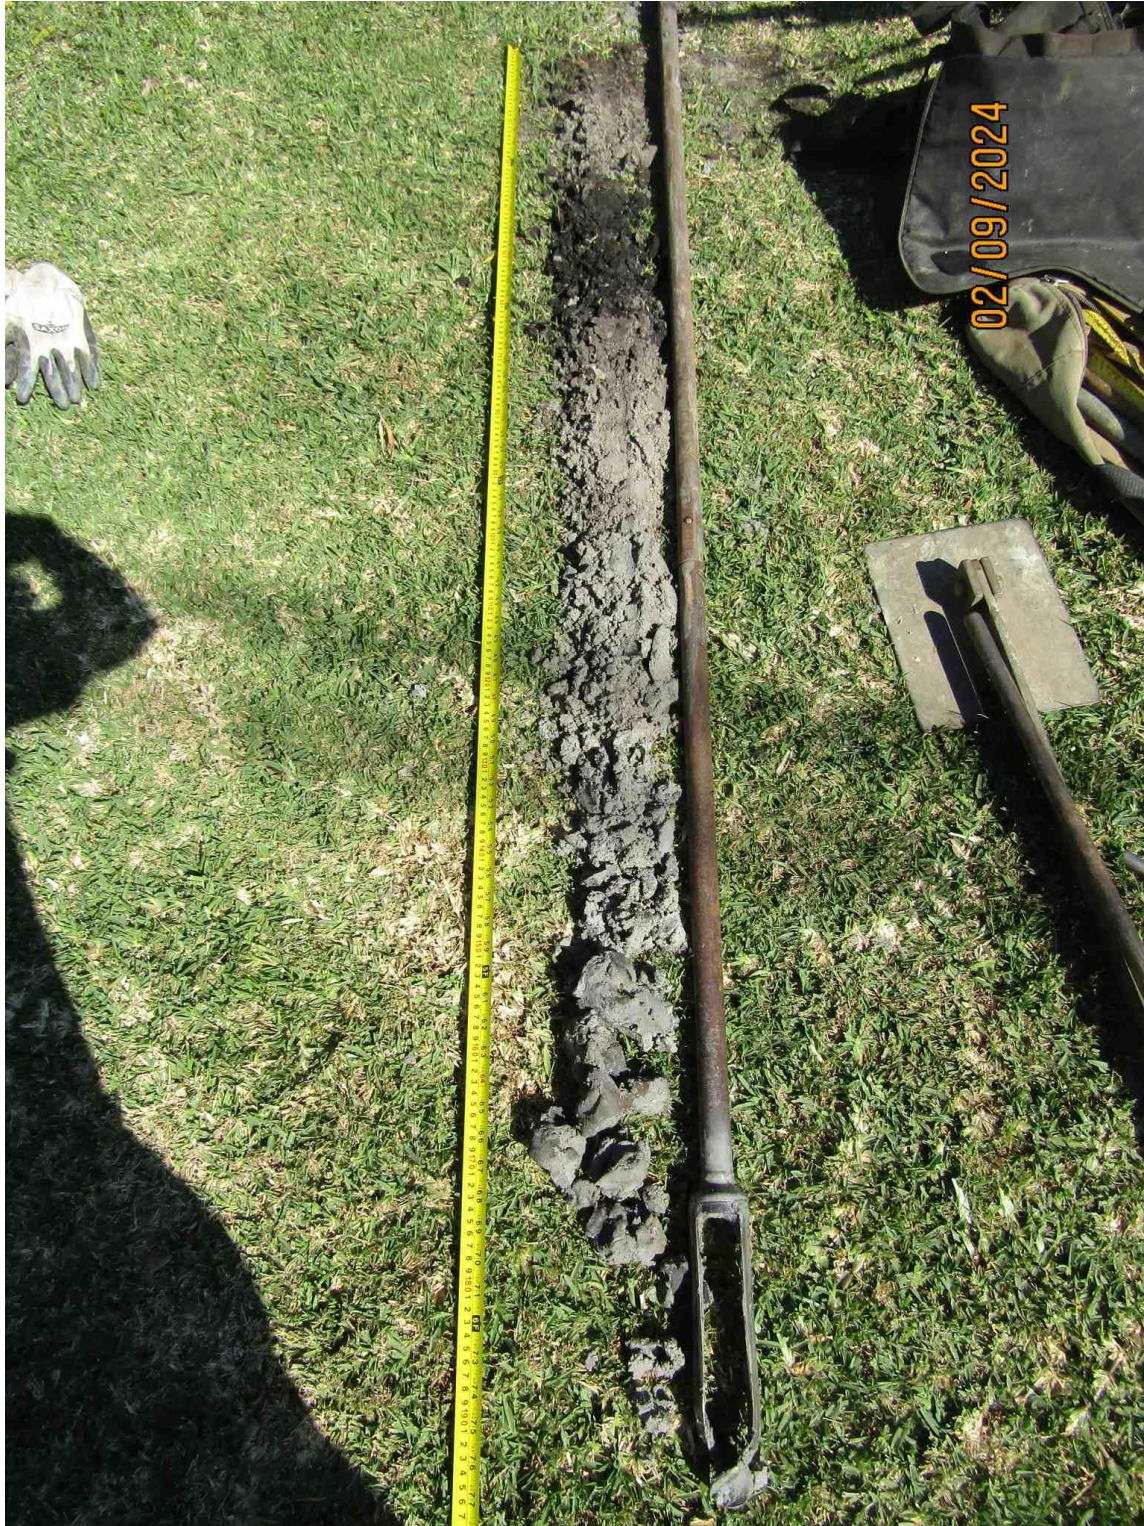
AUGER HOLE 1 (~RL9.5) – AH1 (Photo 3)

Depth (m)	Material Encountered
0.0 to 0.3	FILL , silty soil and sand, dark brown, grey, moist, fine to medium grained.
0.3 to 0.7	TOPSOIL , silty and peaty soil, dark brown, black, moist, Medium Dense, fine to medium grained, high organic content.
0.7 to 1.4	ALLUVIAL SEDIMENT , Sand, grey, moist to damp, Dense, medium grained.
1.4 to 2.0	CLAY , probably alluvial sediment, damp to wet, Stiff to Hard.

Refusal @ 2.0m on Hard Clay. Groundwater seepage encountered at 1.6m.

Photo 3: AH1 – Downhole is from top to bottom.
