DETAILED GEOTECHNICAL REPORT

**PROPOSED CHILD CARE CENTRE
723-727 Warringah Road Forestville NSW**

N.G. Child & Associates

9 November 2021

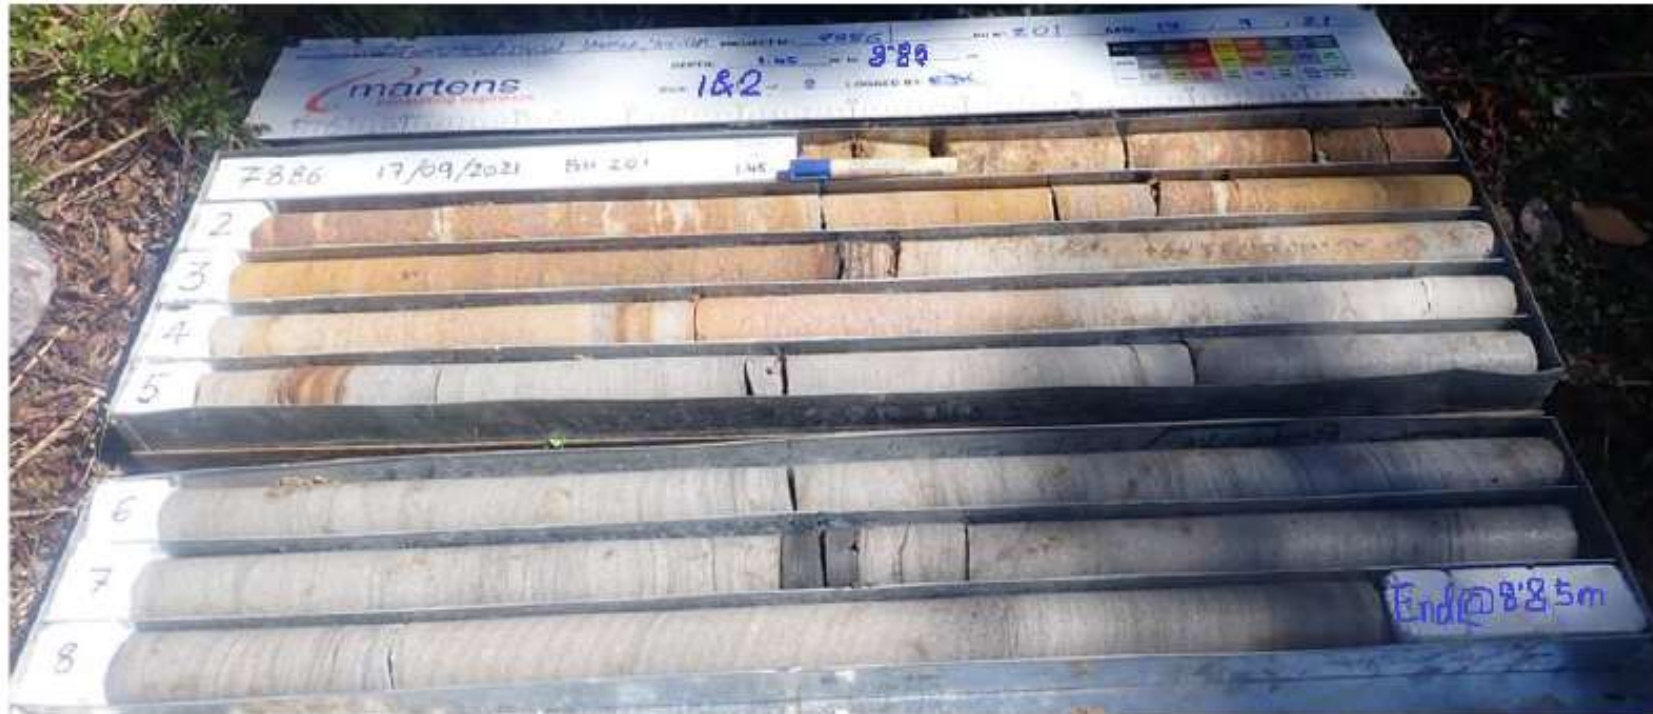
Martens & Associates Pty Ltd ABN 85 070 240 890		Environment Water Wastewater Geotechnical Civil Management	
Drawn:	WB	PHOTO OF ROCK CORE (BH201) Proposed Child Care Centre - 723-727 Warringah Road, Forestville, NSW	Drawing:
Approved:	SK		FIGURE 2
Date:	26.10.2021		File No: P200788&JR01 V01
Scale:	N/A

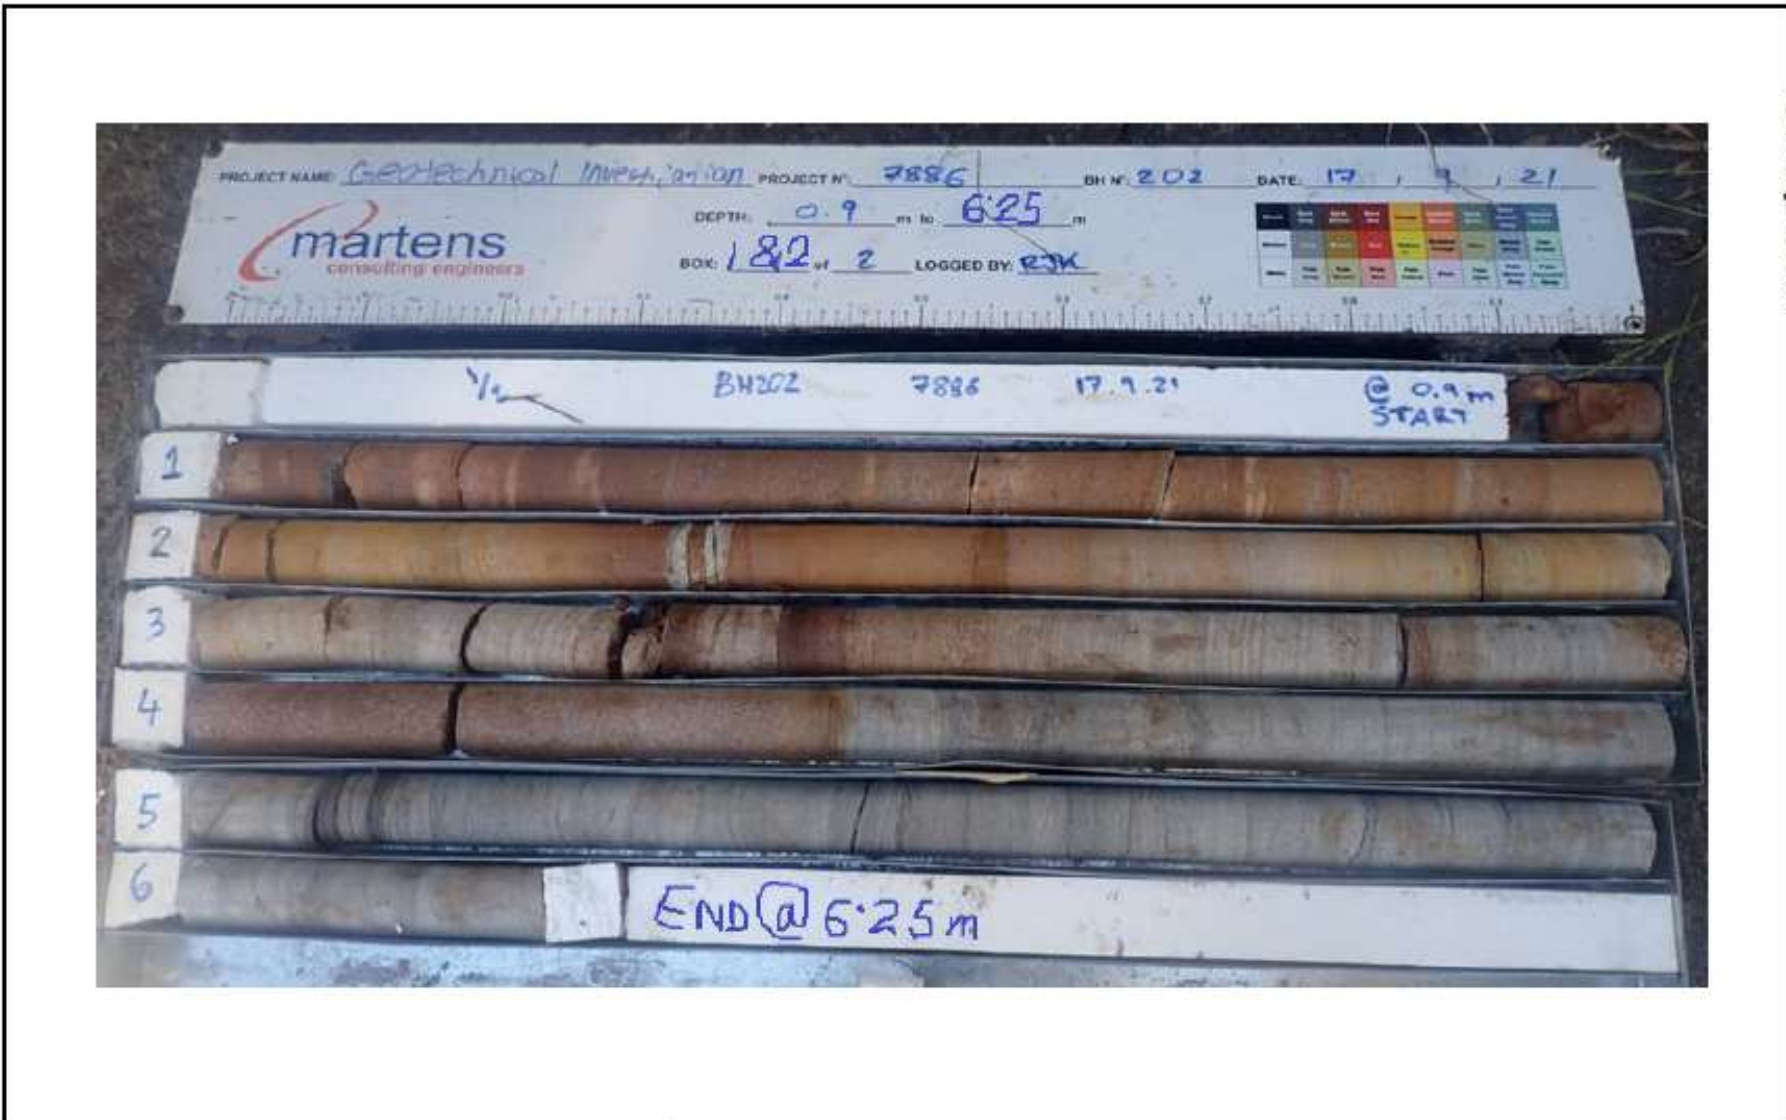
Martens & Associates Pty Ltd ABN 85 070 240 890		Environment Water Wastewater Geotechnical Civil Management	
Drawn:	WB	PHOTO OF ROCK CORE (BH202) Proposed Child Care Centre - 723-727 Warringah Road, Forestville, NSW	Drawing:
Approved:	SK		FIGURE 3
Date:	26.10.2021		File No: P200788&JR01 V01
Scale:	N/A
