# GEOTECHNICAL ASSESSMENT

**PRIME ENGINEERING CONSULTANTS PTY LTD**

*790A Barrenjoey Road, Palm Beach, New South Wales*

*Report No: 20/1245*

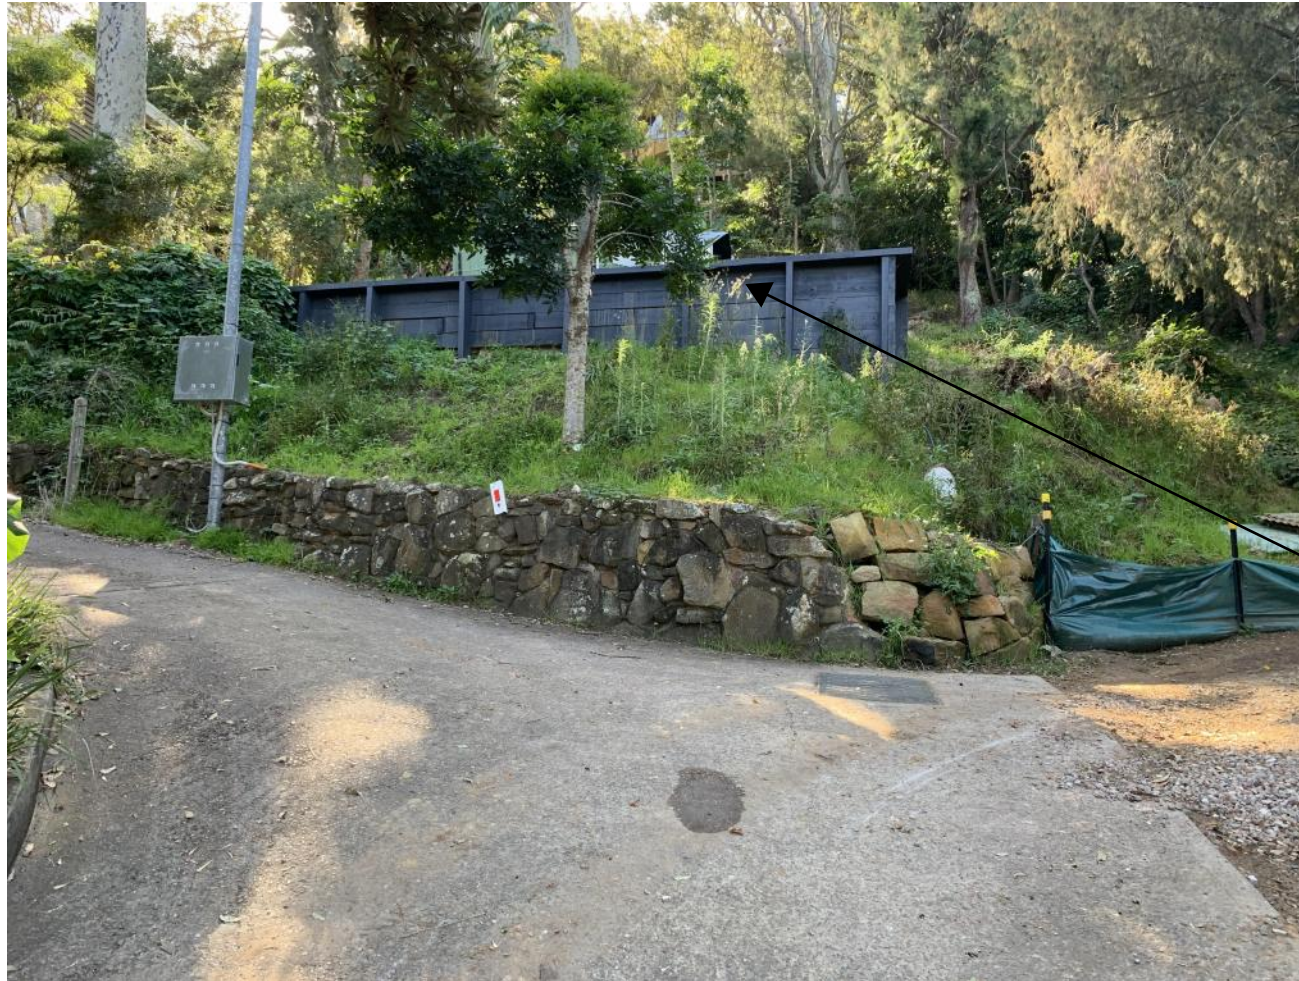
**PROJECT: 790A BARRENJOEY ROAD, PALM BEACH**  
**PROJECT No: 30433/3736D-G**  
**REPORT No: 20/1245**  
**TITLE: PHOTO 1 - FRONT OF SITE**

| Hazard Description | Estimated Volume (m <sup>3</sup> ) | Justification |
|---|---|---|
| Failure of the recently constructed retaining wall at the front of the proposed dwelling (H2) | 10 | The existing wall appears stable, however the fill placed behind the wall has not been compacted during placement. Any movement or failure of this wall could have significant consequences not only for down slope receptors, but also any structures that may be supported by the retaining wall backfill. |

**Recently  
constructed  
retaining  
wall**

At the time of writing this report it was not known if the recently constructed retaining wall at the front of the site (Hazard 2) is to remain, or if it will be demolished as part of the bulk earthworks. If the wall is to remain then it is recommended that independent engineering certification for the wall be obtained. Further, the backfill of the wall appears poorly compacted, and therefore under no circumstances should footings be constructed within these backfill materials.

Under no circumstances should structural loads be founded within topsoil or uncontrolled fill materials. Further, no structural loads should be founded within the zone of influence of the recently constructed retaining wall at the front of the site (Hazard 2).

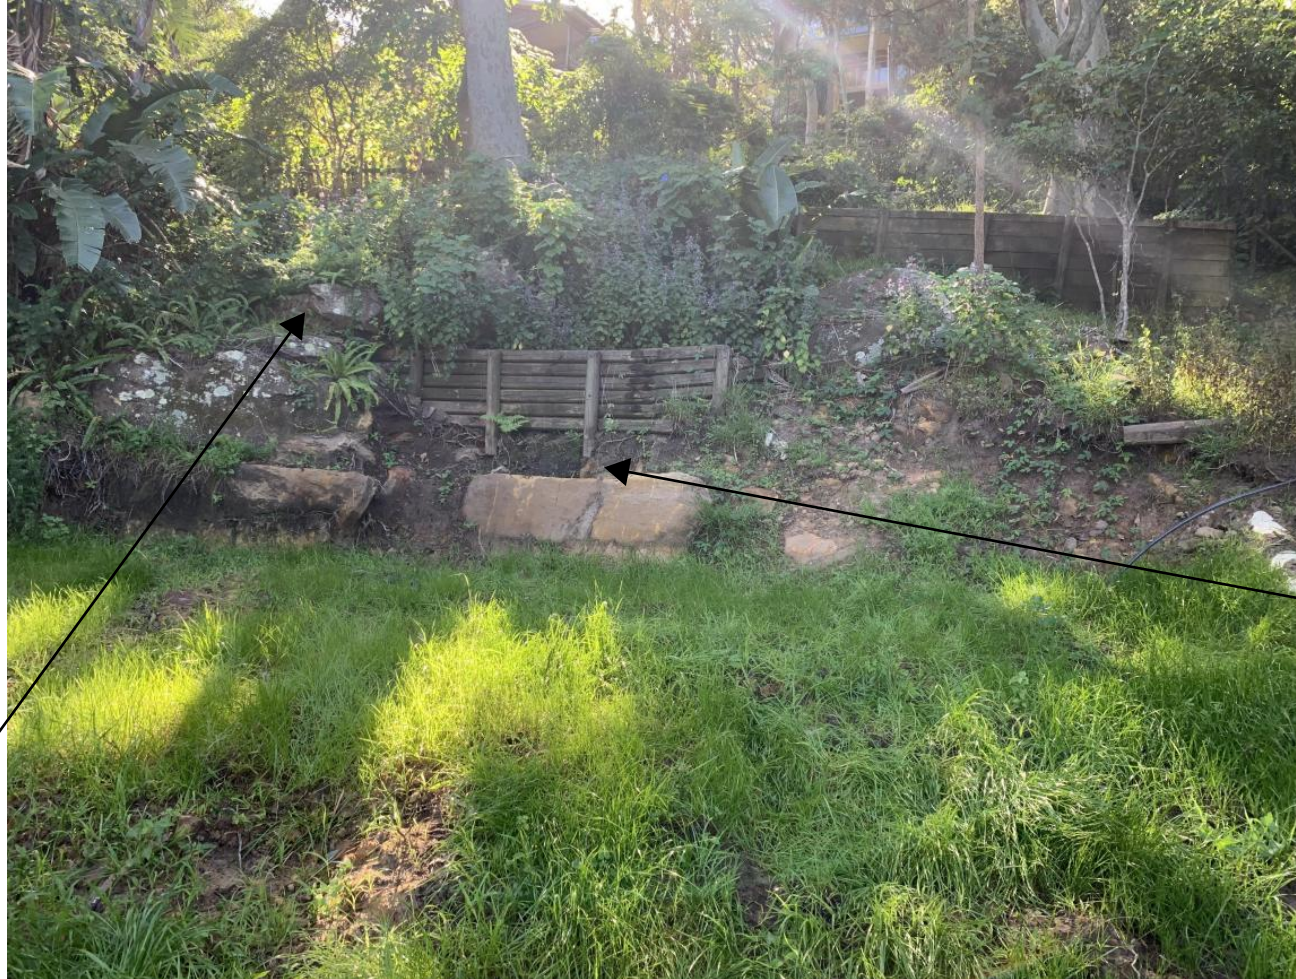
**PROJECT: 790A BARRENJOEY ROAD, PALM BEACH**  
**PROJECT No: 30433/3736D-G**  
**REPORT No: 20/1245**  
**TITLE: PHOTO 2 - BUILDING PLATFORM AREA**

| Hazard Description | Estimated Volume (m <sup>3</sup> ) | Justification |
|---|---|---|
| Failure of a cut slope including toppling of boulders (H3) | 5 | The cut slopes at the rear of the proposed secondary dwelling have been constructed near vertical. There is evidence of minor embankment instability and the cuts have exposed the base of the foundations for a low height wall. The slopes are also supporting large detached boulders. |

**Detached  
sandstone  
boulders**

**Retaining  
wall  
footings  
exposed**

All loosened rocks should either be stabilised or removed from the sides of the excavation as it proceeds. If floaters are encountered care will be required as they can often be sizeable in this geological environment, appearing to be part of the “solid” rock profile.

Due to the colluvial nature of the soils we strongly recommend that all cut slopes be supported in the long term by an engineer designed retaining wall.

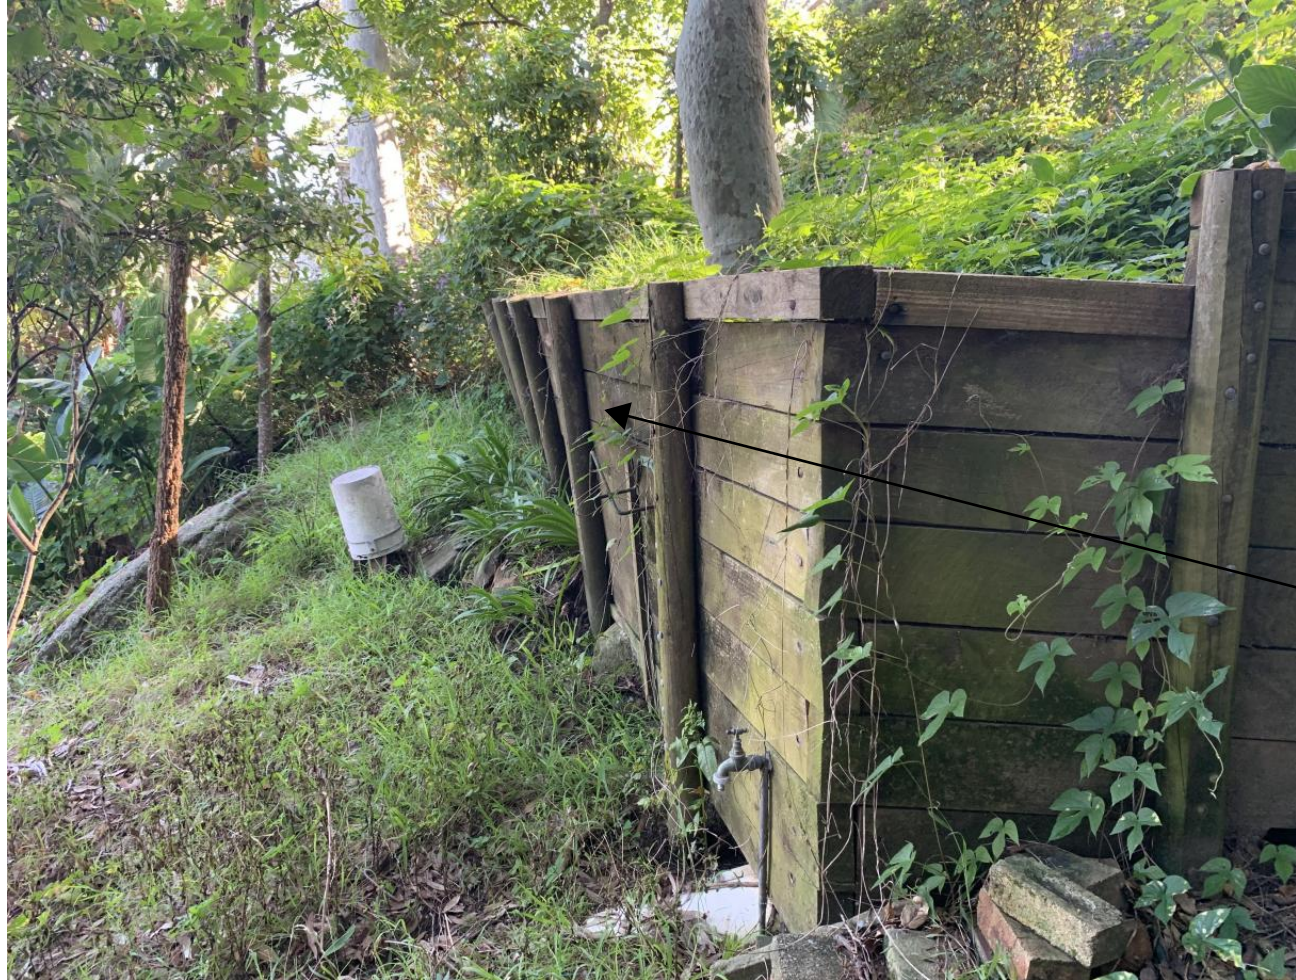
**PROJECT: 790A BARRENJOEY ROAD, PALM BEACH**  
**PROJECT No: 30433/3736D-G**  
**REPORT No: 20/1245**  
**TITLE: PHOTO 3 - RETAINING WALL AT REAR**

| Hazard Description | Estimated Volume (m <sup>3</sup> ) | Justification |
|---|---|---|
| Failure of the tiling wall up-slope of the proposed dwelling (H1) | 5 | The existing wall is tilting and showing signs of distress. The wall is located directly above the proposed secondary dwelling. |

**Tilting Wall**

To address Hazard 1, it is recommended that the tilting timber post and panel retaining wall at the rear of the site either be stabilised, or preferably demolished and re-constructed.

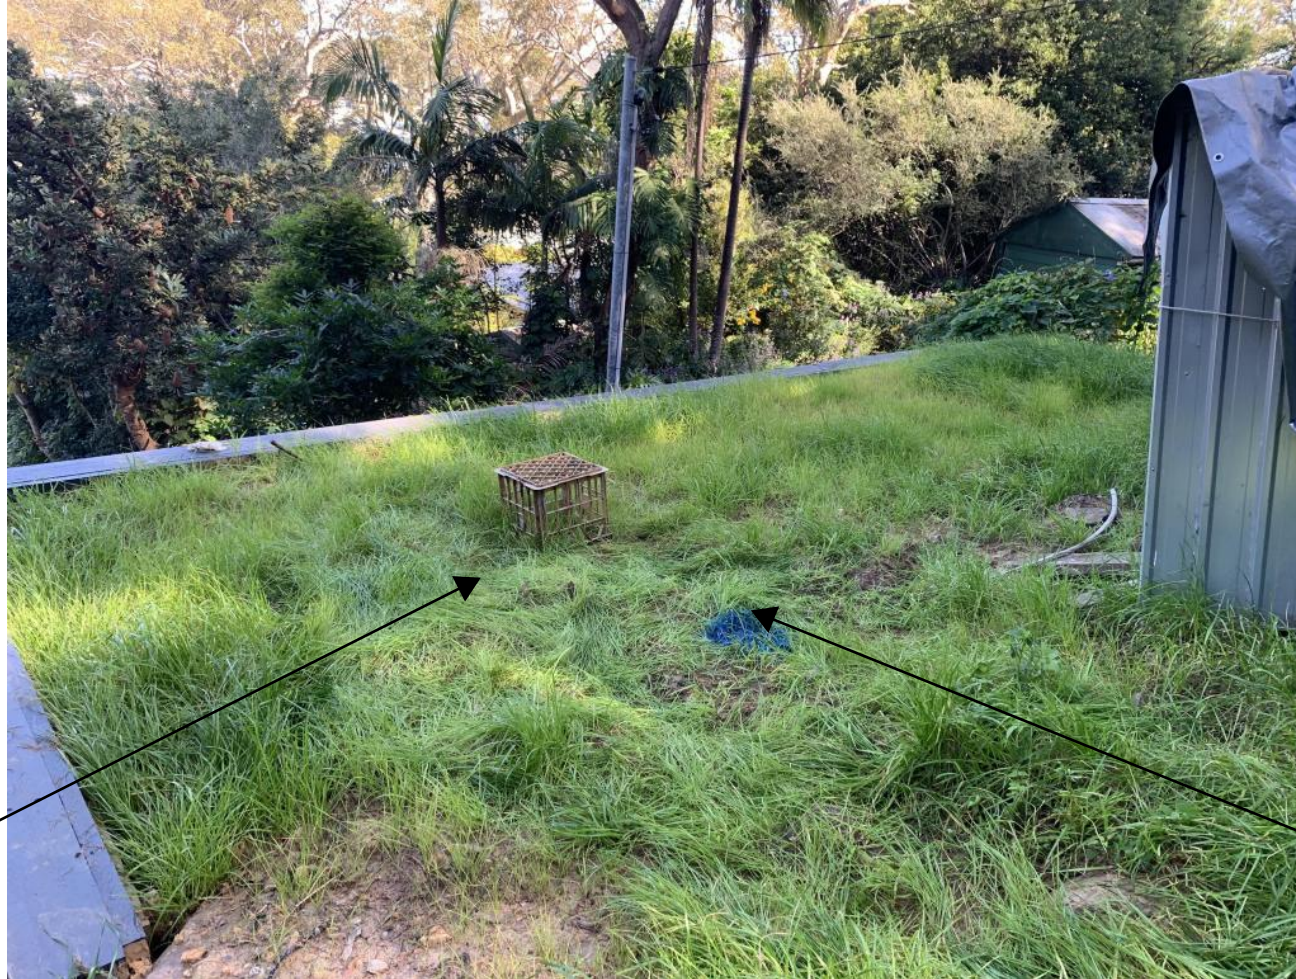
**PROJECT: 790A BARRENJOEY ROAD, PALM BEACH**  
**PROJECT No: 30433/3736D-G**  
**REPORT No: 20/1245**  
**TITLE: PHOTO 4 - BH1 AREA**

**Filled  
Ground**

**BH1**

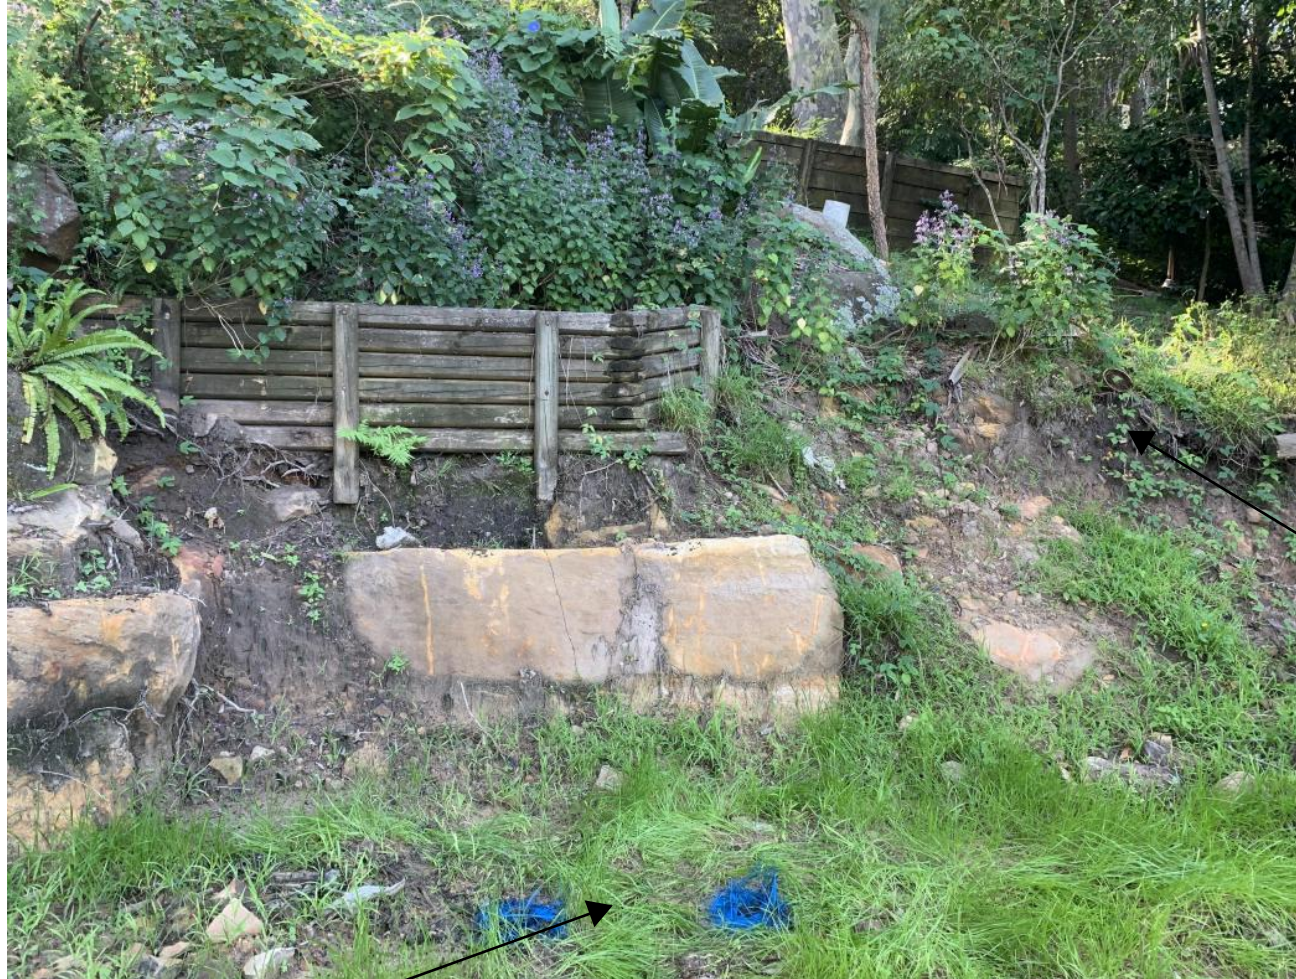
**PROJECT: 790A BARRENJOEY ROAD, PALM BEACH**  
**PROJECT No: 30433/3736D-G**  
**REPORT No: 20/1245**  
**TITLE: PHOTO 5 - BH2 AREA**

**BH2**

**Oversteepened  
embankment**

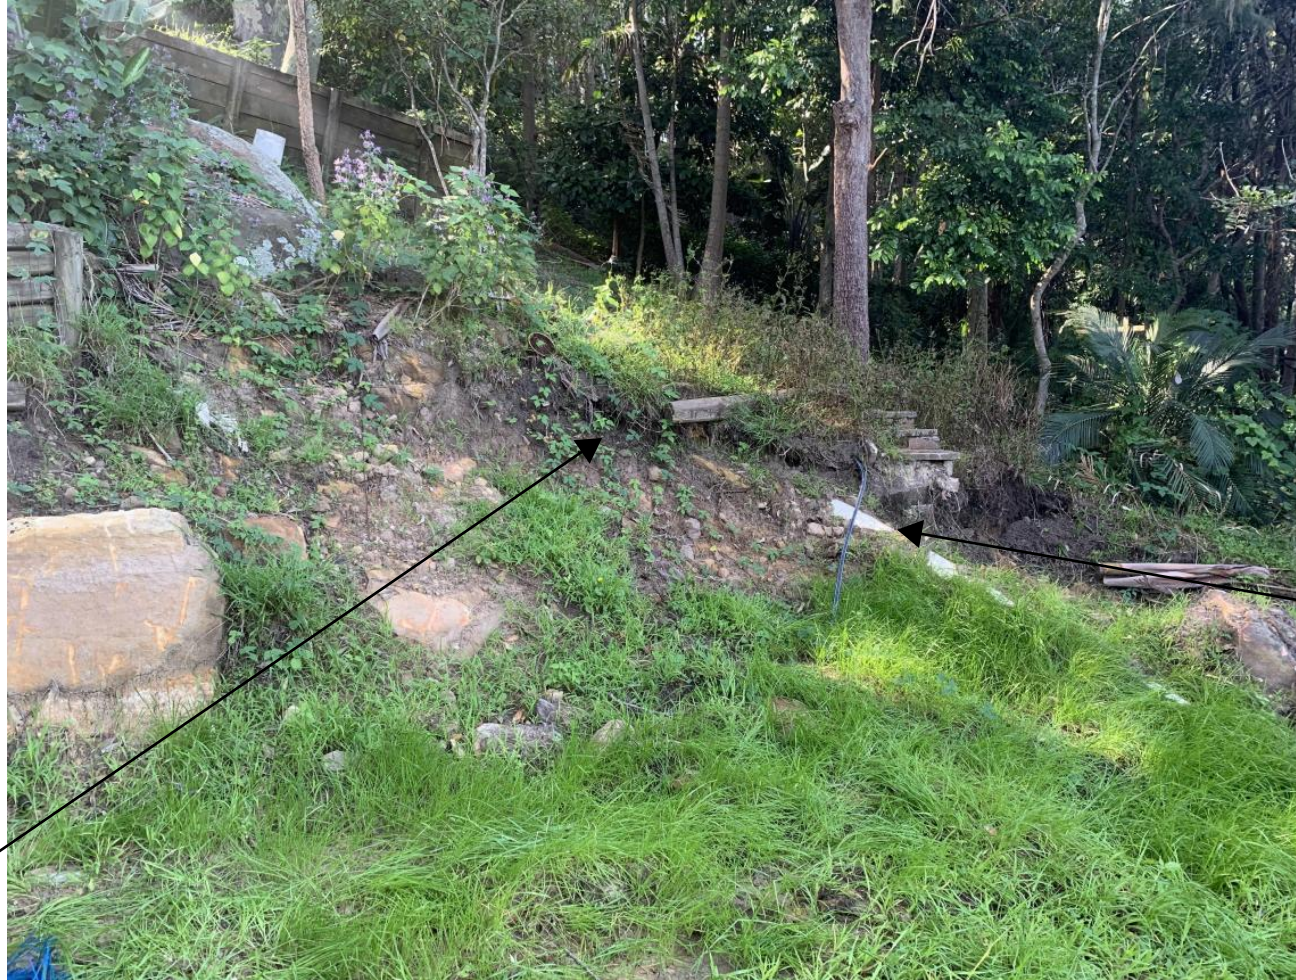
**PROJECT: 790A BARRENJOEY ROAD, PALM BEACH**  
**PROJECT No: 30433/3736D-G**  
**REPORT No: 20/1245**  
**TITLE: PHOTO 6 - OVERSTEEPENED EMBANKMENT**

**Cut slope**

**PVC Pipe  
Exposed**

The further excavation works will likely result in the removal of the existing low height coppers log retaining wall and will also provide an opportunity to address the management of the cut slopes identified as Hazard 3.
