## **PRELIMINARY ASSESSMENT: Acid Sulfate**

New Semi-detached Houses and Pools at **103 Ocean Street, North Narrabeen**

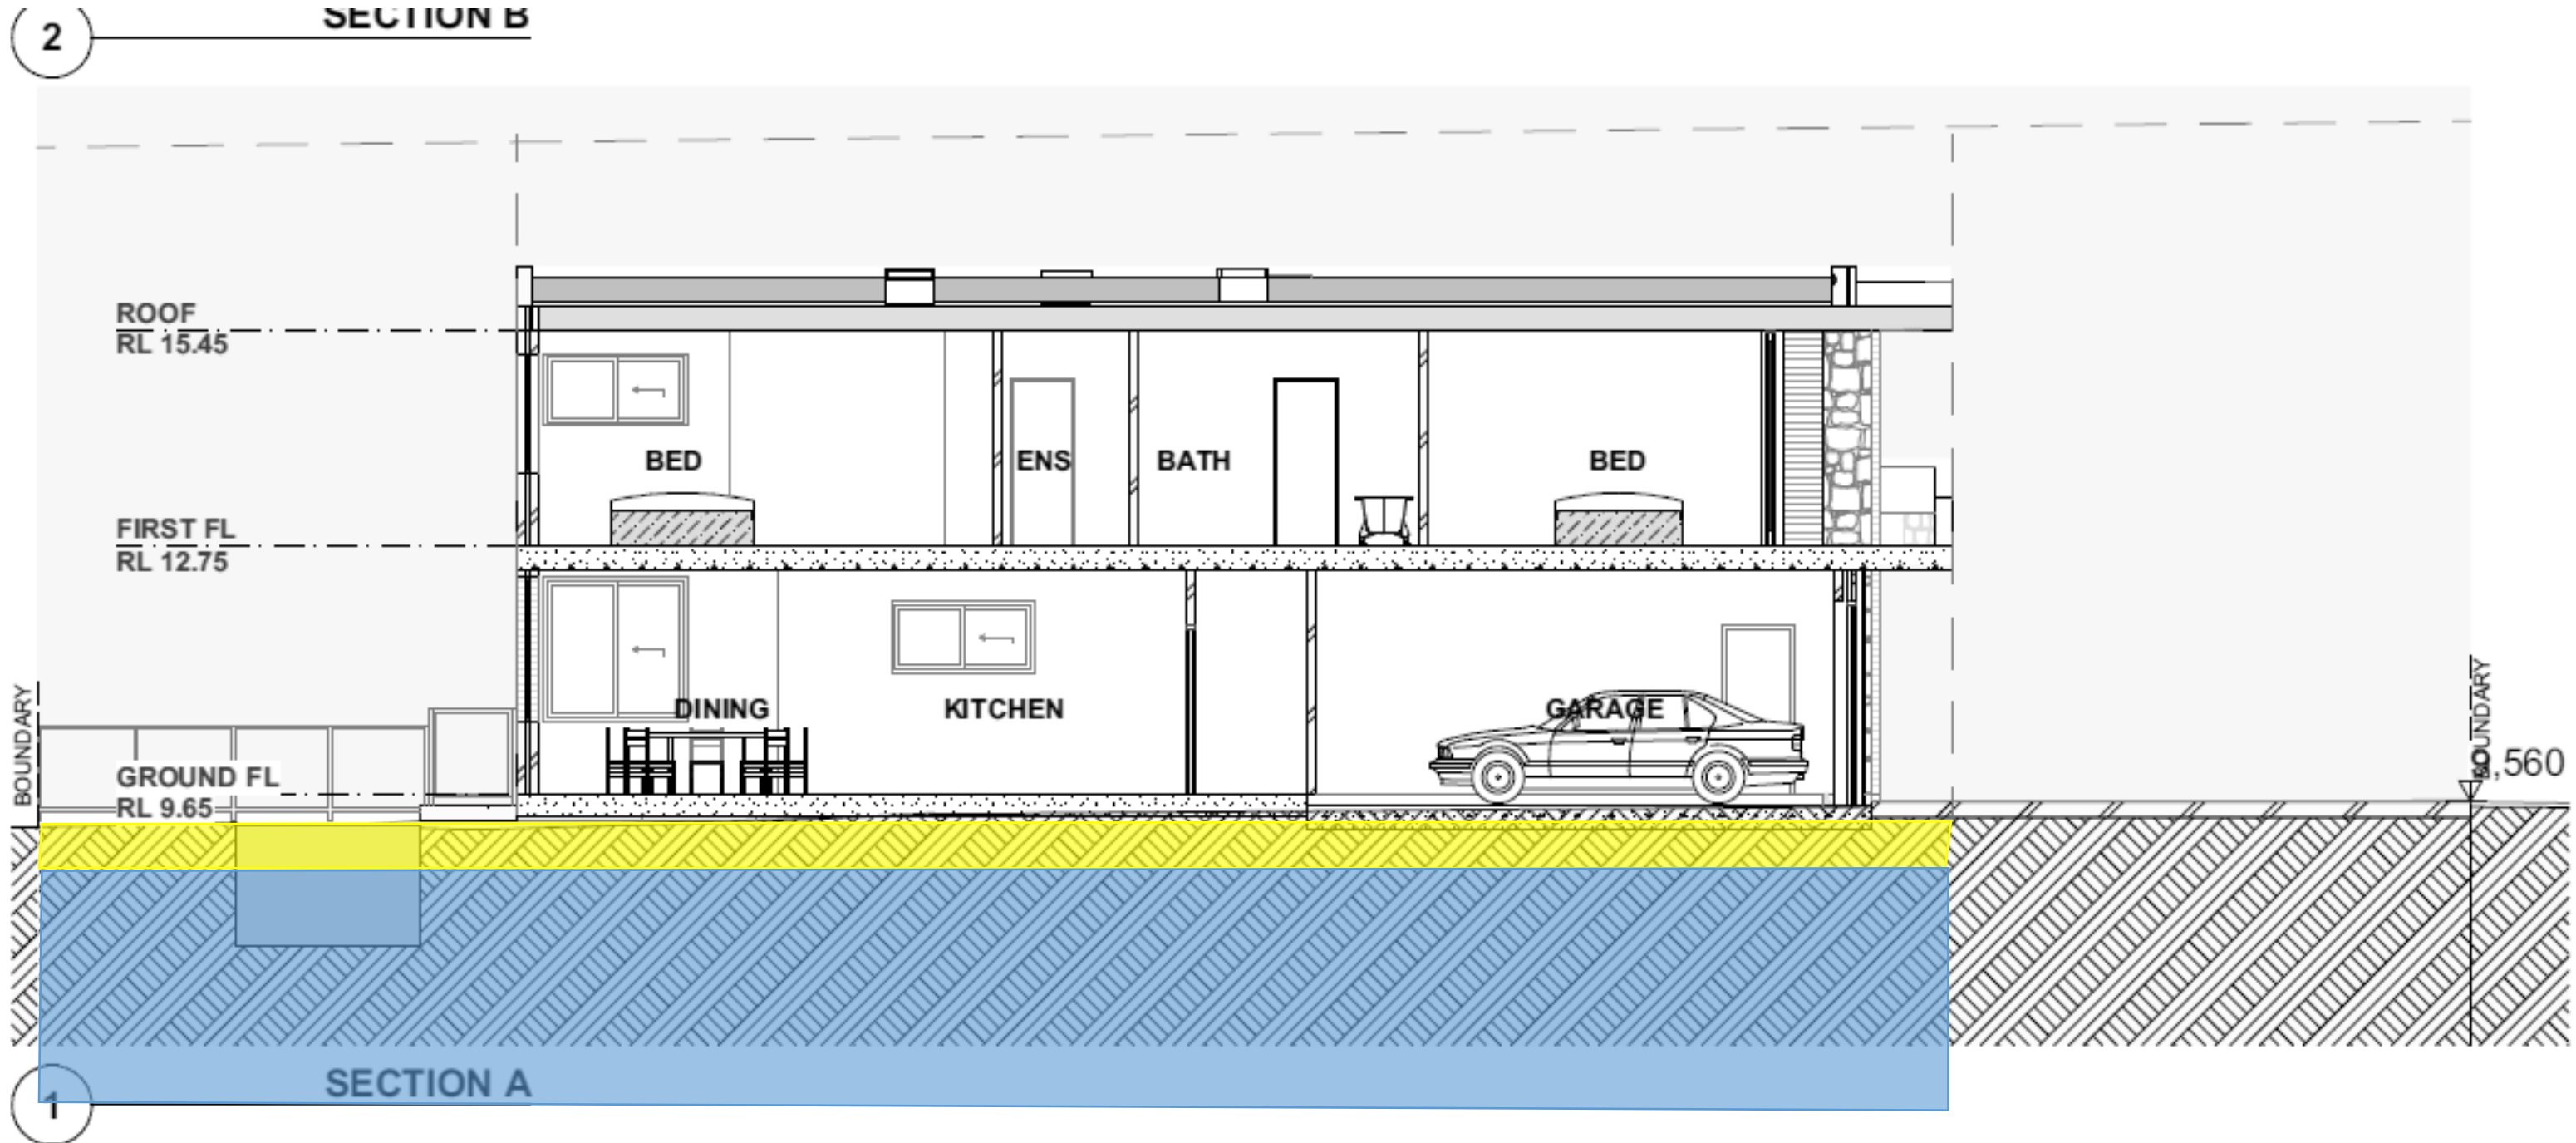
TYPE SECTION – Diagrammatical Interpretation of expected Ground Materials

This residential property is on the E side of the road and is located on the near-level to gentle terrain on the W side of Narrabeen Beach. The surface varies between RL9.0 and RL9.4. The Sydney 1:100 000 Geological Sheet indicates the site is underlain by Medium to fine “marine” sand (Qhf) of the foredune.

Ground testing indicates that sand sediments extend to a depth of at least ~5.0m. The sediments are Holocene in age (spanning in time from present to ~10 000 years ago).
