5 Kooloora Avenue, Freshwater

Foundation Inspections: Mid Floor Piers, Basement Retaining Wall, & Piers Parallel to Original Retained Wall

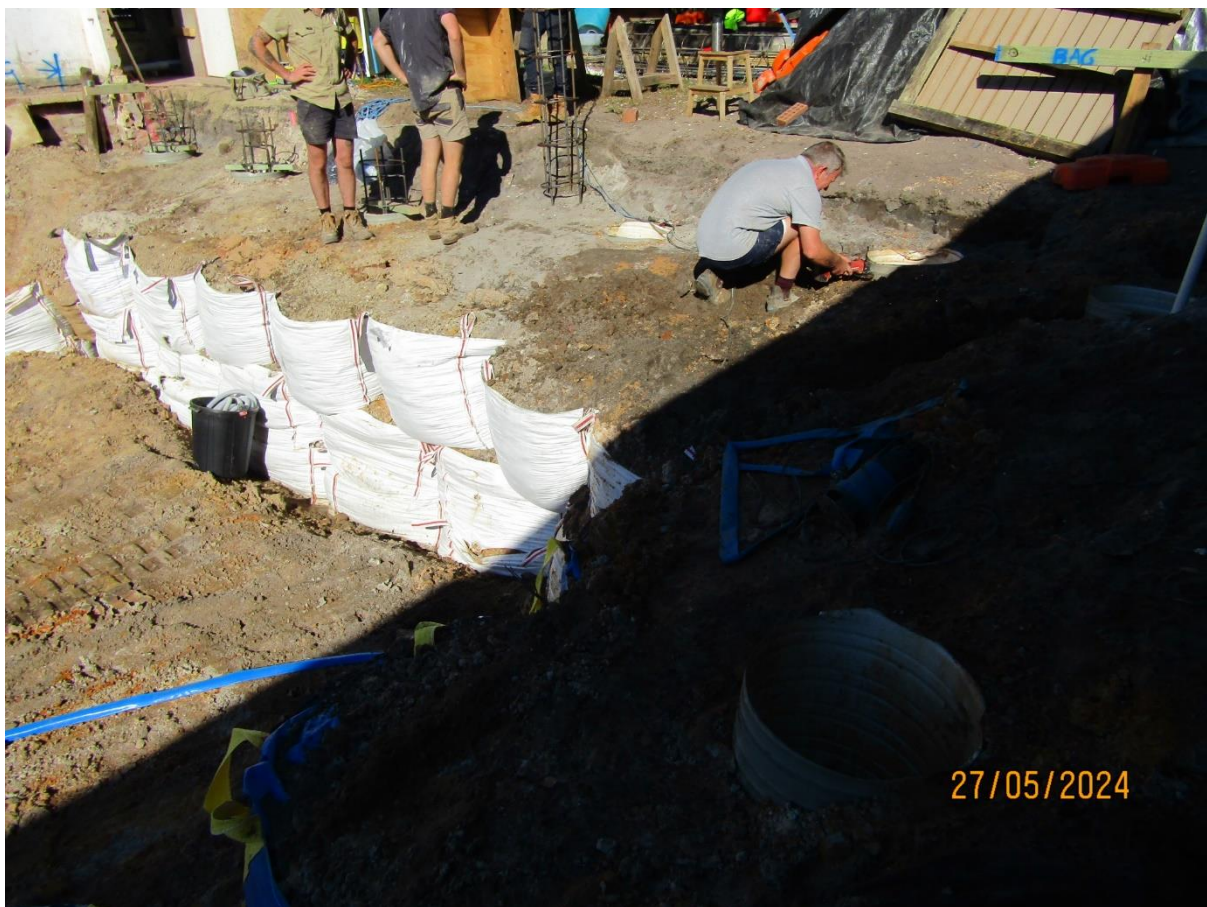
Photo 1

At the time of the inspection, the piers for the mid floor level of the proposed house were completed (Photo 1). The piers were taken to depths of between 2.3 to 2.9m below the current surface and had encountered Hard Clay. This material achieves a maximum allowable bearing capacity of 300kPa. As discussed with the Forman on site, as the clay gets soft when it is saturated, it is recommended a sump and pump system be installed to collect and remove the water. Once this is done, any soft clay over the footing surface is to be removed to expose the harder clay below.

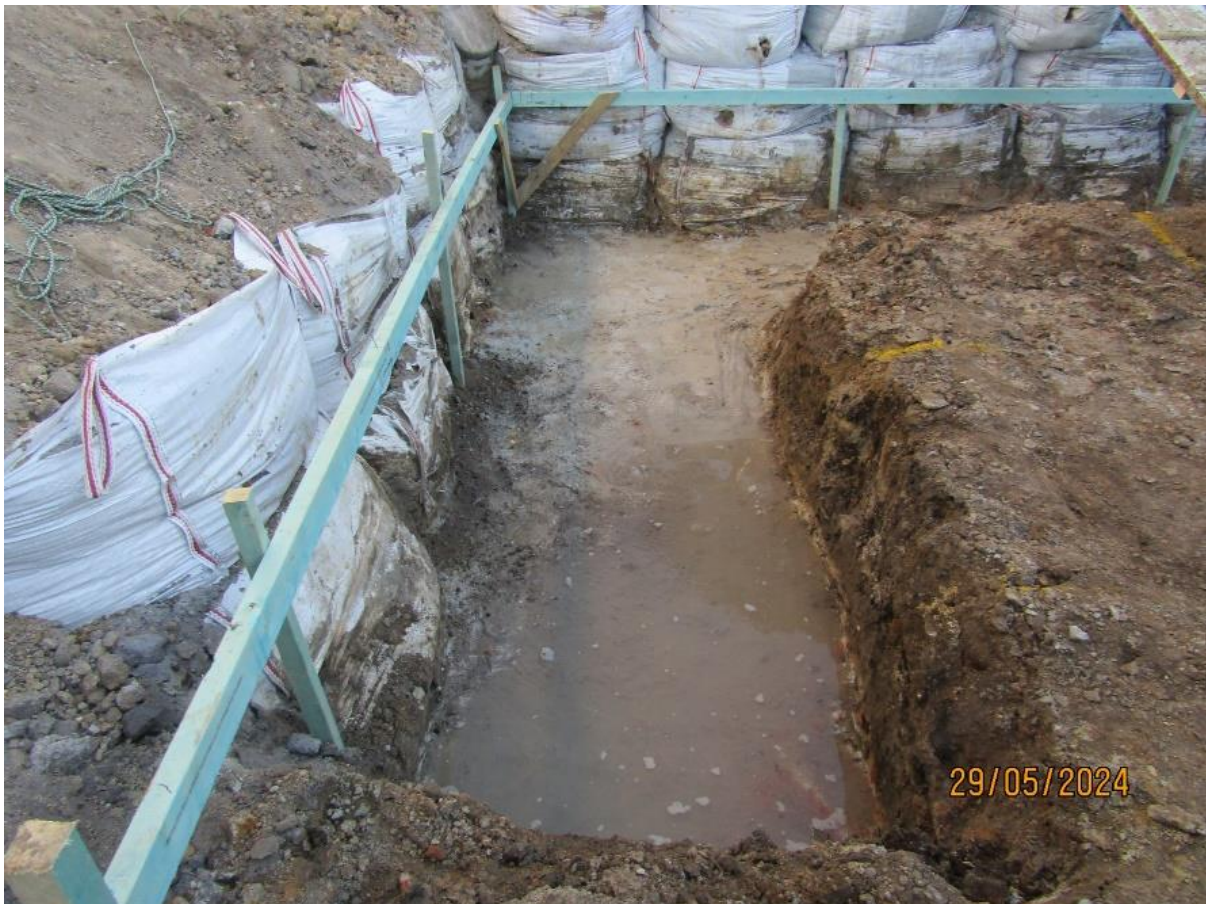
Photo 2

The foundation for the concrete footing supporting the retaining wall basement had been taken to Firm to Stiff clay (Photo 2). Water was pooling over the foundation surface at the time of the inspection. As discussed with the Forman on site, as the clay gets soft when it is saturated, it is recommended a sump and pump system be installed to collect and remove the water. Once this is done, any soft clay over the footing surface is to be removed to expose the harder clay below, that is a suitable foundation with a maximum allowable bearing pressure of 200kPa.
