REPORT

ON
GEOTECHNICAL INVESTIGATION

FOR
PROPOSED NURSING HOME DEVELOPMENT

AT
181 FOREST WAY, BELROSE, NSW

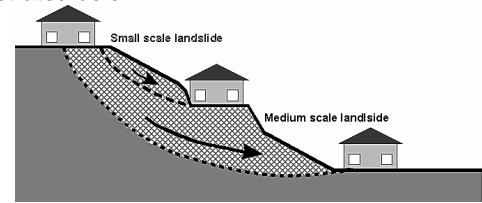
Figure 1

Rotational or circular slip failures (Figure 1) - can occur on moderate to very steep soil and weathered rock slopes (Table 1). The sliding surface of the moving mass tends to be deep seated. Tension cracks may open at the top of the slope and bulging may occur at the toe. The ground may move in discrete "steps" separated by long periods without movement. More rapid movement may occur after heavy rain.

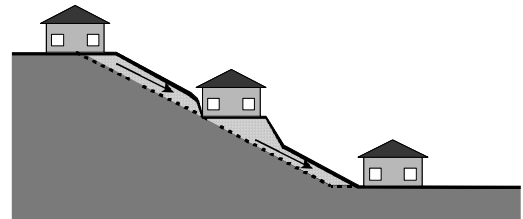
Figure 2

Translational slip failures (Figure 2) - tend to occur on moderate to very steep slopes (Table 1) where soil, or weak rock, overlies stronger strata. The sliding mass is often relatively shallow. It can move, or deform slowly (creep) over long periods of time. Extensive linear cracks and hummocks sometimes form along the contours. The sliding mass may accelerate after heavy rain.

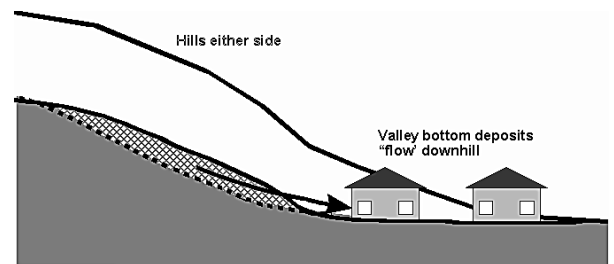
Figure 4

Debris flows and mud slides (Figure 4) - may occur in the foothills of ranges, where erosion has formed valleys which slope down to the plains below. The valley bottoms are often lined with loose eroded material (debris) which can "flow" if it becomes saturated during and after heavy rain. Debris flows are likely to occur with little warning; they travel a long way and often involve large volumes of soil. The consequences can be devastating.
