Subject: TRIMMED 5 Portion DP 590990 Lovett Bay DA 2023/1832 Submi ion

OBJECTIONS AND COMMENTS ON DA 2023/1832

5 PORTIONS, LOVETT BAY NSW

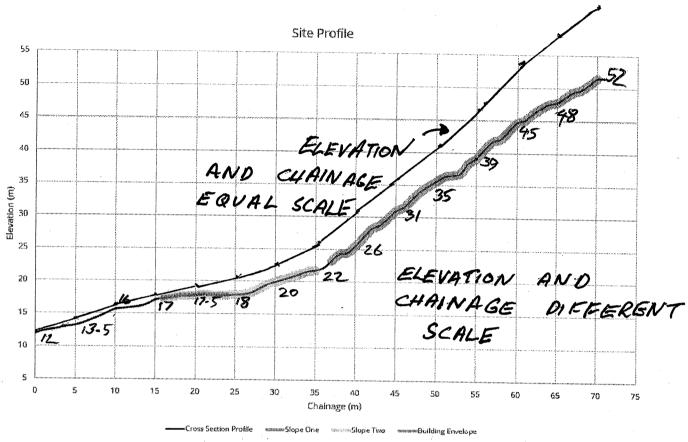
Figure 3.1: Profile Cross-section south to north (site building envelope in blue)

Figure 3.1 profile cross-section is misleading. The elevation and chainage are different scales, giving a shallower appearance of the slope of the land.

The inclination of a slope is the biggest consideration when determining the type(s) of landslide and likelihood. It is closely related to the landform (Section 3.2). Lidar data with a $1m^2$ resolution has been used for the terrain analysis. The slope profile is based on 3.0m elements which reveals an average slope of 38.6° and a maximum slope of 50.7° above the building envelope. Within the building envelope, the average slope is 4.7° .

Refer to DRG-04 The block is steeply sloping from the water's edge, starting at 20 degrees and increasing to 45 degrees.

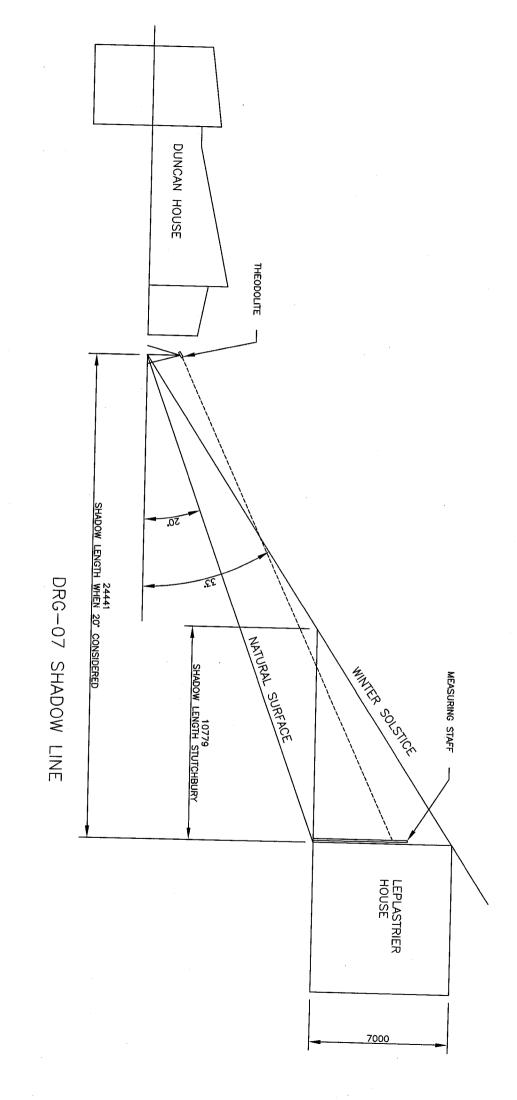
Analysis does not take into account that the land between 5 Portions and 3 Portions, falls steeply away at around 20 degrees. The shadow lines chase the sloping land until the shadow line catches up. Shadow length is around 11 metres, whereas I have calculated a shadow of approximately 25 metres. **See DRG 07**.

We can argue the correct shadow length, but the simplest solution is to carry out a site measurement. A theodolite can be set up at the Duncan House to sight a measuring staff at the Leplastrier designed building at the front elevation. Knowing the distance and the angle, an accurate drawing can be compiled. See **DRG -07.** No surveyor is required as I have a theodolite and can do a full and accurate check with a representative of the Leplastrier family.
