GEOTECHNICAL INVESTIGATION:

New Boarding House at **16 Wyatt Avenue, Belrose**

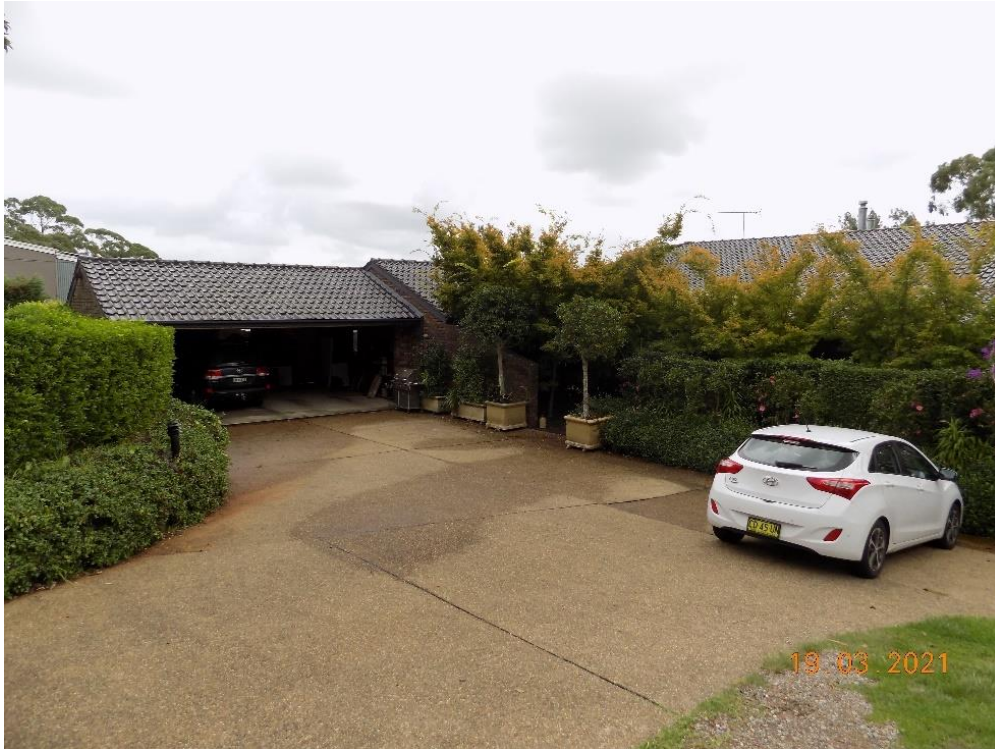
Photo 1

- 2.3** At the road frontage, a concrete driveway runs to a stable brick garage on the uphill side of the house (Photo 1). Between the road frontage and the house is a gently sloping lawn. The two-storey brick house will be demolished as part of the proposed works. An excavation has been made in the slope below the house for a pool that will also be demolished as part of the proposed works. Filling has been placed around the pool to create a level platform. The fill is supported by a concrete block retaining wall that appears stable (Photo 2). Competent Medium Strength Sandstone outcrops below the retaining wall. The outcrop is undercut along the majority of its length to ~1.0m. The undercut joint block has a relatively thick cantilever arm relative to its overhang length, is bridged at both sides, and displays no cracking as observed from

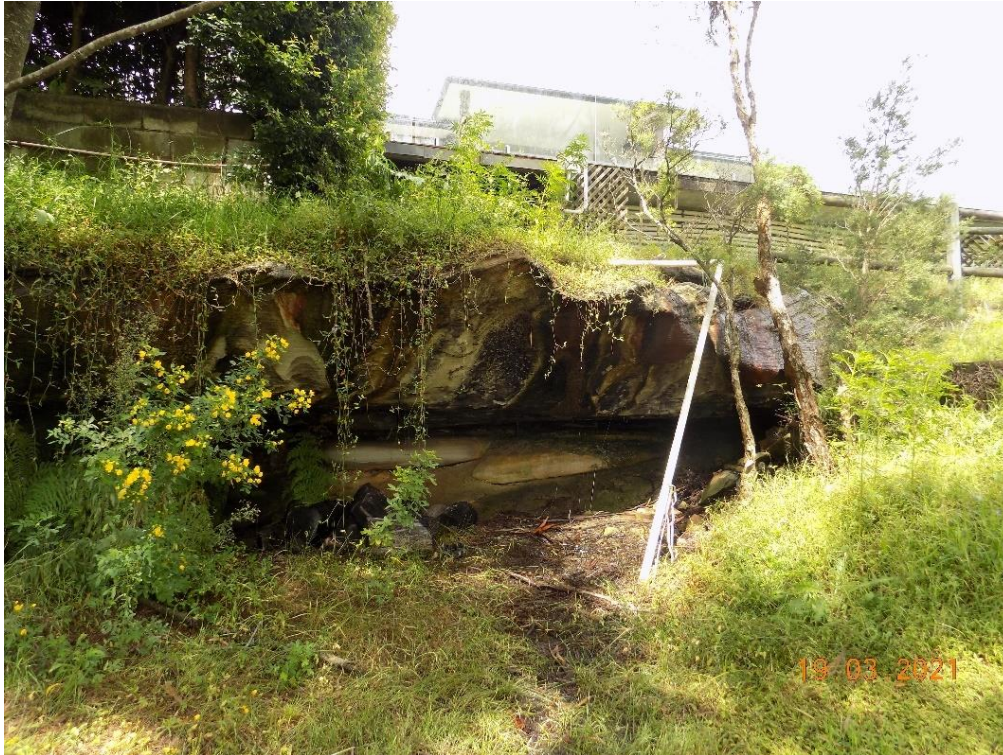
Photo 3

above or below. Thus, it is considered stable (Photo 3). A timber clad garage has been constructed below the outcropping sandstone. The garage will also be demolished as part of the proposed works. A concrete driveway runs down the E side of the property to a sheet metal outbuilding supported on a concrete slab in the NE of the property which will also be demolished as part of the proposed works (Photo 4). A gentle to moderately sloping lawn falls to the lower boundary. Stable Competent Medium Strength Sandstone outcrops near the lower boundary (Photo 5).

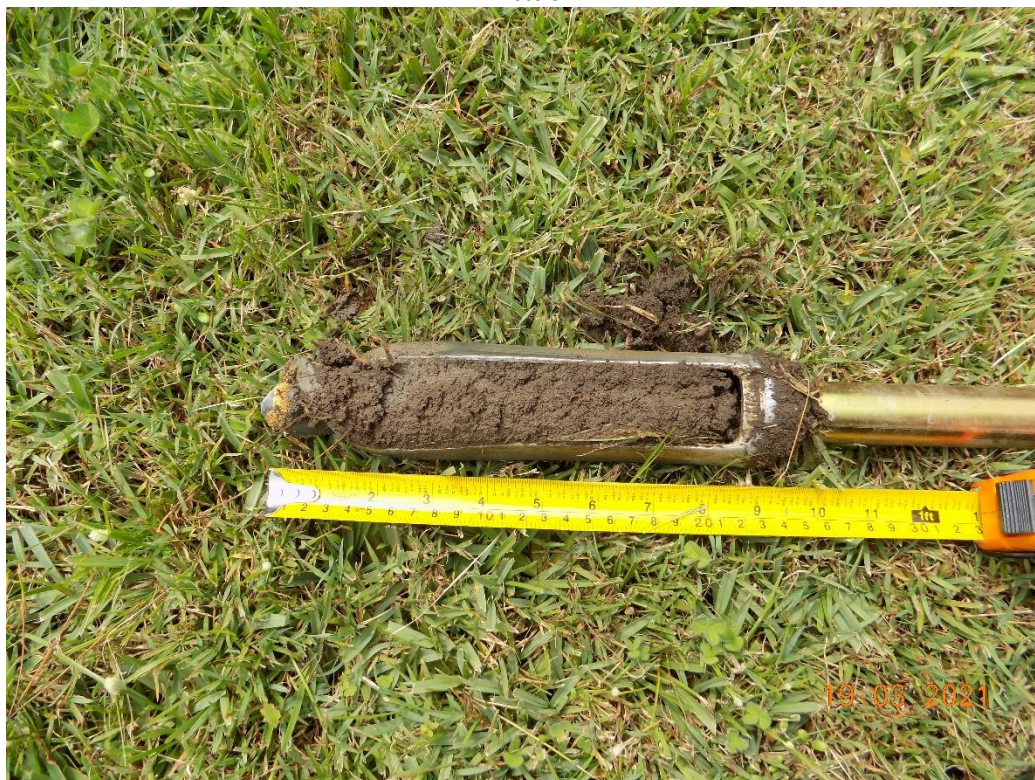
Photo 6

AUGER HOLE 1 (~RL13.4) – AH1 (Photo 6)

Depth (m)	Material Encountered
0.0 to 0.2	SOIL , dark brown, low density, dry, fine to medium grained with fine trace organic matter and rock fragments.

Refusal @ 0.2m on Medium Strength Sandstone. No water table encountered.
