# “GROWING MY WAY”

## *Construction Impact & Preliminary Management Statement*

February 2023, updated May 2023

Proposed works is for *Alterations & additions to the FSLSC & surrounds*.

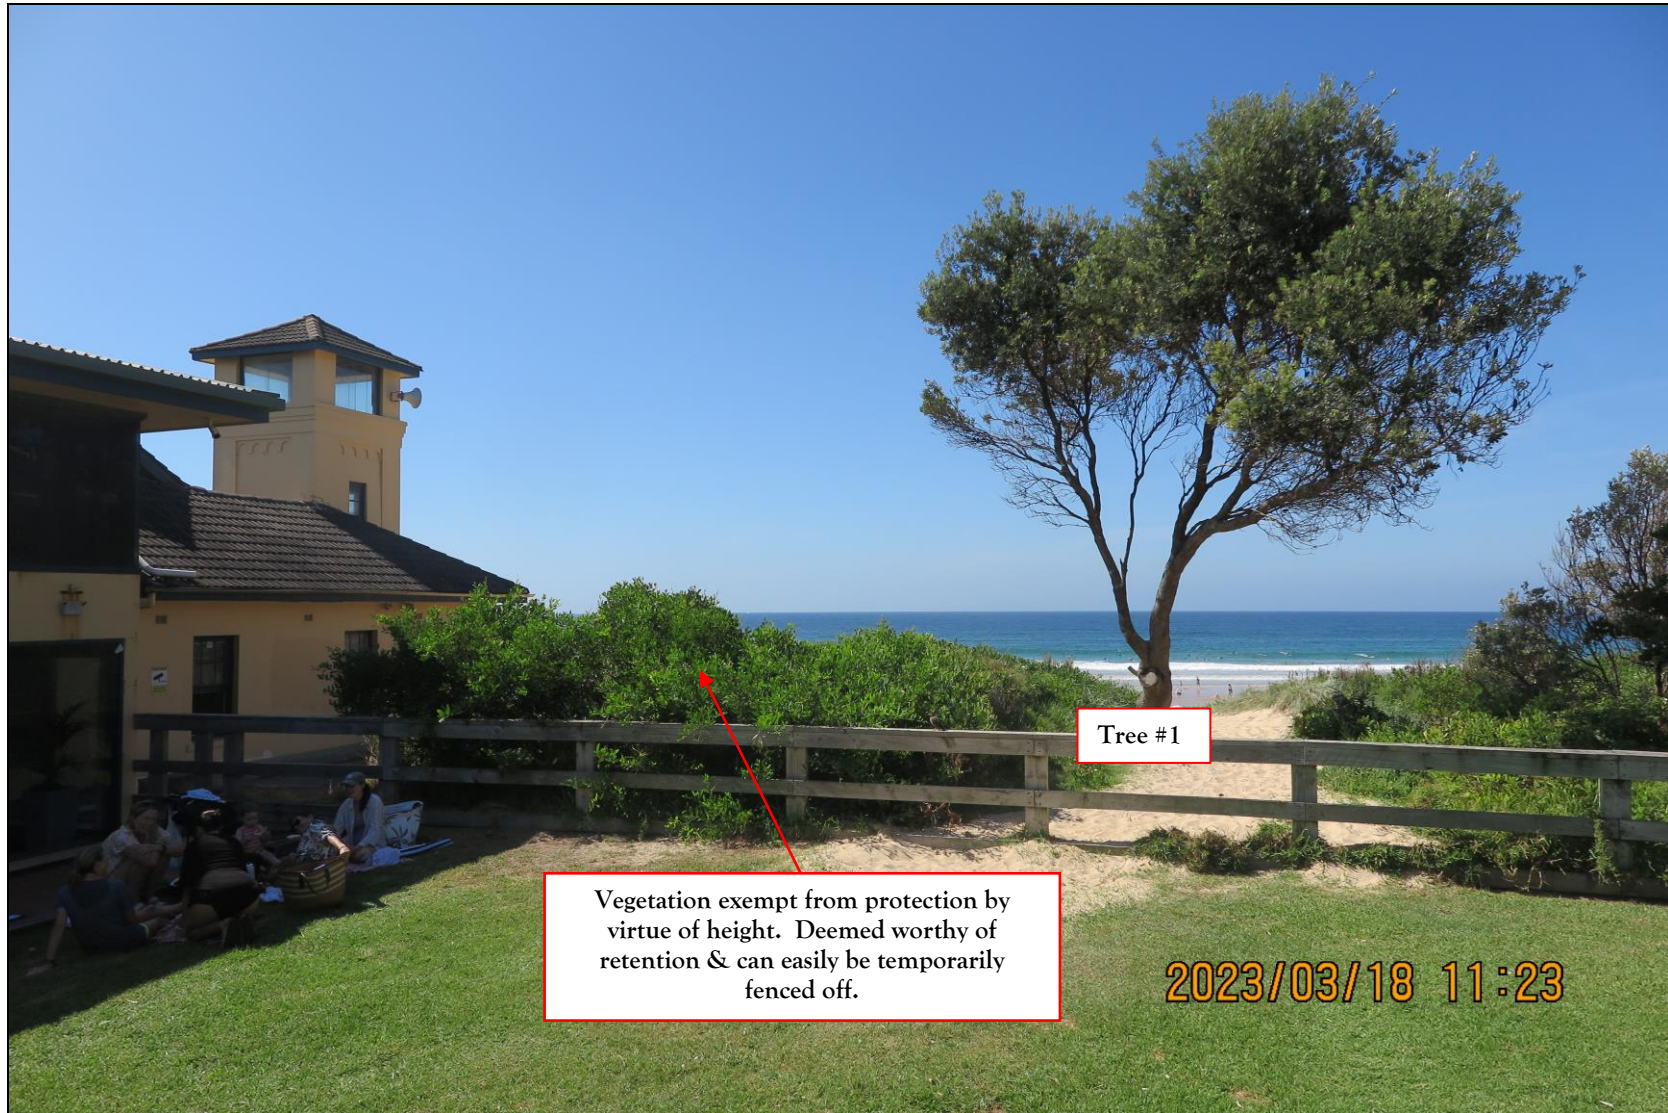
Figure 7: Illustrates the location & condition of Tree #1, assessed to be of high significance & retention values.

Identification	Height (m)	Crown (m)	DBH (m)	TPZ (m)	SRZ (m)	Age	Health/Vigour	Structure	Significance/Retention Values	Comments
1	<i>Banksia integrifolia</i> Coast Banksia	<9.00	<9.50	0.40	4.80	2.63	Mature	Fair to Good & Fair to Good	Appears sound	High/High	<u>Retain, Protect &amp; Manage:</u>
2	<i>Banksia integrifolia</i> Coast Banksia  <i>Banksia serrata</i> Old Man Banksia  <i>Schefflera arboricola</i> Taiwan Umbrella Tree	<8.00	<8.50	0.37	4.44	2.61	Mature	Good & Good	Appears sound	High/High	<i>Banksia serrata</i> is exempt from protection by location (<2.00m from approved building) & <i>Schefflera arboricola</i> is exempt by species.
3	<i>Banksia integrifolia</i> Coast Banksia	<5.00	<3.50	0.20	2.40	1.85	Semi Mature	Fair to Good & Fair to Good	Appears sound	High/High	<u>Retain, Protect &amp; Manage:</u>

**Tree 1:** This tree is confirmed to be a locally indigenous species with an approximate age of less than fifty years (50). There is no valid Horticulture or Arboriculture reason to condemn the tree. It has simply been assessed as being of High Retention & Significance values relative to the nearby as proposed works.

This tree is specified to have standard Tree Protection instated to isolate it from any potential to be disturbed by the as proposed works. This specification is compliant with the *Australian Standard (AS4970-2009 Protection of trees on development sites.)*. See Chapters 3, 4 & 5.

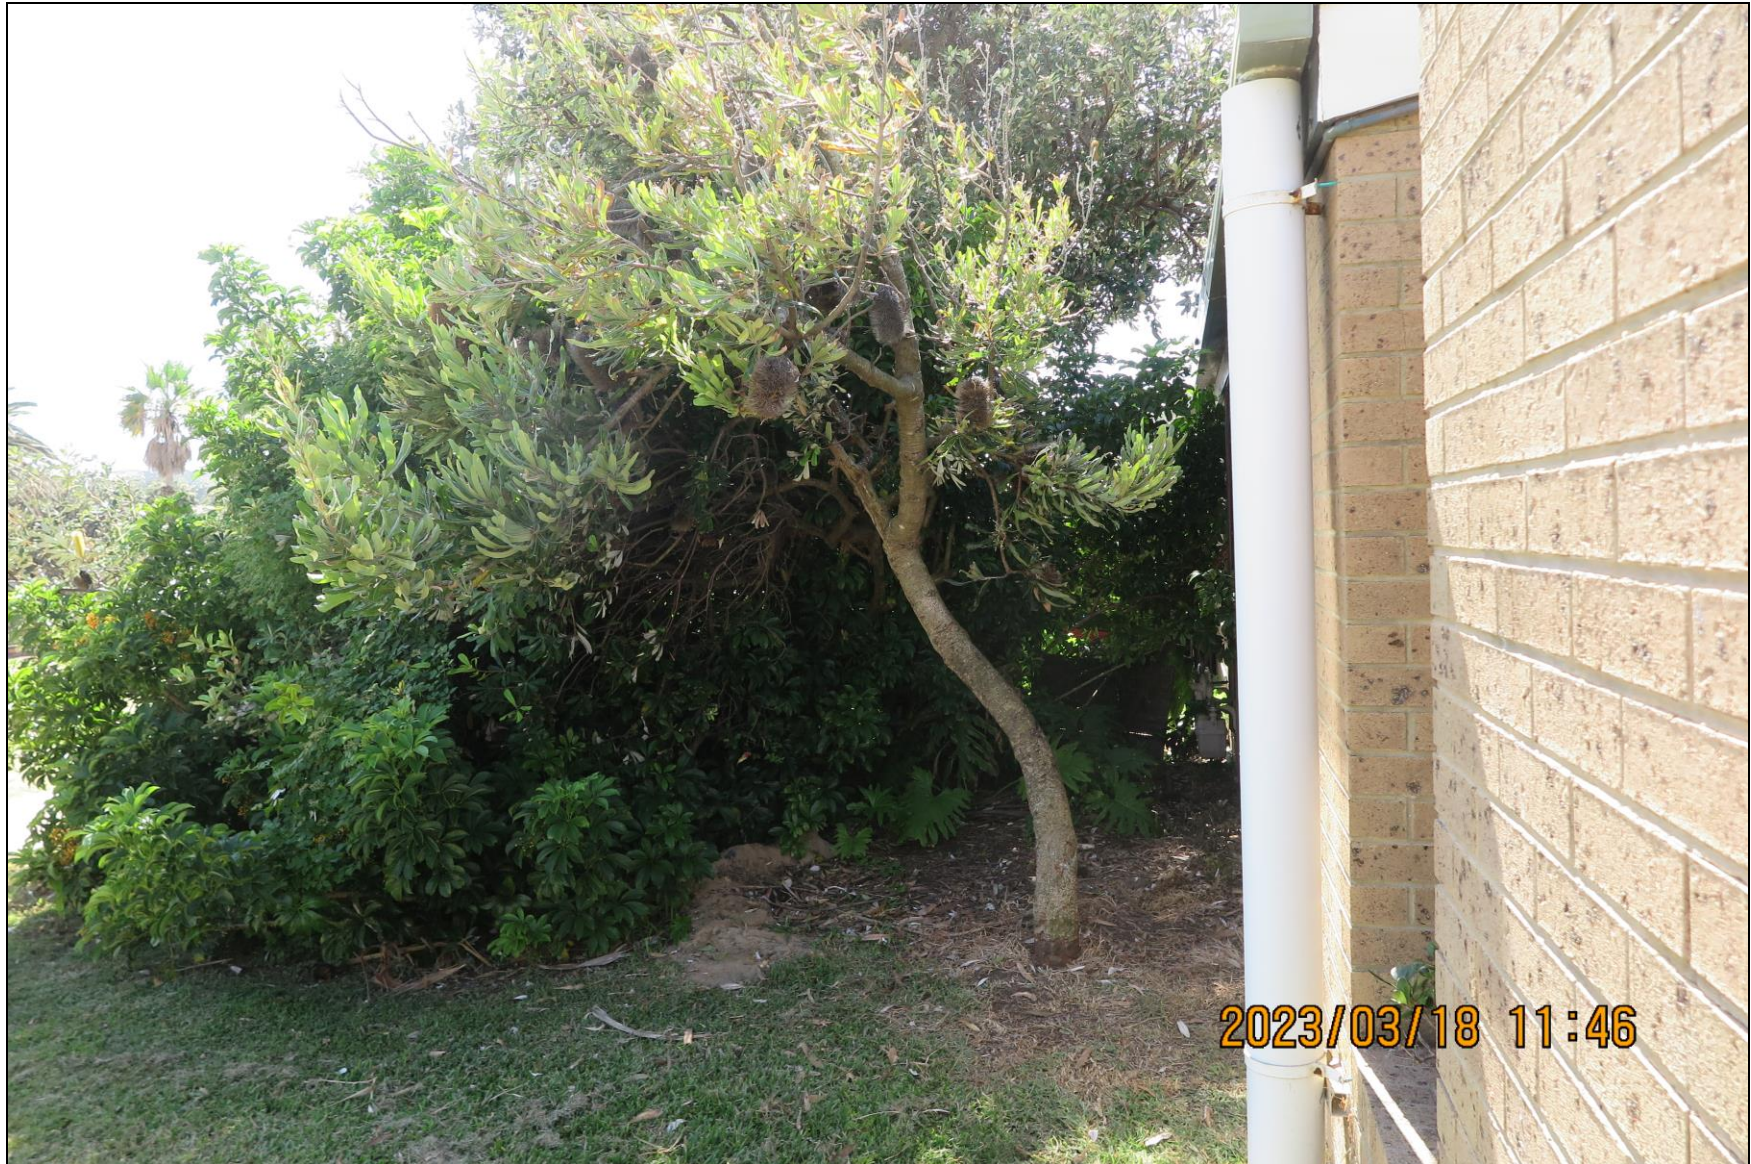
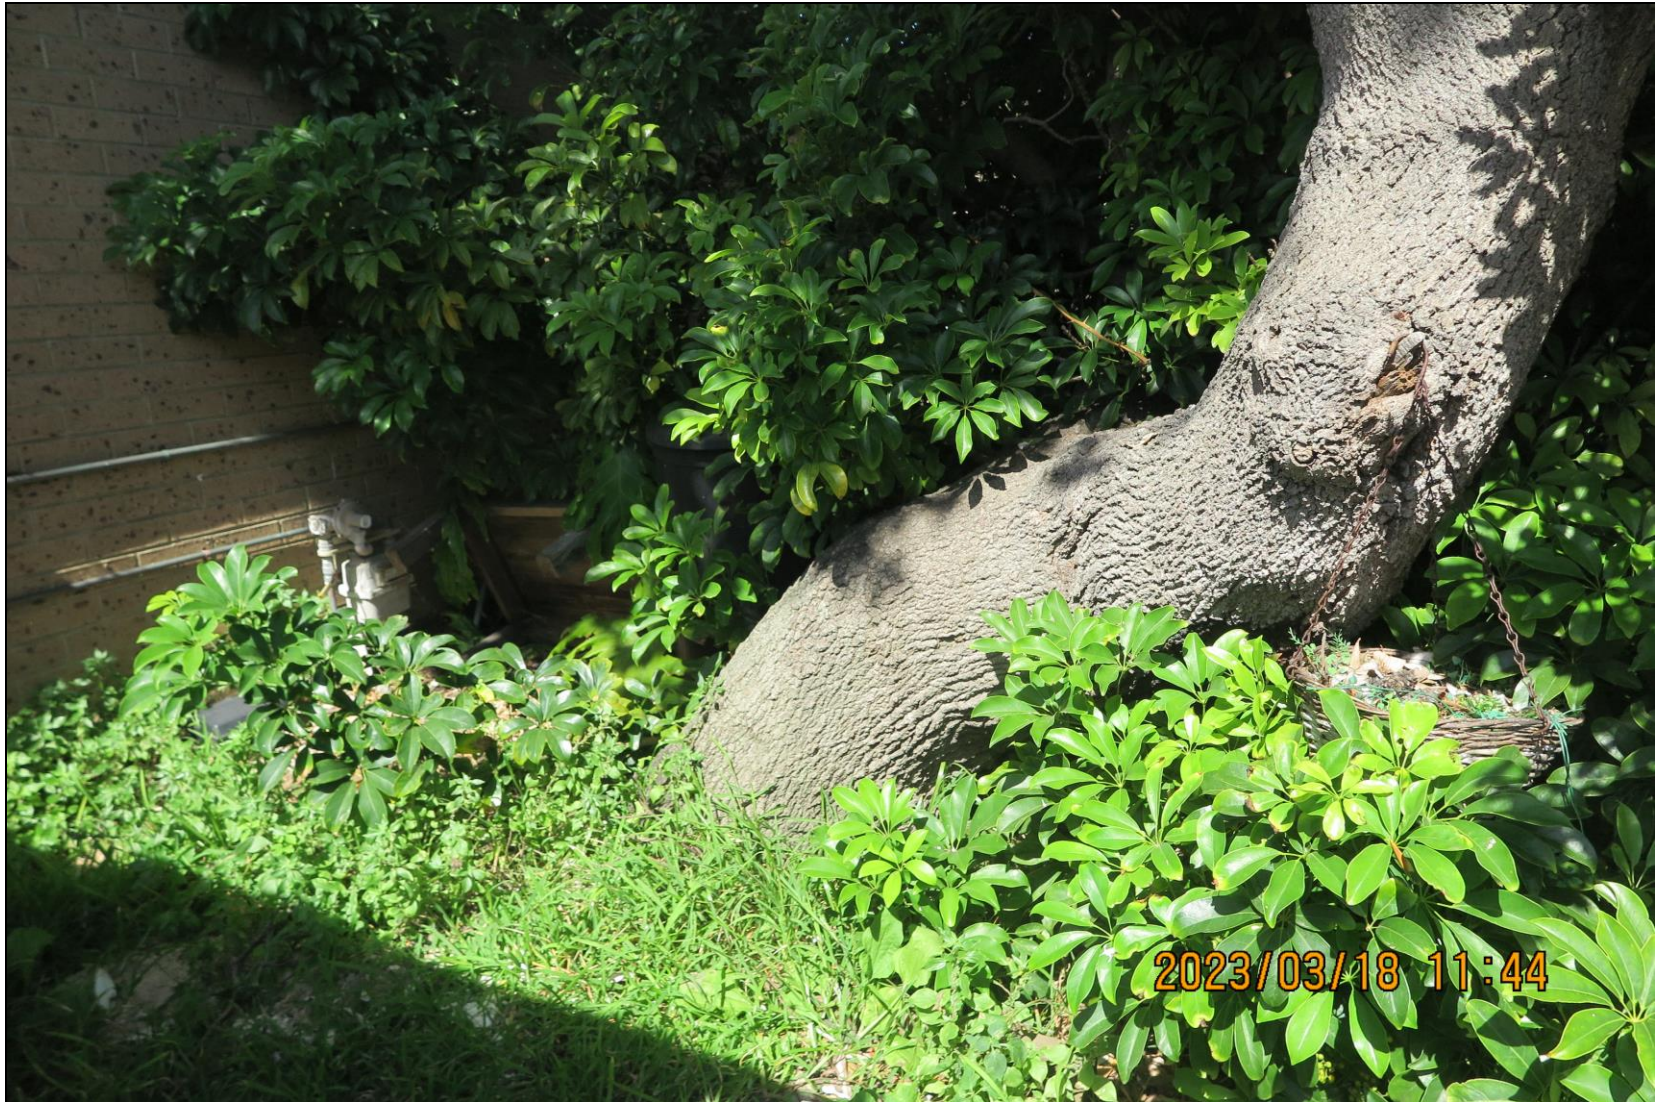
Figure 8: Previous page & above illustrates the trees/vegetation that makes up Tree/s #2. Note; above Banksia integrifolia is less than 2.00m from approved building.

**Tree/s #2:** These trees are incompatible with the as proposed works. Simply, they are located where the below & above ground western end of the surf club footprint is to be expanded.

These trees will be specified to be replaced within the as proposed landscape concept plan

- Whilst there is no challenge that two (2) Tree /s #2 discussed trees are of High Significance by size & species they are simply not able to be viably retained with the subject site being redeveloped to include a western end of clubhouse expanded footprint.

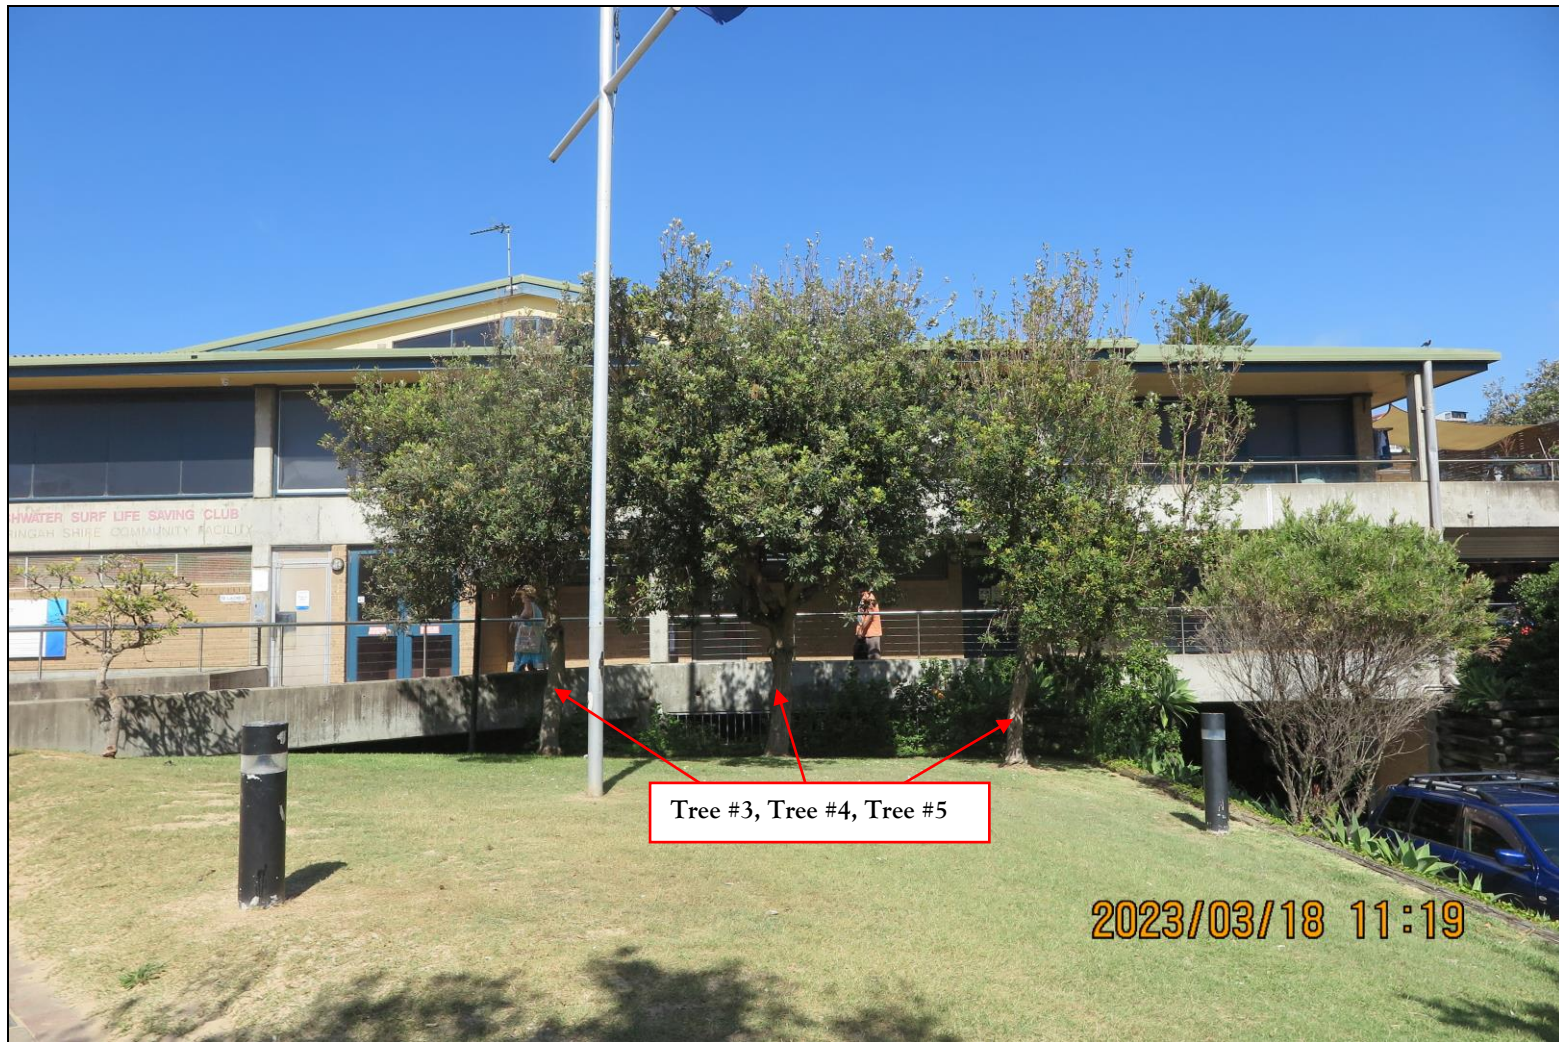
Figure 9: Illustrates the location & condition of Tree 33, Tree #4 & Tree #5.

Identification	Height (m)	Crown (m)	DBH (m)	TPZ (m)	SRZ (m)	Age	Health/Vigour	Structure	Significance/Retention Values	Comments
4	<i>Banksia integrifolia</i> Coast Banksia	<6.00	<4.50	0.27	3.24	1.91	Semi Mature	Fair to Good & Fair to Good	Appears sound	High/High	<u>Retain, Protect &amp; Manage:</u>
5	<i>Banksia integrifolia</i> Coast Banksia	<5.50	<3.00	0.16	2.00	1.79	Semi Mature	Fair & Fair	Appears sound	High/High	<u>Replace:</u> Banksia integrifolia is likely exempt from protection by location_(<2.00m from approved building). If not exempt, the tree is supported to be replaced on the grounds of conflict with new built form infrastructure (pedestrian ramp plus vehicle/equipment access ramp).
A	<i>Banksia integrifolia</i> Coast Banksia	<7.00	<7.00	0.35	4.20	2.34	Mature	Good & Good	Appears sound	High/High	<u>Retain, Protect &amp; Manage:</u>
B	<i>Banksia integrifolia</i> Coast Banksia	<4.00	<3.00	0.23	2.76	1.88	Mature	Fair & Fair	Suppressed /Struggling	High/High	<u>Retain, Protect &amp; Manage:</u>

**Tree #3:** This tree is part of a group of three (3) trees known as Tree #3, Tree #4 & Tree #5. This tree is confirmed to be a locally indigenous species with an approximate age of less than fifteen years (15). There is no valid Horticulture or Arboriculture reason to condemn the tree. It has simply been assessed as being of High Retention & Significance values relative to the nearby as proposed works.

**Tree #4:** This tree is part of a group of three (3) trees known as Tree #3, Tree #4 & Tree #5. This tree is confirmed to be a locally indigenous species with an approximate age of less than fifteen years (15). There is no valid Horticulture or Arboriculture reason to condemn the tree. It has simply been assessed as being of High Retention & Significance values relative to the nearby as proposed works.

**Tree #5:** This tree is part of a group of three (3) trees known as Tree #3, Tree #4 & Tree #5. This tree is confirmed to be a locally indigenous species with an approximate age of less than fifteen years (15). There is no valid reason by virtue with conflict of new infrastructure that this tree cannot be replaced. Simply, the tree cannot be retained by virtue of the as proposed new proposed infrastructure, i.e., the pedestrian ramp plus vehicle/equipment access ramp.

This tree will be specified to have standard Tree Protection instated to isolate it (as a group of three (3) trees) from any potential to be disturbed by the as proposed works.

This tree is specified to have standard Tree Protection instated to isolate it from any potential to be disturbed by the as proposed works. This specification is compliant with the *Australian Standard (AS4970-2009 Protection of trees on development sites.)*. See Chapters 3, 4 & 5.

No canopy pruning is envisaged as being necessary. In the event canopy pruning is required the retained Project Arborist is to prepare the specification in a manner totally compliant with the *Australian Standard (AS4373-2007 Pruning of amenity trees)*. See Chapter 7.

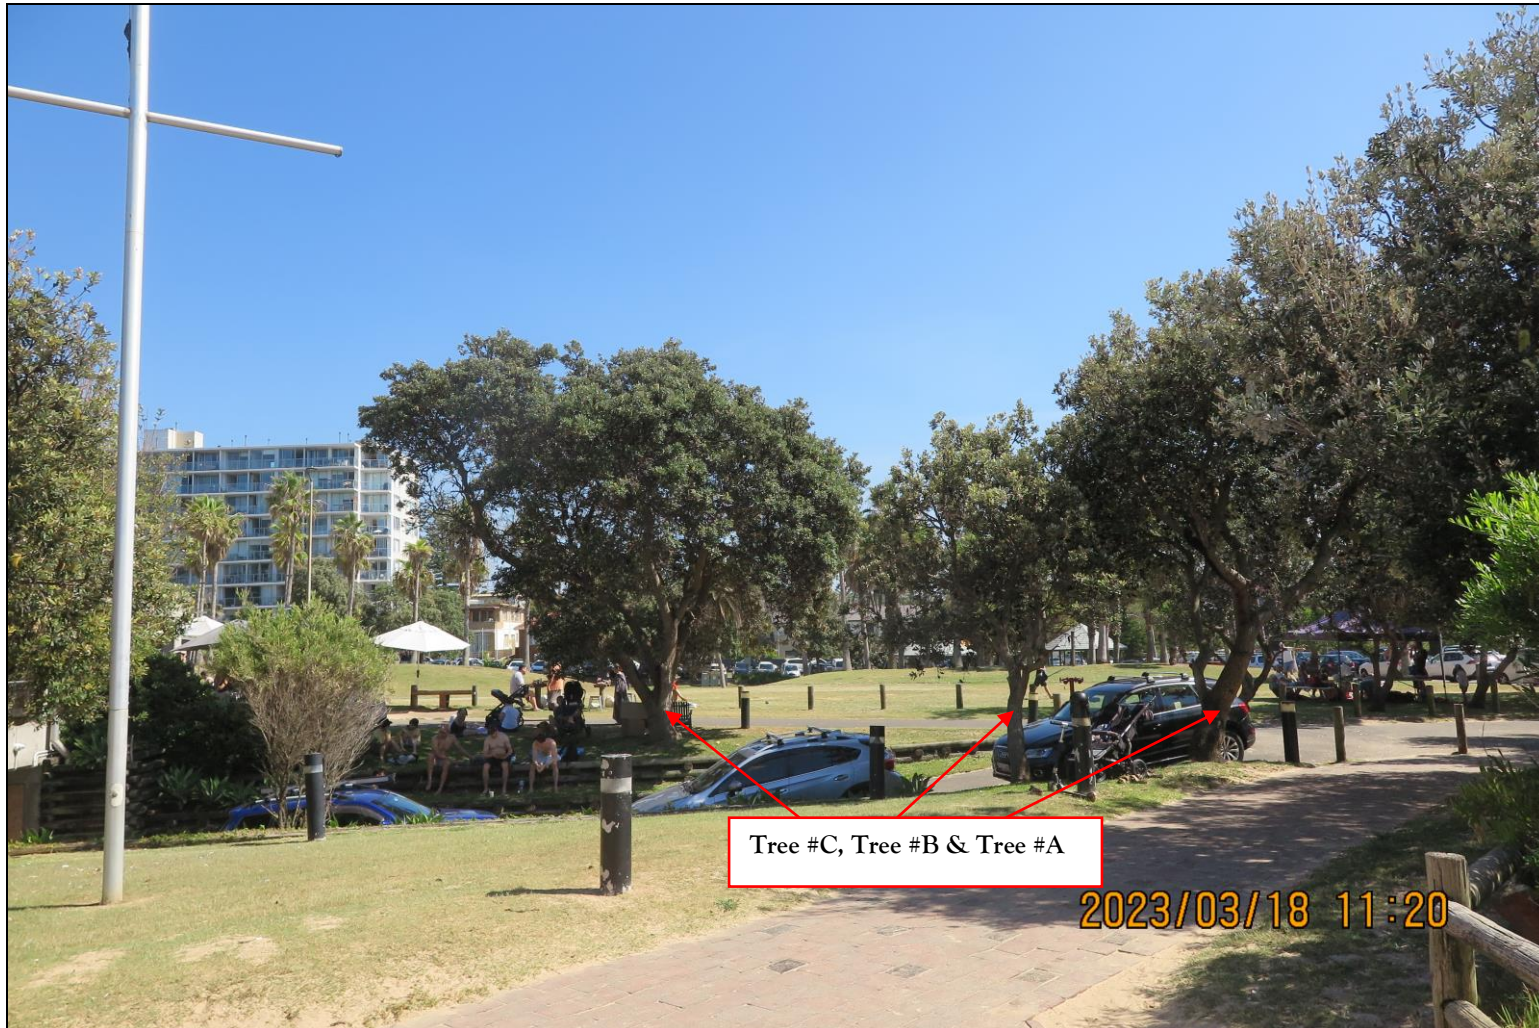
Figure 10L Illustrates the location & condition of Tree #A, Tree #B & Tree #C.

C	<i>Banksia integrifolia</i> Coast Banksia	<7.50	<8.00	0.61	7.32	2.74	Mature	Good & Good	Appears sound	High/High	<u>Retain, Protect &amp; Manage:</u>

**Tree #A:** This tree is part of a group of two (2) trees known as Tree #A & Tree #B. This tree is confirmed to be a locally indigenous species with an approximate age of less than twenty years (20). There is no valid Horticulture or Arboriculture reason to condemn the tree. It has simply been assessed as being of High Retention & Significance values relative to the nearby as proposed works.

**Tree #B:** This tree is part of a group of two (2) trees known as Tree #A & Tree #B. This tree is confirmed to be a locally indigenous species with an approximate age of less than twenty years (20). There is no valid Horticulture or Arboriculture reason to condemn the tree. It has simply been assessed as being of High Retention & Significance values relative to the nearby as proposed works.

**Tree #C:** This tree is a stand-alone tree specimen. This tree is confirmed to be a locally indigenous species with an approximate age of less than twenty-five years (25). There is no valid Horticulture or Arboriculture reason to condemn the tree. It has simply been assessed as being of High Retention & Significance values relative to the nearby as proposed works.

This tree will be specified to have standard Tree Protection instated to isolate it (as a group of two (2) trees) from any potential to be disturbed by the as proposed works.

This tree is specified to have standard Tree Protection instated to isolate it from any potential to be disturbed by the as proposed works. This specification is compliant with the *Australian Standard (AS4970-2009 Protection of trees on development sites.)*. See Chapters 3, 4 & 5.

No canopy pruning is envisaged as being necessary. In the event canopy pruning is required the retained Project Arborist is to prepare the specification in a manner totally compliant with the *Australian Standard (AS4373-2007 Pruning of amenity trees)*. See Chapter 7.

No canopy pruning is envisaged as being necessary. In the event canopy pruning is required the retained Project Arborist is to prepare the specification in a manner totally

compliant with the *Australian Standard (AS4373-2007 Pruning of amenity trees)*. See Chapter 7.
