Acid Sulfate Soil Assessment – Passmore Reserve, Manly Vale, NSW

1. Introduction and Background

JBS&G Australia Pty Ltd (JBS&G) was engaged by BBF Town Planners on behalf of Northern Beaches Council (Council, the client) to undertake an Acid Sulfate Soil (ASS) Assessment in relation to a Development Application (DA) for new lighting at Passmore Reserve, Manly Vale (the site). The site location is provided in **Figure 1**, and the site layout is provided in **Figure 2, Attachment 2**. Sample locations are provided on **Figure 3, Attachment 2**, reflecting the locations of the proposed lighting.

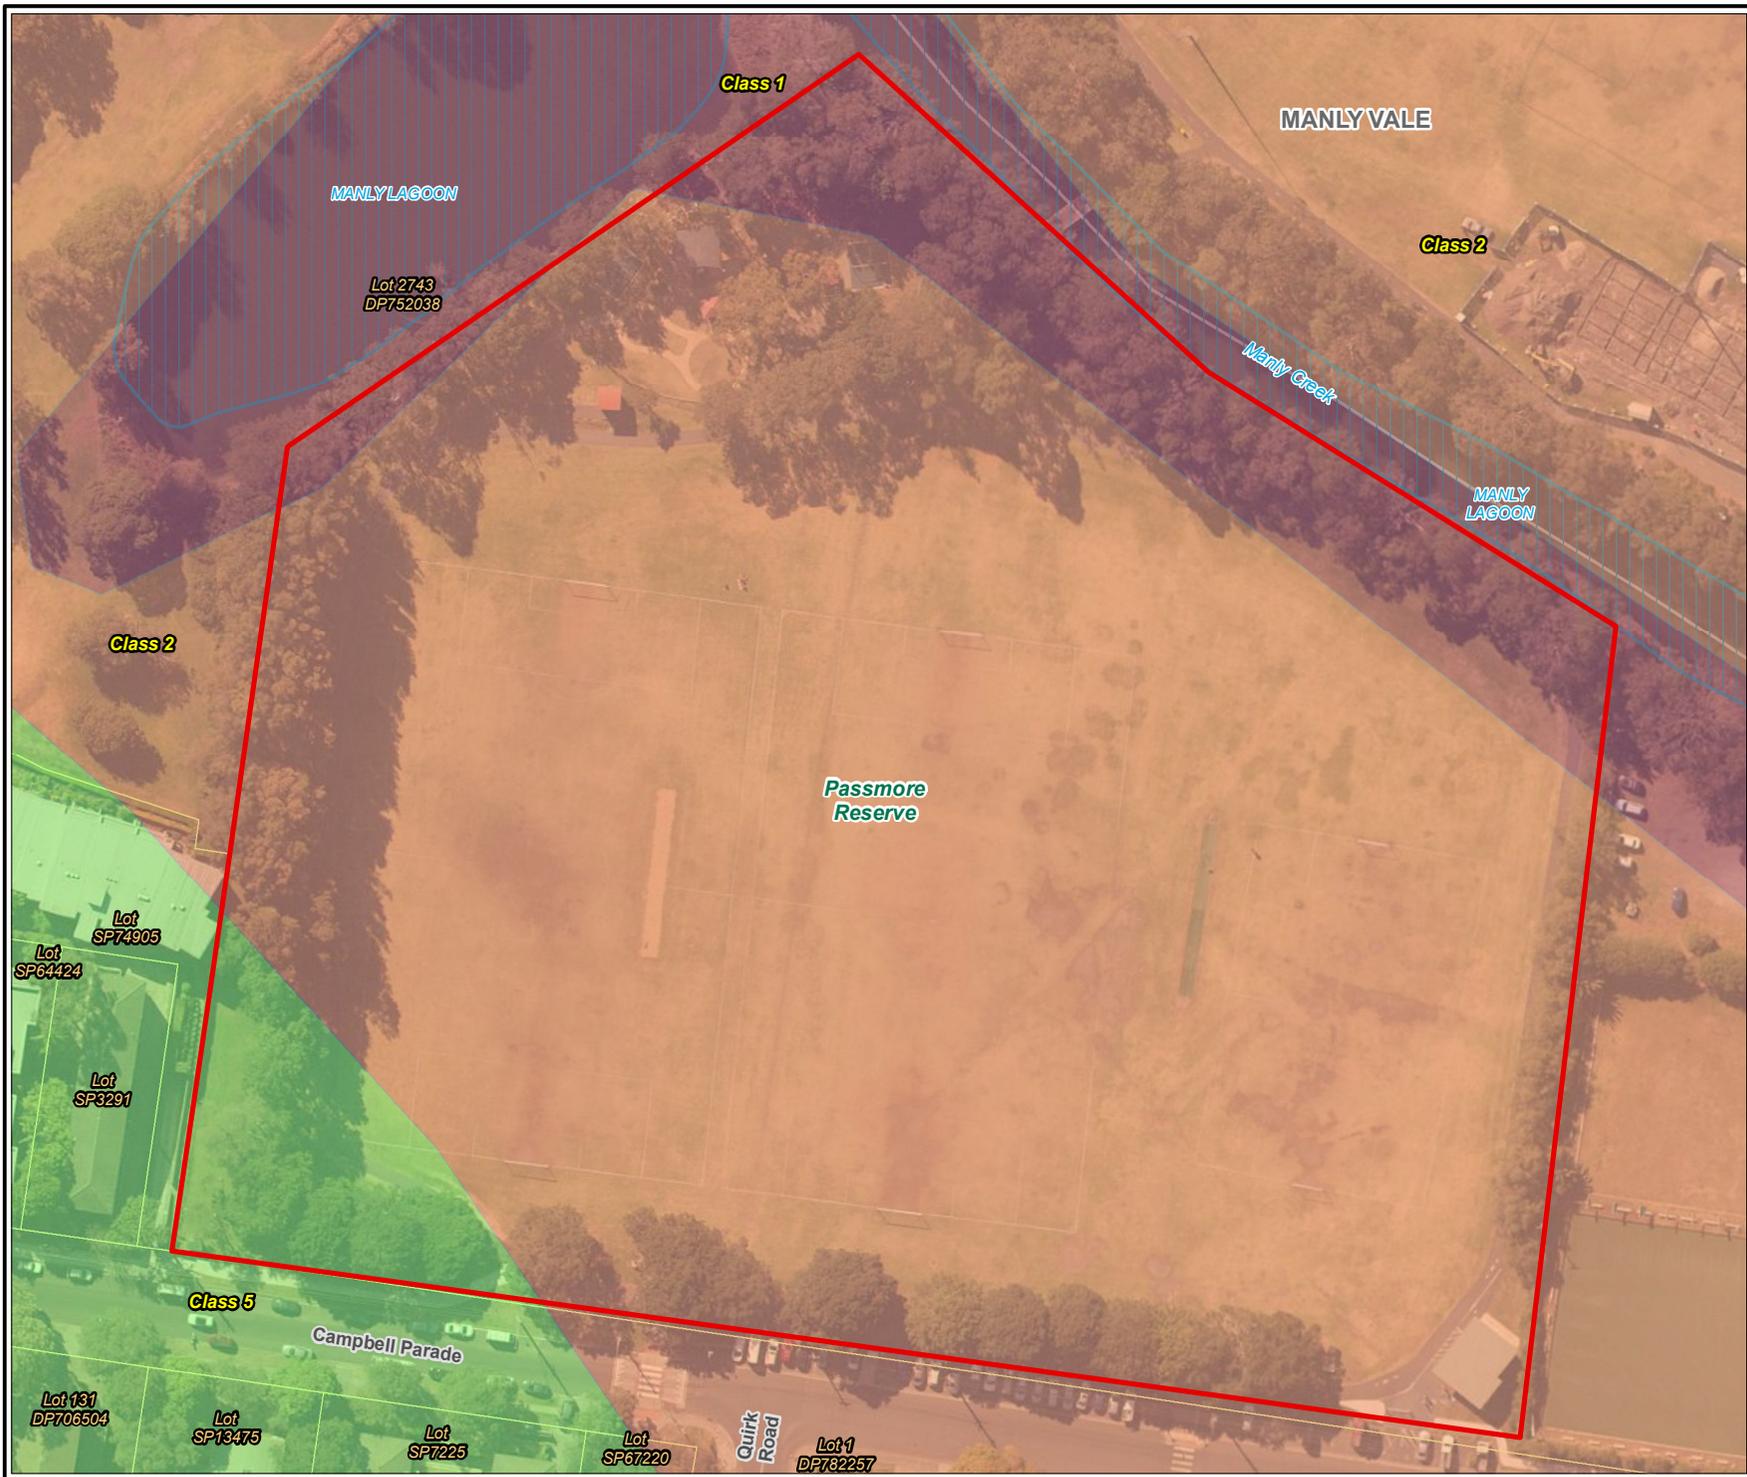
FIGURE 2

North/north-eastern portion of the site (along Manly Vale Creek) has been classified into Class 1, ASS conditions considered likely to be found on and below the natural ground surface;

Central portion of the site has been classified into Class 2, ASS conditions considered likely to be found below the natural ground surface; and

Southwest portion of the site has been classified into Class 5, considered unlikely to contain acid sulfate soil conditions (located within 500m on adjacent class 1-4 land).

**SITE LAYOUT AND ACID
SULPHATE SOILS RISK
CLASSIFICATIONS**

Acid sulfate soil risk classification mapping is shown on **Figure 2, Attachment 2**.

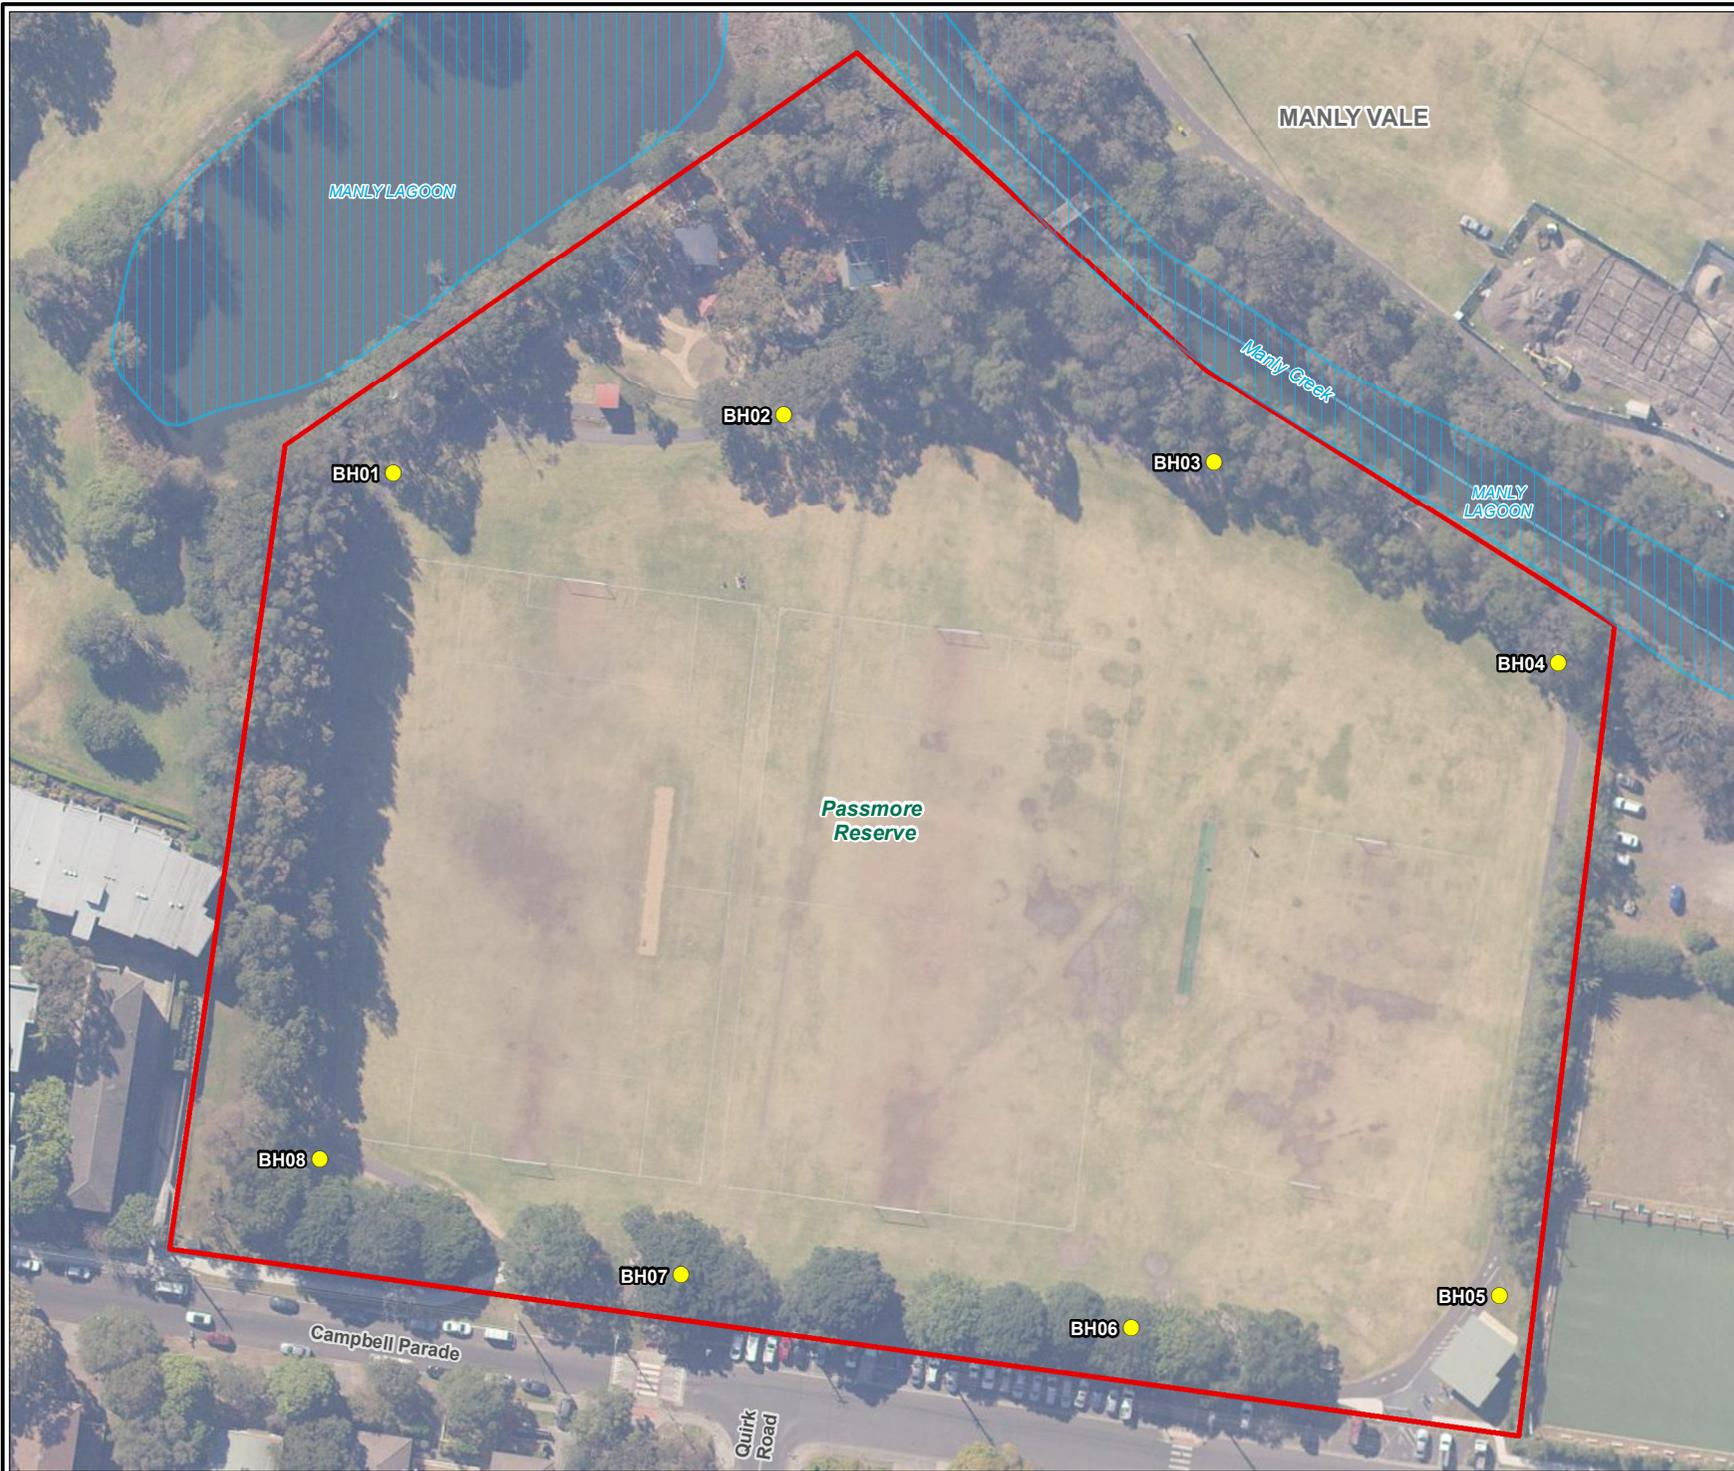
FIGURE 3

A total of eight soil sampling locations were selected targeting areas where excavations for light poles is proposed. The sampling locations are shown on **Figure 3, Attachment 2**. Each sample location was manually hand excavated using an extendable hand auger to a maximum depth of 1.0 m bgs. Field soil samples were collected directly from the hand auger and were immediately transferred into sealed zip-lock bags, surrounded by ice within a pre-cooled esky. A new pair of disposable nitrile gloves was used to collect each soil sample.

SAMPLE LOCATIONS

The field investigation program was conducted on 11 September 2019 which included a site inspection, hand excavation and sampling of material from a variety of depths by a trained and experienced JBS&G Environmental Consultant. A total of seven test pits (BH01 to BH07) in targeted location were advanced to 1.0 m bgs between into underlying soils (PASS) **Figure 3, Attachment 2.**
