Tony McLain Architects

Land Capability and Wastewater Management Options Assessment: Proposed Dwelling and Horse Stables, 113 Orchard Street, Warriewood, NSW

P2108165JR05V03
July 2024

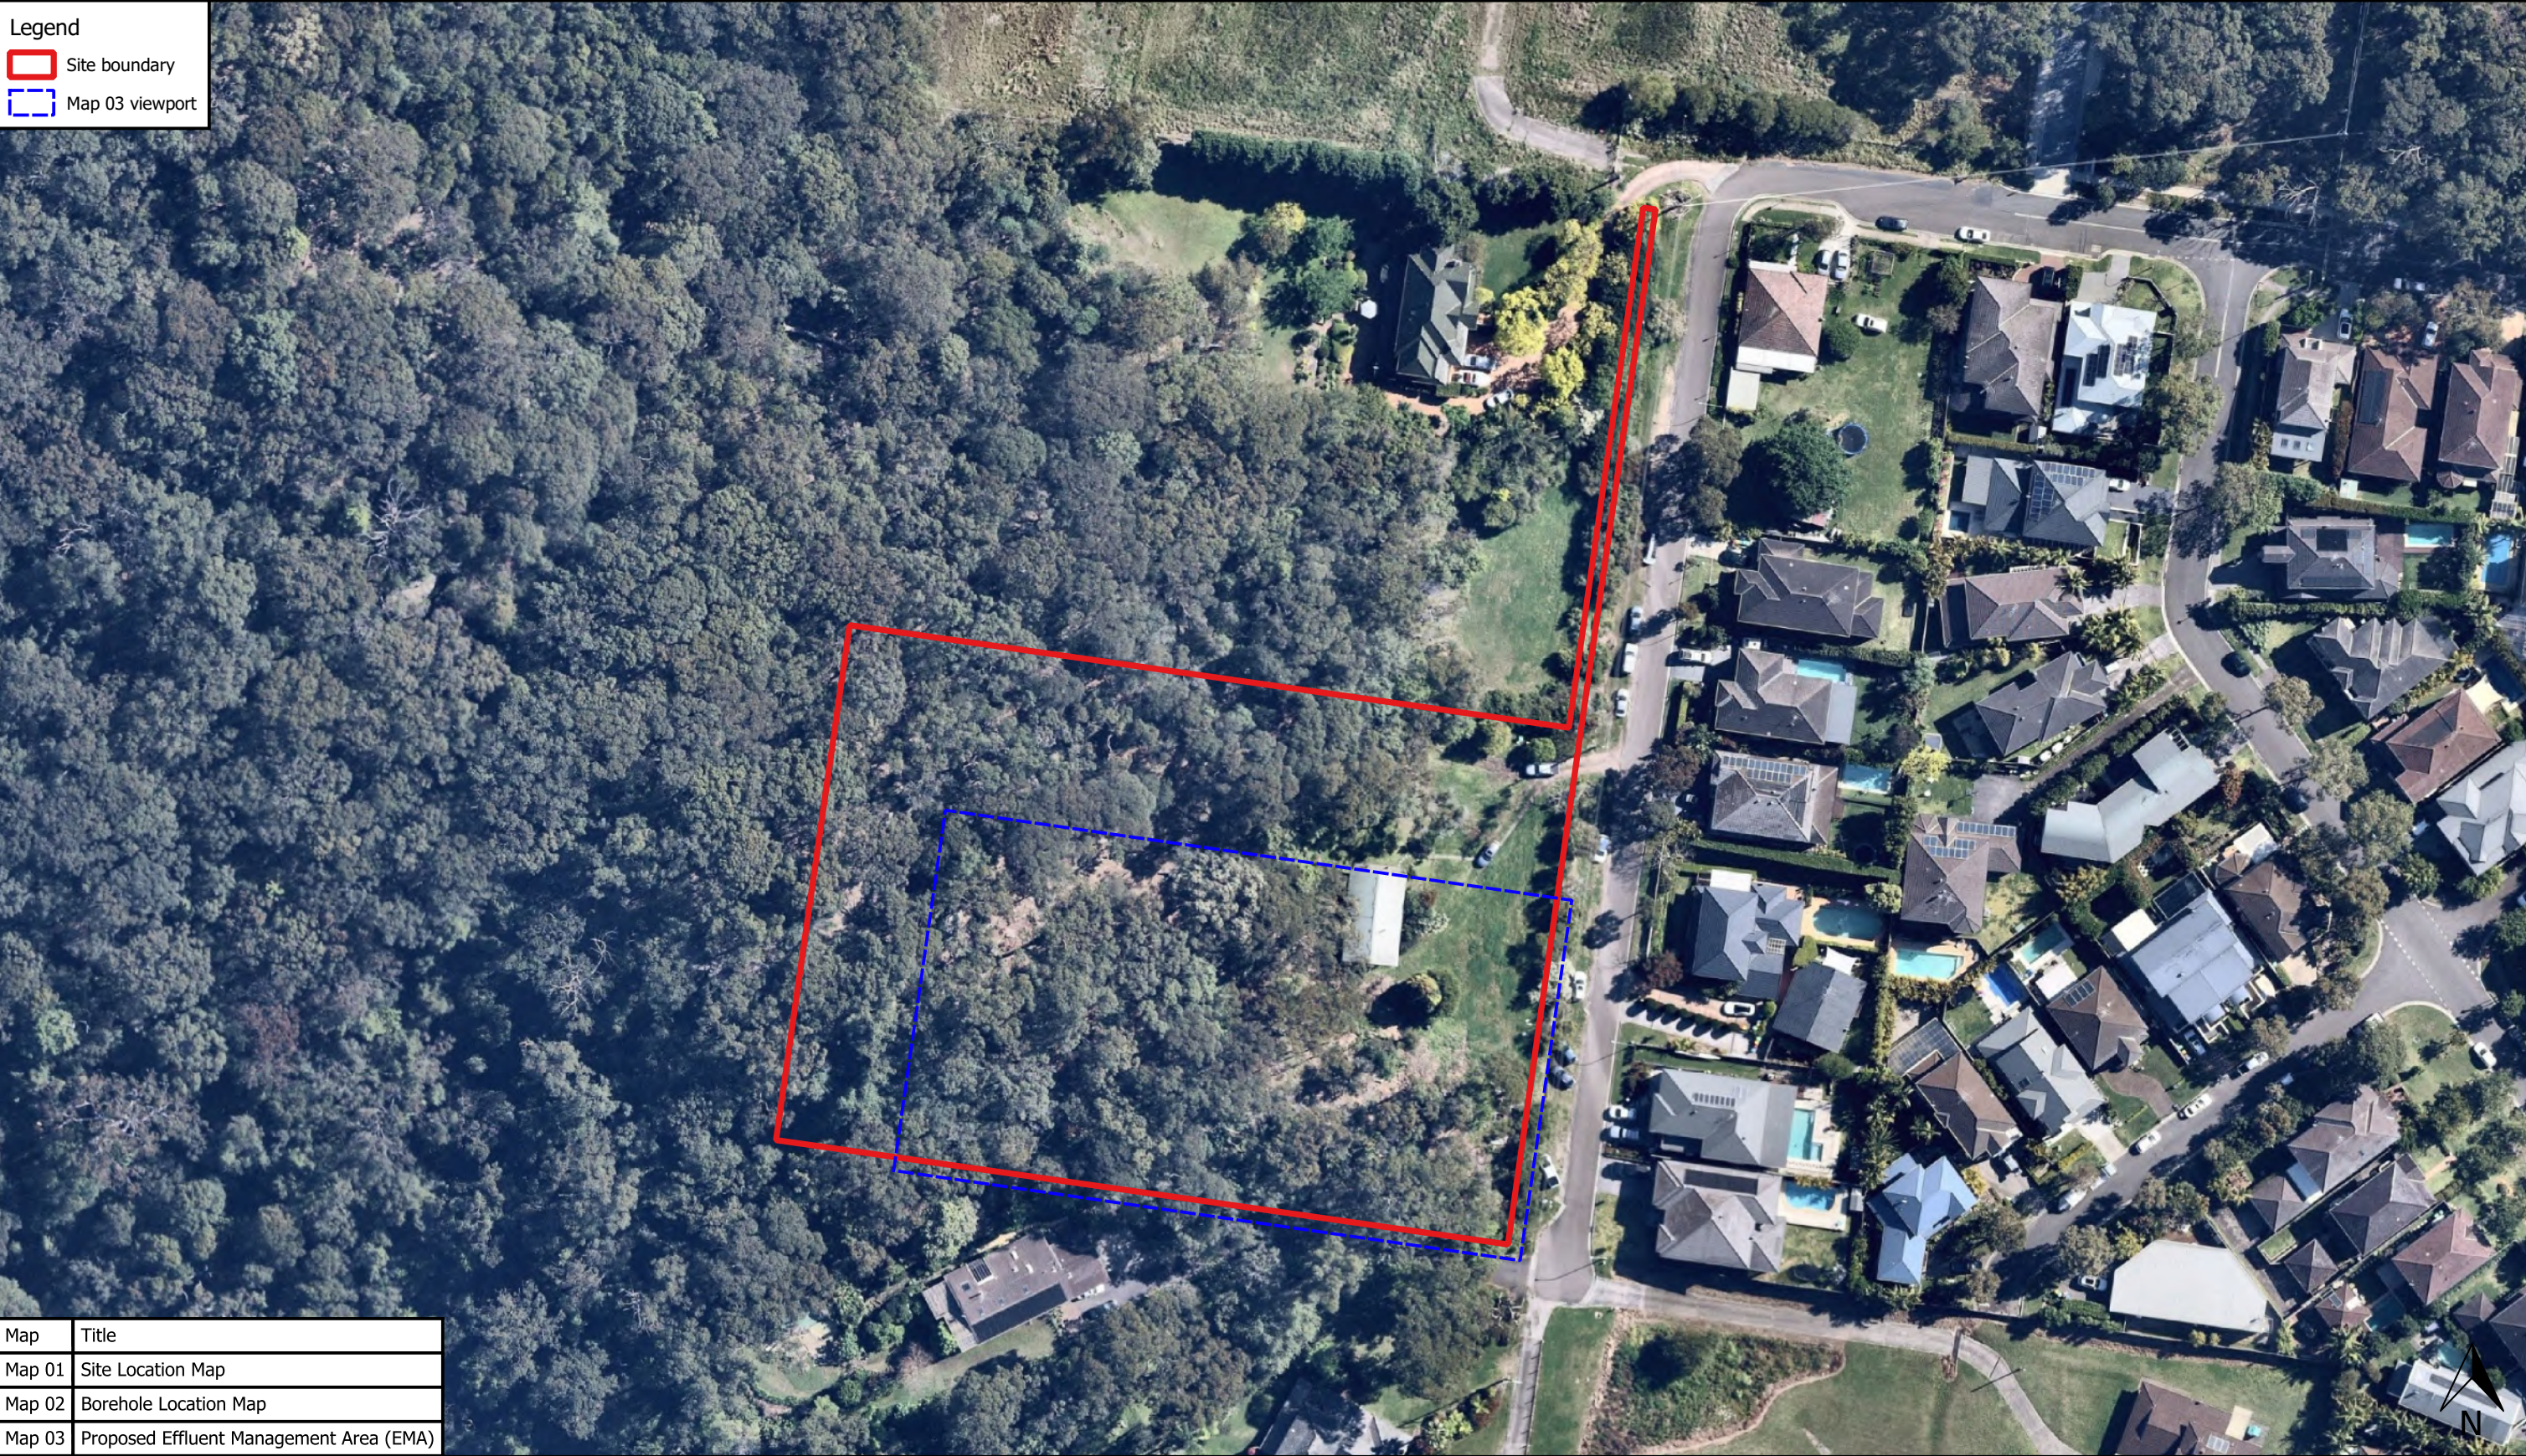
Map Title / Figure:

Site Location Map

A summarised site description is provided in Table 1 and site plan is provided in Map 01 (Attachment A).

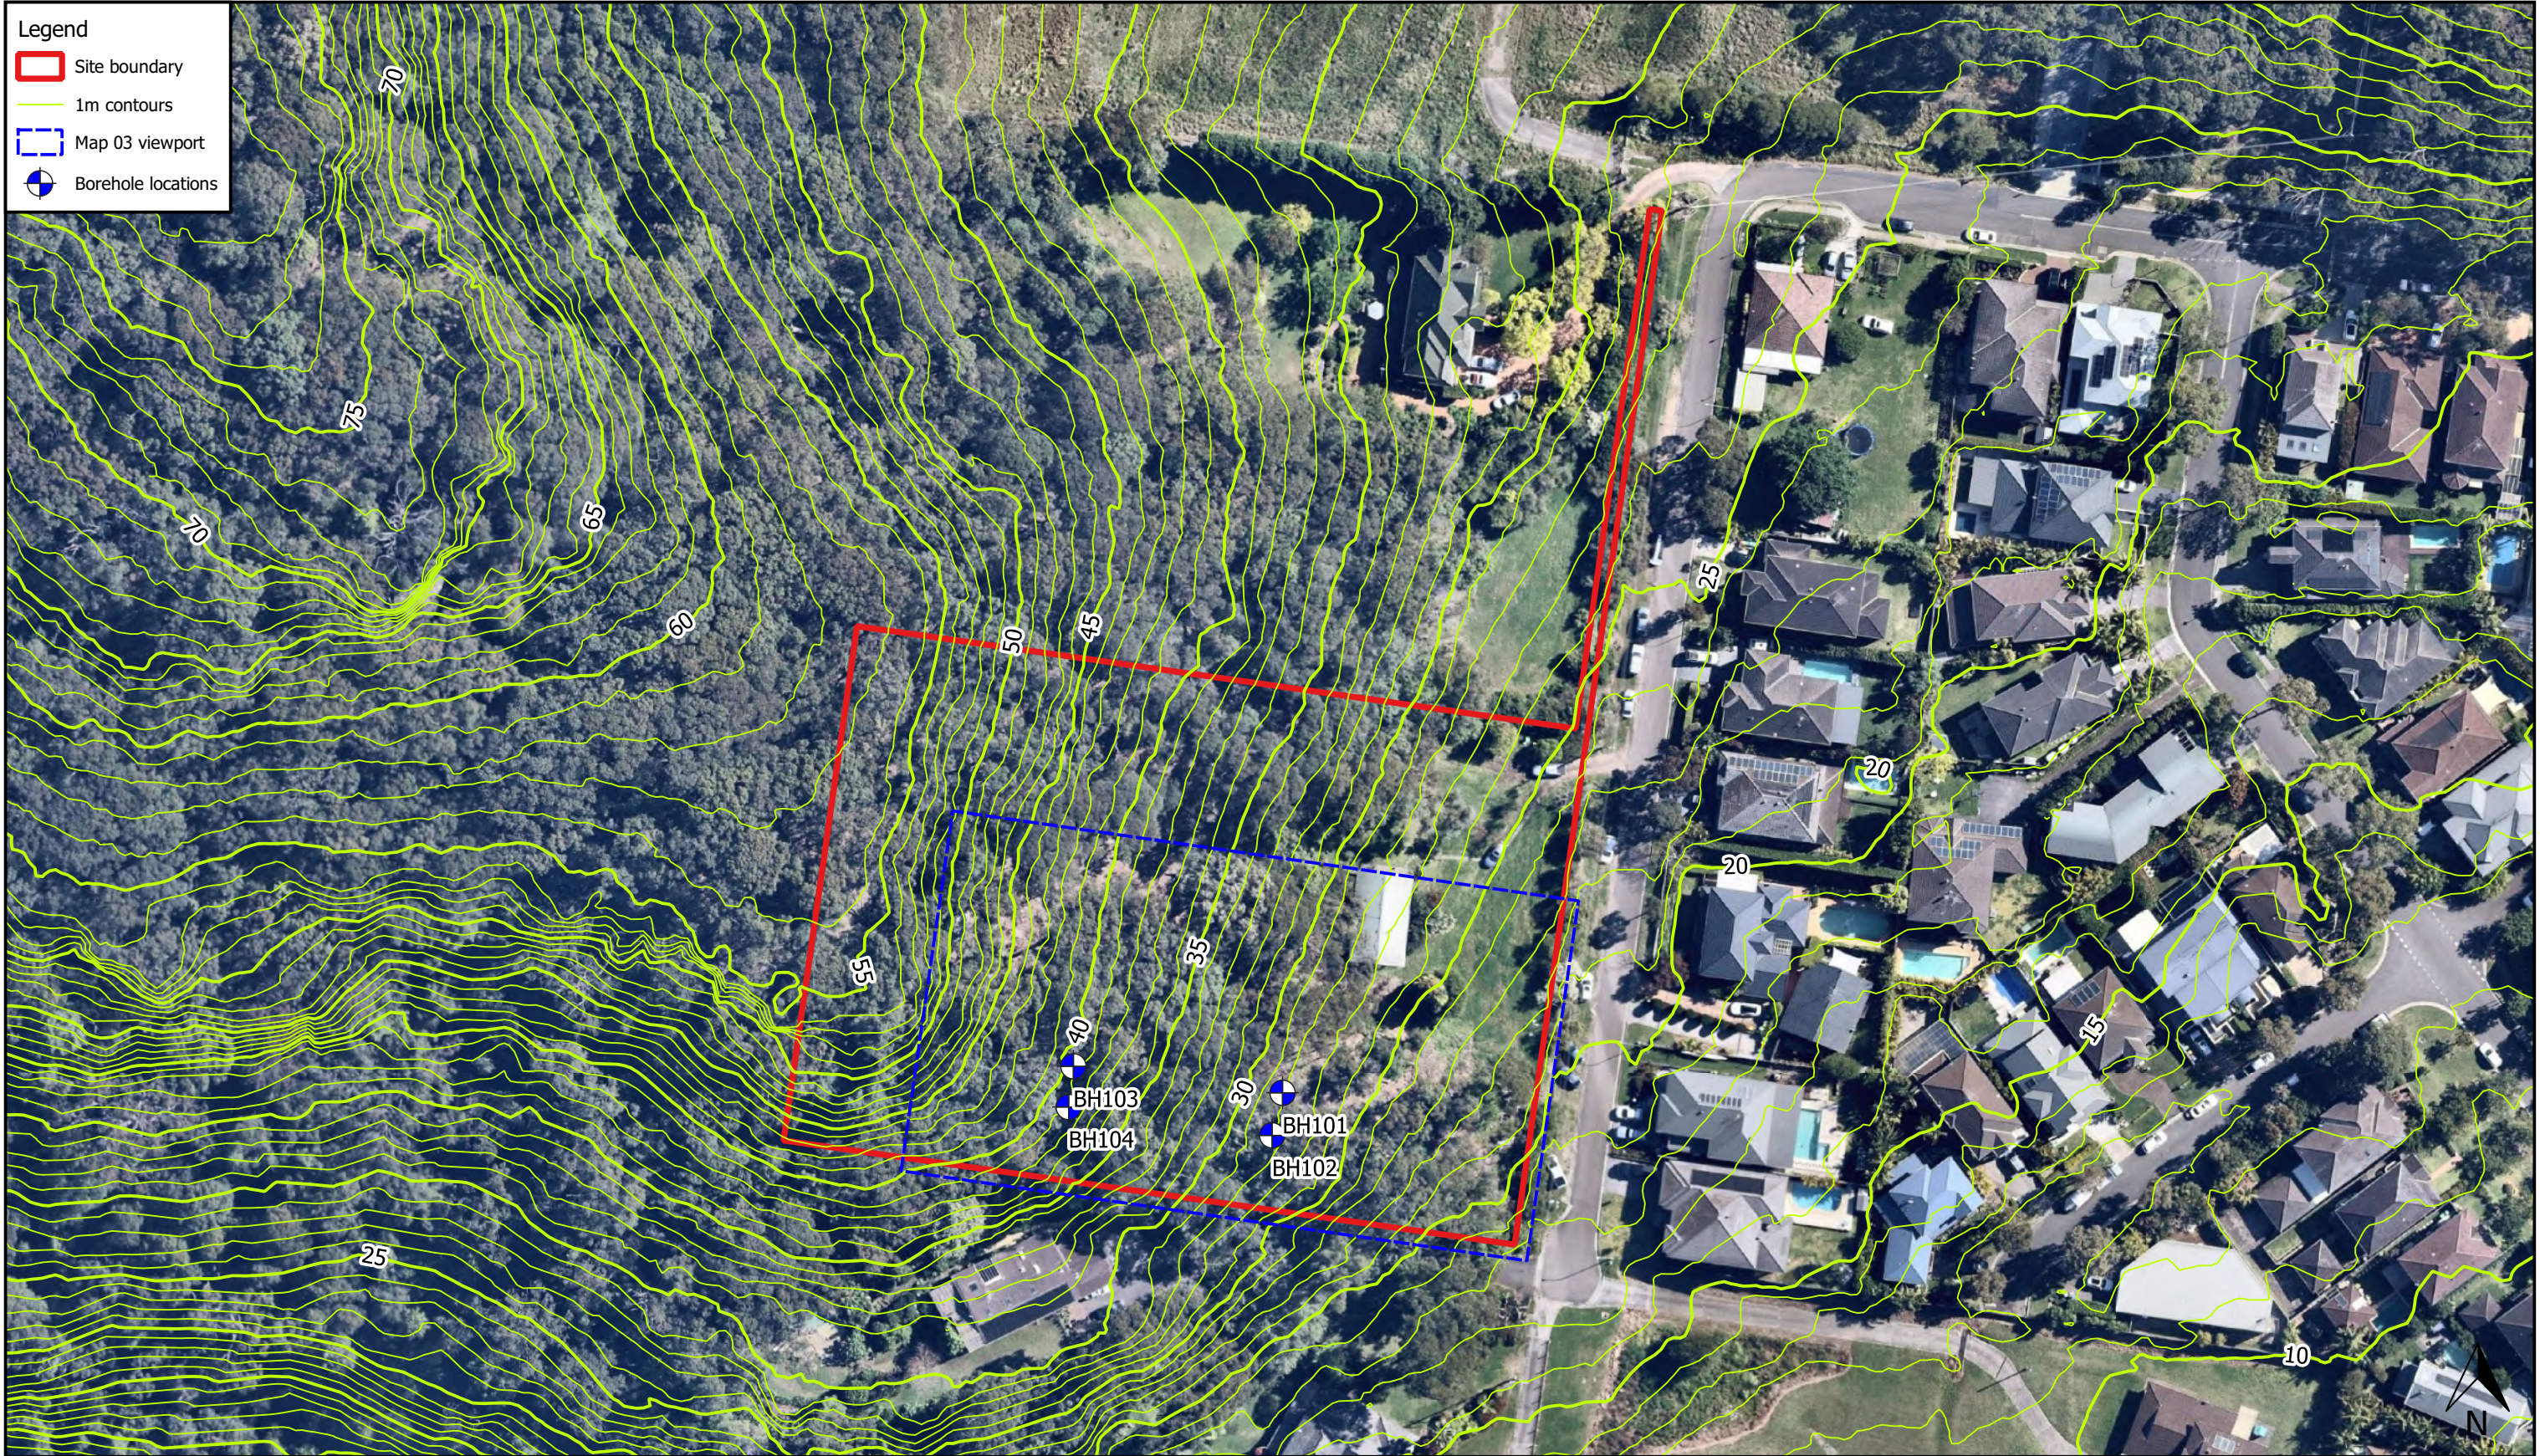
Map Title / Figure:
Borehole Location Map

Source of contour lines: ELVIS Lidar.
Source of Aerial Photo: Nearmap.

Soil characteristics encountered during borehole investigations in potential onsite effluent management areas (EMAs) consisted of sand, sandy loam and clayey sands topsoils to depths of approximately 400 mm overlying clay loams grading to light to medium clays at depth. The locations of the boreholes are shown in Map 02 (Attachment A).
