Report Title: Geotechnical Report 29 Wandeen Road, Clareville

Report Date: 6/7/22

GEOTECHNICAL INVESTIGATION:

Alterations and Additions at **29 Wandeen Road, Clareville**

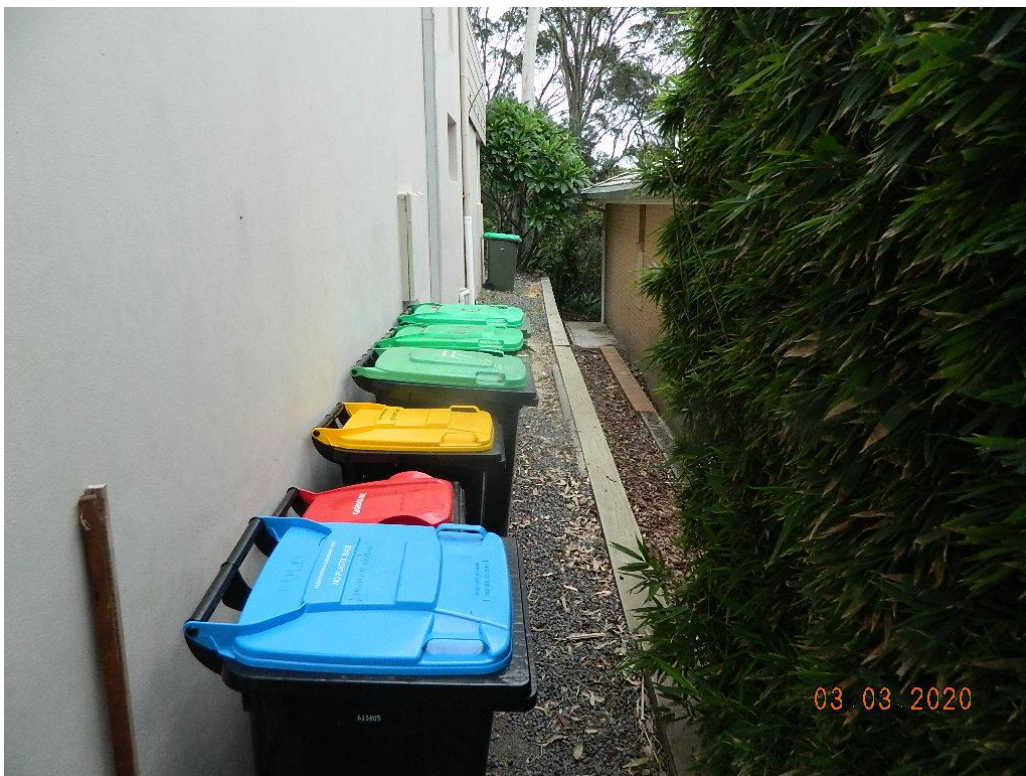
Photo 4

A $\sim 0.6\text{m}$ high timber retaining wall supports a cut for the downhill property to the W along part of the W common boundary (Photo 4). A $\sim 1.6\text{m}$ high timber retaining wall supports a cut in the slope next to the house along part of the E common boundary. Where the wall changes direction and extends onto the neighbouring property the supporting soldier post is tilting (Photos 5 & 6) some 10° from vertical. Due to its location the wall poses no significant threat to life or property. See '**Section 16** Ongoing maintenance.

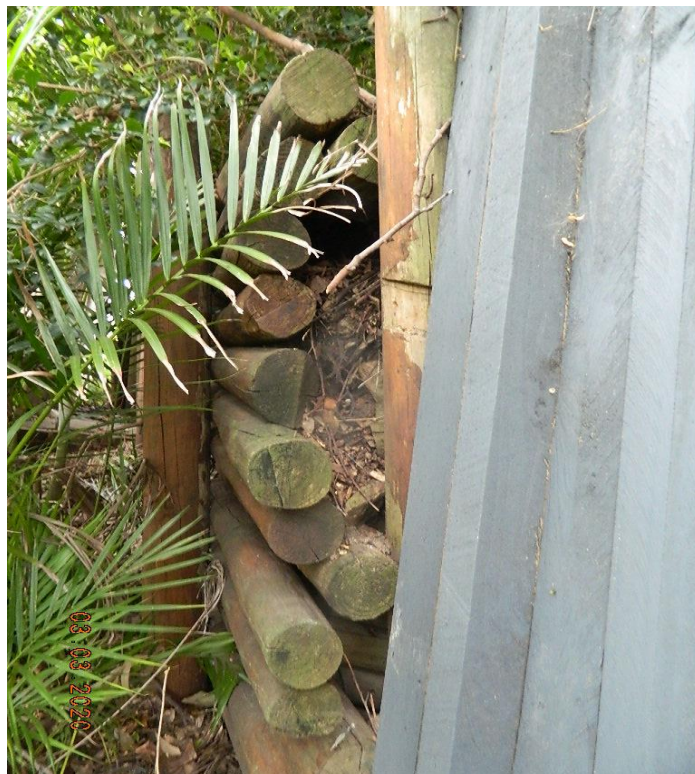
Photo 5

- The lift portion of the excavation comes underneath the first floor of the house and comes flush with the E perimeter masonry wall supporting the house.
- The storage room portion of the excavation comes underneath the first floor of the house and is setback ~1.1m from the E perimeter masonry wall supporting the house.
- The undercroft (connected to the proposed pool pump and water tank room) portion of the excavation is outside the footprint of the house. It comes flush with the S masonry house wall and is set back ~0.2m from a timber retaining wall near the E common boundary (Photo 5) and ~0.6m from the E common boundary.

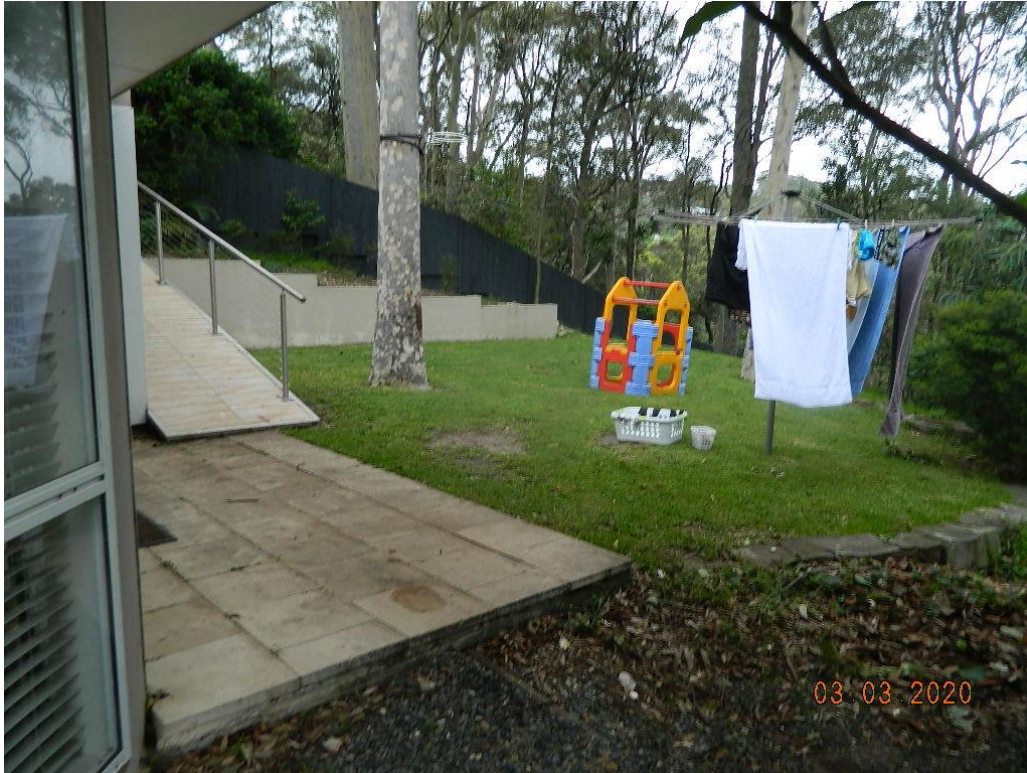
Photo 7

A cut and fill in the slope provides a near level lawn which extends from the S side of the house (Photo 7). Above the lawn a stable masonry retaining wall up to $\sim 1.4\text{m}$ high supports the cut (Photo 8). The lawn drops away to the S where the fill batter merges into the natural slope (Photos 9 & 10).

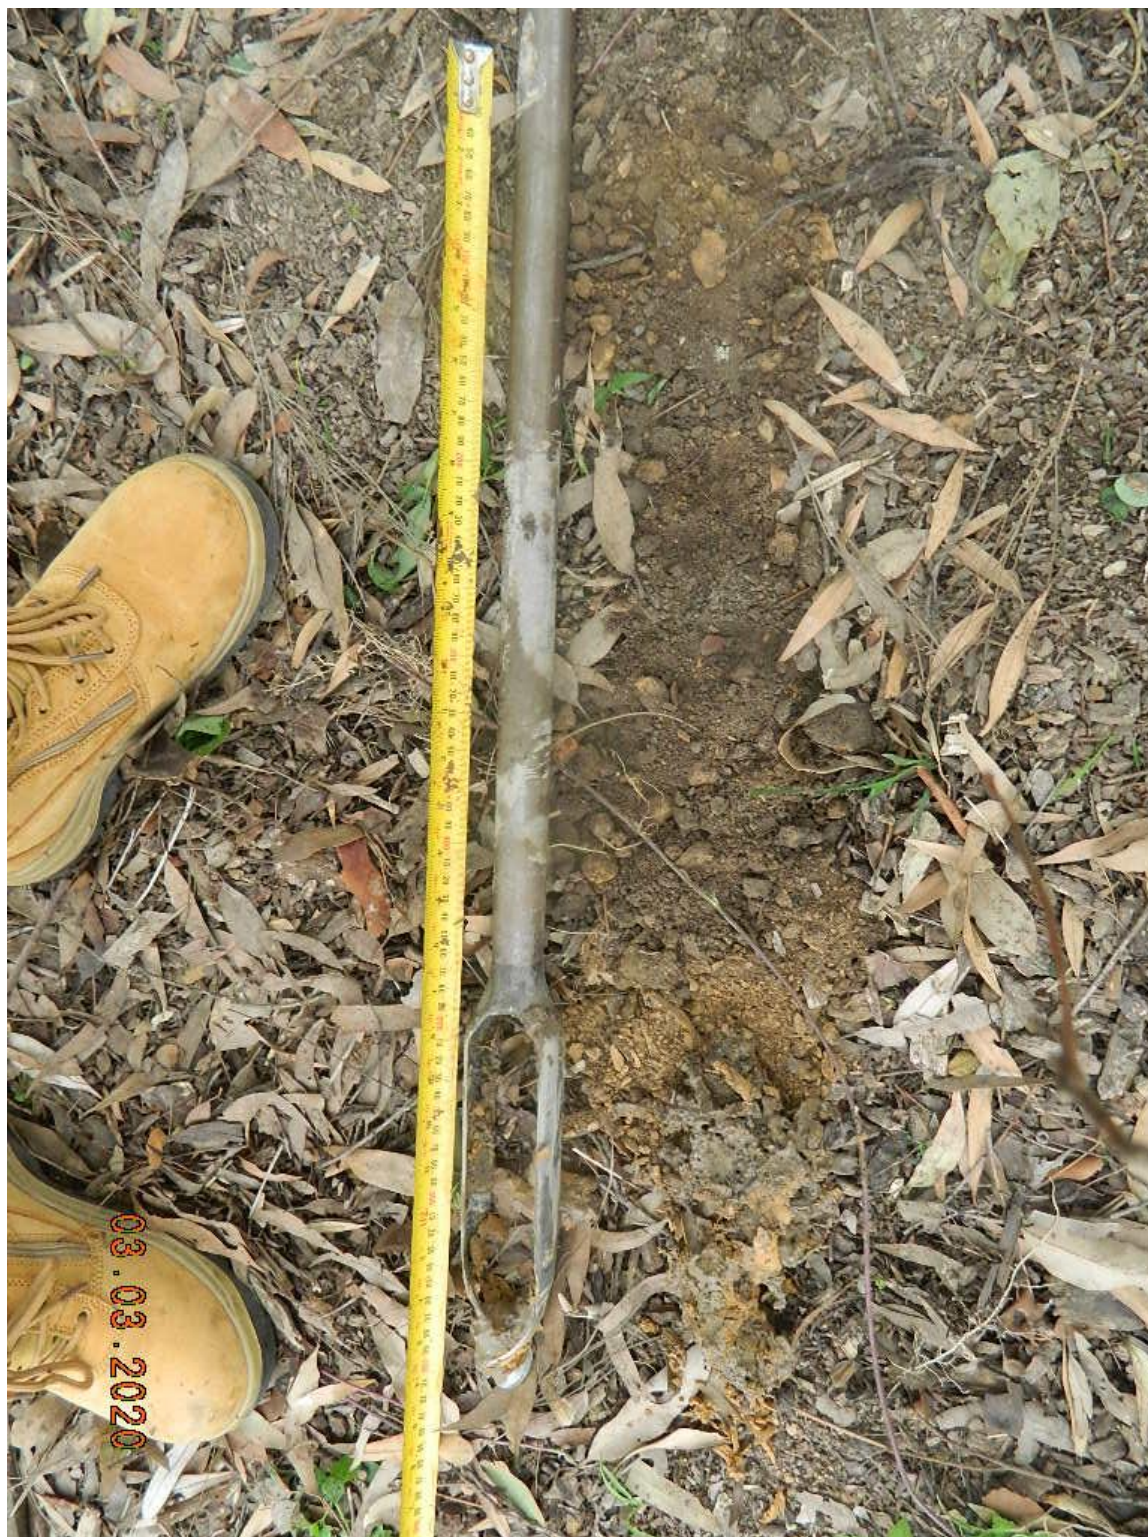
Photo 11: AH1 – Downhole is from top to bottom

AUGER HOLE 1 (~RL58.4) – AH1 (photo 11)

Depth (m)	Material Encountered
0.0 to 0.5	CLAYEY SOIL , brown and orange, dry.
0.5 to 0.7	CLAY , orange, firm to stiff, dry.

End of Hole @ 0.7m in Clay. No watertable encountered.
