**Marine Habitat Survey**

**Address | 121 Florence Terrace, Scotland Island**

**Job Number 18-046-08**

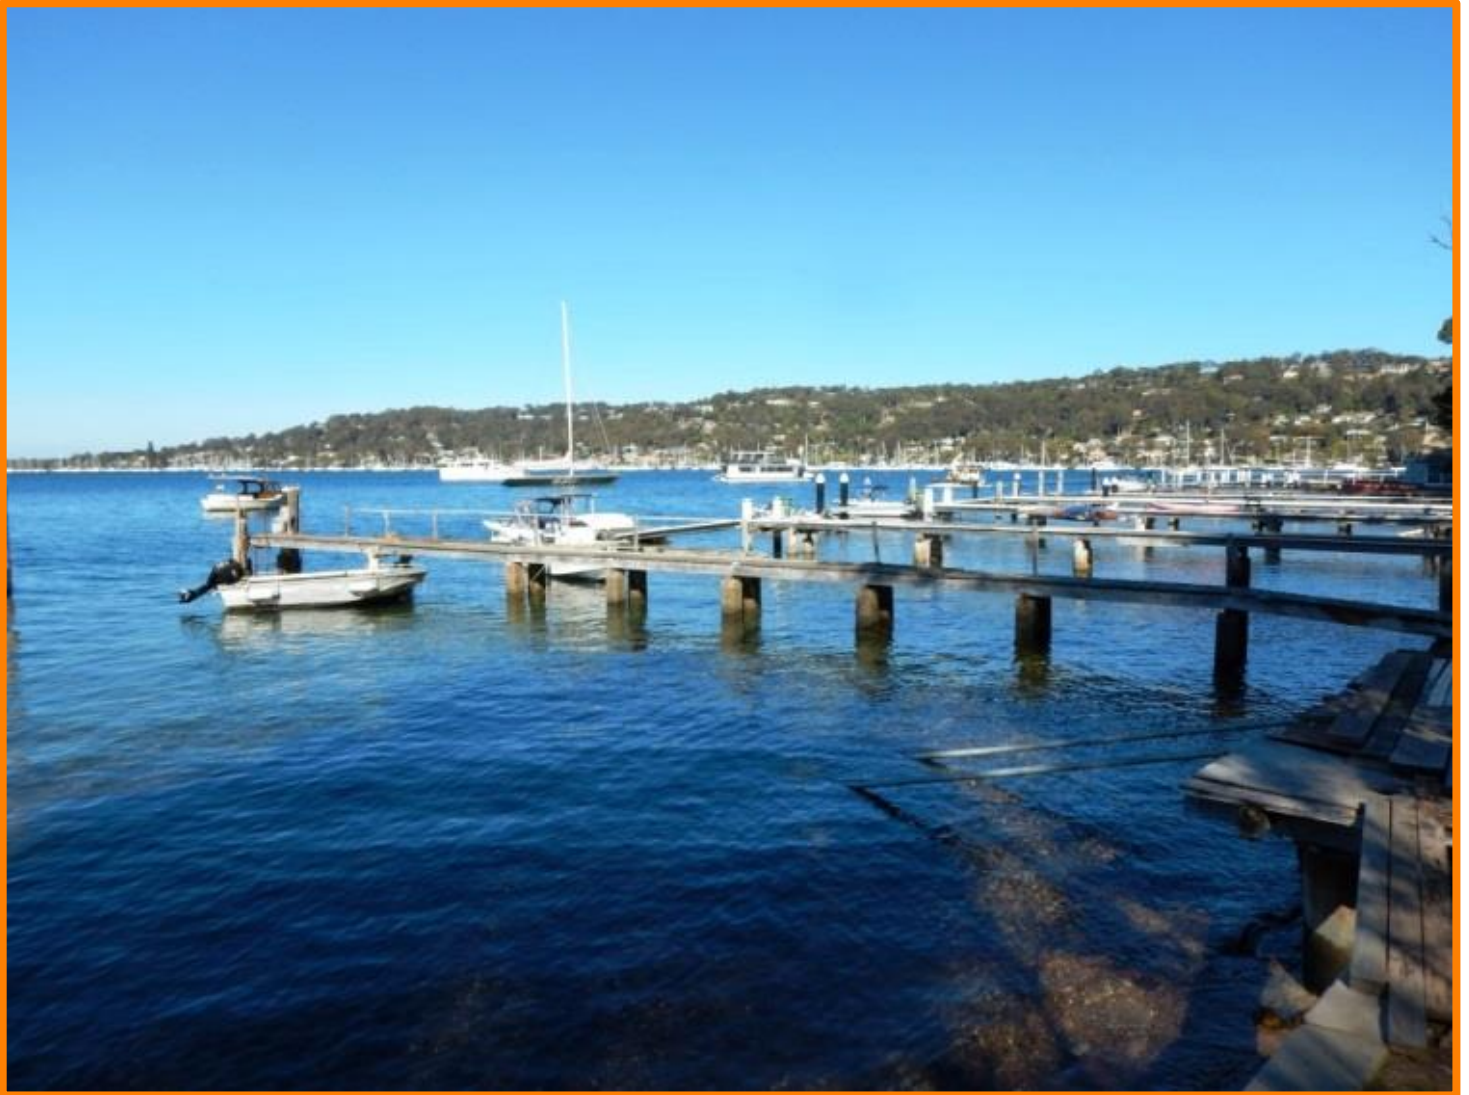
Two patches of medium density, medium leaf length *Zostera* (ZosB2M), mixed with the invasive *Caulerpa taxifolia*, were present off either side of the outer section of the existing jetty (see the seagrass map in Appendix B). Off the south-western side of the jetty, the patch started 1.6 m off the jetty and stretched 6 m near the outer end of the jetty. Off the north-eastern side of the jetty, the patch was smaller and started 1.4 m off the third last pier and stretched 2.5 m.

There was no seagrass in the footprint of the proposed jetty, ramp, pontoon or berthing area. No *Posidonia* was observed in the survey area.

There was a 1.4 – 1.6 m buffer between the two patches of medium density, medium leaf length *Zostera* (ZosB2M) and any new piling works. The shading footprint of the new jetty would be very similar to that of the existing jetty. The seabed in the location of the proposed new jetty, ramp, pontoon, stabilising piles and berthing area was colonised by the invasive green alga *Caulerpa taxifolia* and not any seagrass.

The proposed waterfront development design layout plans (provided by Stephen Crosby & Associates – Drawing 2128-DA01) and mapped seagrass at 121 Florence Terrace, Scotland Island is provided overleaf.

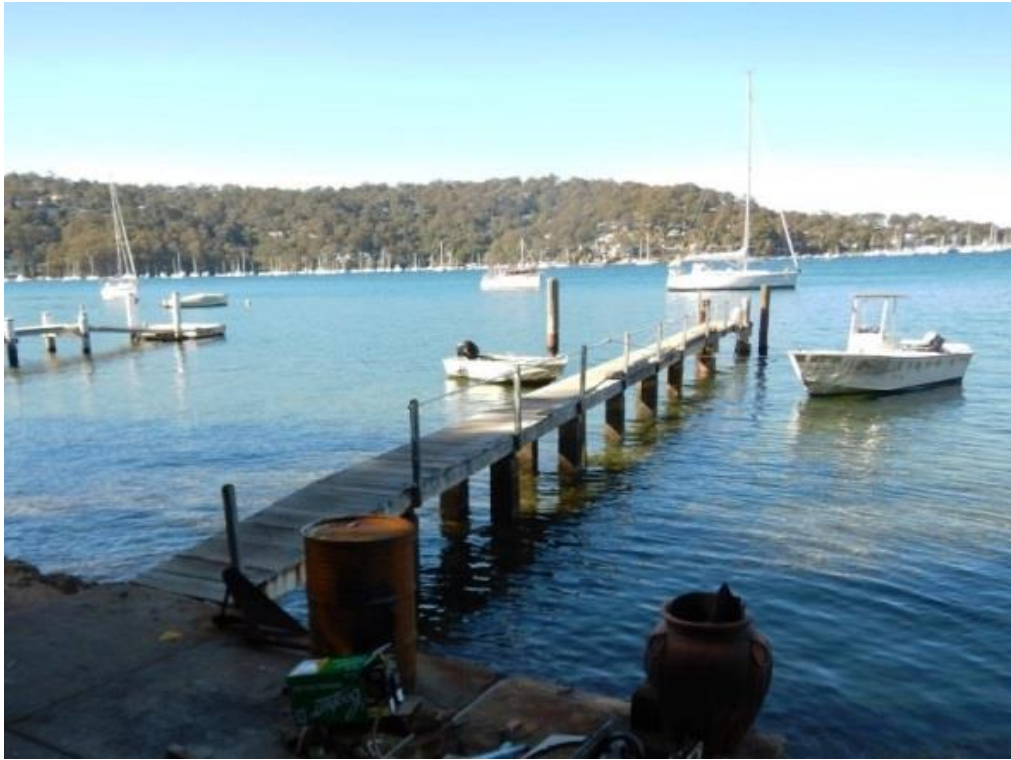
**Photo 1.** The existing timber jetty and berthing piles at The Property.

- a timber jetty (28 x 1.3 m) on the south-western side of The Property, supported on 12 concrete block piers and four outer timber piers;
- three timber berthing piles; and
- a set of slip rails on the north-eastern side of The Property.

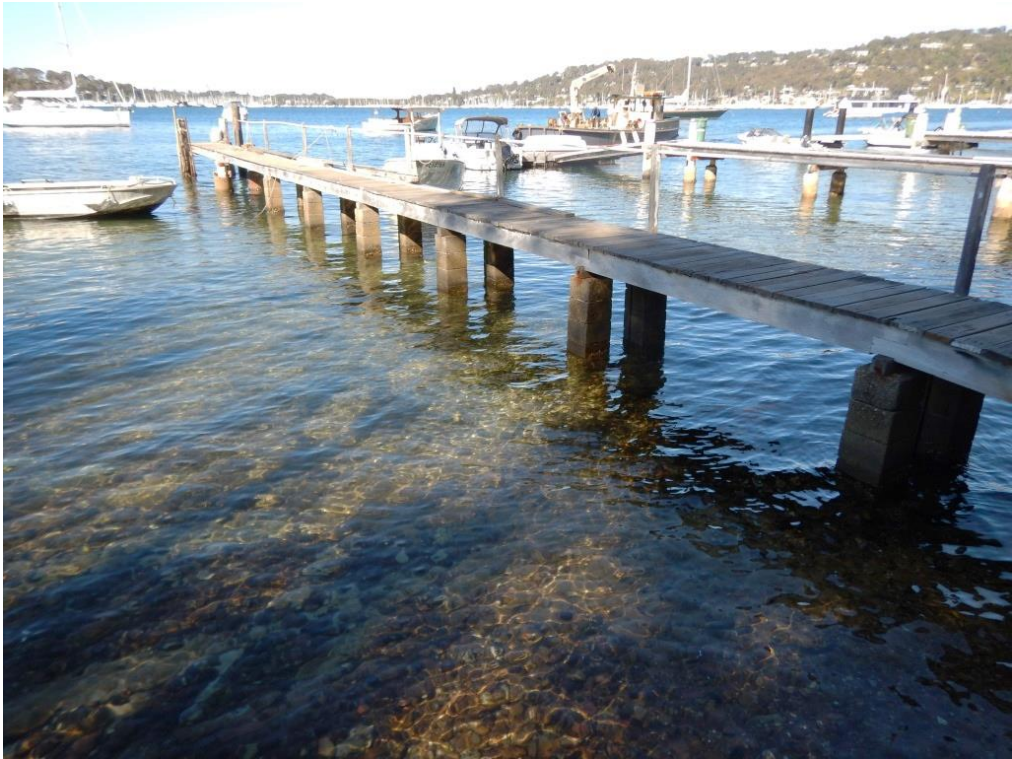
**Photo 3.** Intertidal habitats at the site – concrete jetty piers and submerged rocky seabed.

The intertidal zone at The Property consisted of artificial and natural habitats. A sandstone block seawall stretched across the width of The Property (Photo 4), and was fronted by an extensive, gradually sloping area seabed composed of lots of rock and rubble on top of areas of bedrock and sand (Photo 3). The concrete jetty piers provided additional artificial intertidal habitats (Photos 1 - 3).

The seawall and jetty piers were colonised by a low/medium density cover of Sydney rock oysters (*Saccostrea glomerata*) along with low numbers of periwinkles (*Bembicium nanum*). The rocky rubble was colonised by oysters and patches of Neptune's necklace (*Hormosira banksii*).
