ON  
**GEOTECHNICAL ASSESSMENT**  
**(In Accordance with Pittwater Council Risk  
Management Policy)**

FOR  
**PROPOSED HOUSE**

AT  
**40 SUNRISE ROAD, PALM BEACH, NSW**

Date: 13 March 2023  
Ref: 33855BYrptrev1

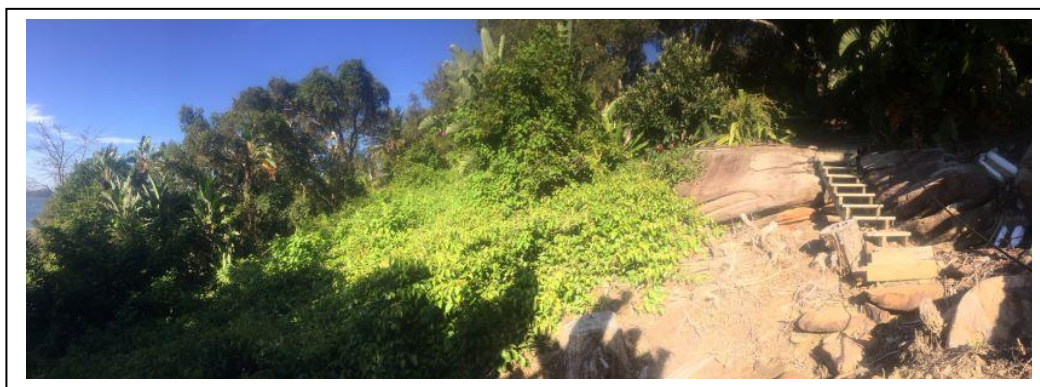
Where present sandstone outcrops are a maximum of about 2.7m in height and were assessed to be of at least medium to high strength. There appears to be two low height sandstone cliff lines that run diagonally across the site and are located approximately one-third of the way in from either ends of the site. While the upper cliff line could easily be observed and was undercut in places, the lower cliff line was heavily overgrown, inaccessible and could not be viewed, as can be seen in the photo below. Where undercut in the upper cliff line, the overhanging bedrock cantilevered by up to about 1.8m.

- 6.1.1 All proposed footings must be founded in sandstone bedrock. The footings should be designed for an allowable bearing pressure of 600kPa, subject to inspection by a geotechnical engineer prior to pouring. Care must be taken that footings are not founded on undercut sections of the existing cliff beneath the house. Removal of the overhanging rock or underpinning would be required where this occurs.

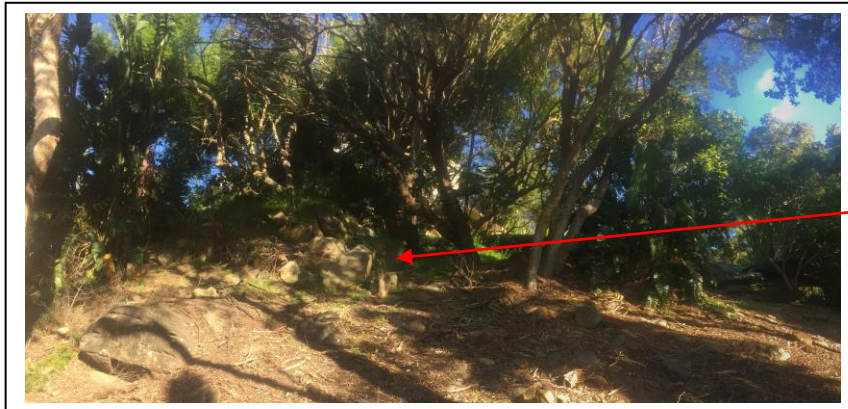
Rough  
Sandstone  
Boulder Wall

Approximately one third of the way down the eastern site boundary is what appears to be a rough sandstone boulder wall that appears to have been constructed to provide a level area to the rear of the house on the adjoining property to the east, 38 Sunset Road. This wall has a maximum height of about 2.5m and is raked back at about 45° to 50°. This wall extends into the site and does not appear to show signs of distress. This is shown in the photo below.
