Address of site 981 Barrenjoey Rd, Palm Beach, NSW

Geotechnical Investigation

Our ref: 5821-G1-Rev2
17 January 2020

Proposed Alterations & Additions 981 Barrenjoey Road, Palm Beach NSW Geotechnical Investigation

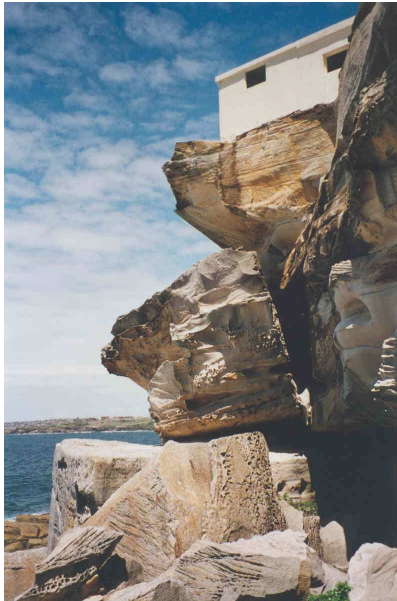
The coast presents a particularly dynamic environment where change is often the norm. Hazards exist in relation to both cliffs and sand dunes. The coast is also the most heavily populated part of Australia and always regarded as "prime" real estate, because of the views and access to waterways and beaches.

Waves, wind and salt spray play a significant part, causing dunes to move and cliff-faces to erode well above sea level. Our response is often to try to neutralise these effects by doing such things as dumping rock in the sea, building groynes, dredging, or carrying out dune stabilisation. Such works can be very effective, but ongoing maintenance is usually needed and total reconstruction may be necessary after a relatively short working life.

In addition to the processes that produce cliff instability on inland cliffs, coastal cliffs are also subjected to repeated cycles of wetting and drying which can be accompanied by the expansive effect of salt crystal growth in gaps in the rocks. These processes accelerate the deterioration of coastal cliffs. At the base of cliffs, direct wave attack and the impact of boulders moved by wave action causes undercutting and hence instability of the overall face. Figure 2 of GeoGuide LR4 provides an example. Whilst the processes leading to coastal cliff collapse may take years, failure tends to be catastrophic and with little warning. In many cases, waves produced by large oceanic storms are the trigger assisted by rainfall to produce collapse. These are also the conditions in which you are more likely to be inside your home and oblivious to unusual noises or movements associated with imminent failure.

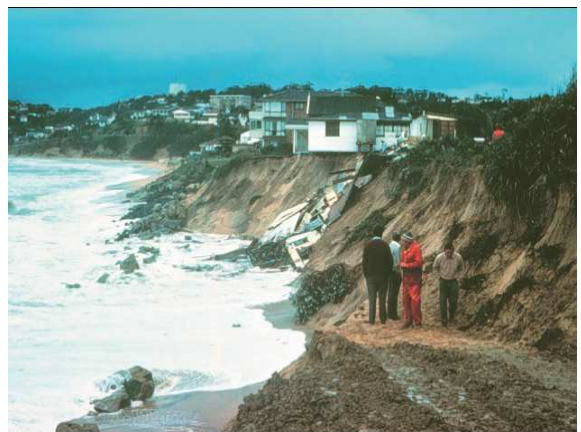
Sand dune escarpment and slope failures

An understanding of coastal processes is essential when determining beach erosion potential. Waves produced by large oceanic storms can erode beaches and cut escarpments into dunes. These may be of relatively short duration, when beach rebuilding happens after the storm, but can be a permanent feature where long term beach recession is taking place. In many locations, houses and infrastructure are sited on or immediately behind coastal dunes. After an escarpment has eroded, those assets may be lost or damaged by subsequent slumping of the dune. It is important that, on erodible coastal soils, the potential for landward incursion of an erosion escarpment is determined. Having done this, the likelihood of slope instability can be established as part of the landslide risk management process. Injury, death and structural damage have occurred around the Australian coast from collapsing sand escarpments.

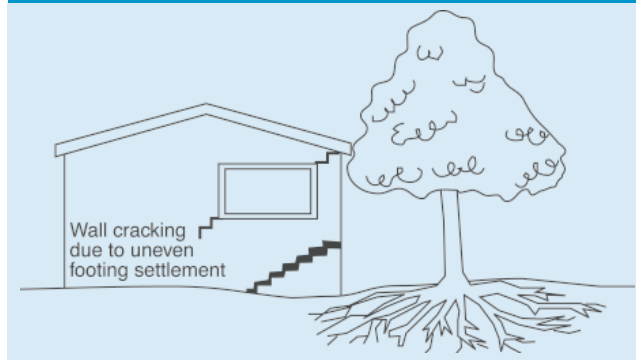
Trees can cause shrinkage and damage

As the weather pattern changes and the soil begins to dry out, the external footings will be first affected, beginning with the locations where the sun's effect is strongest. This has the effect of lowering the external footings. The doming is accentuated and cracking reduces or disappears where it occurred because of dishing, but other cracks open up. The roof lines may become convex.
