205400.01  
2 February 2023  
NB:hb  
R.01.Rev2

**214 Hudson Parade, Clareville**  
**Proposed Alterations and Additions to Boatshed**

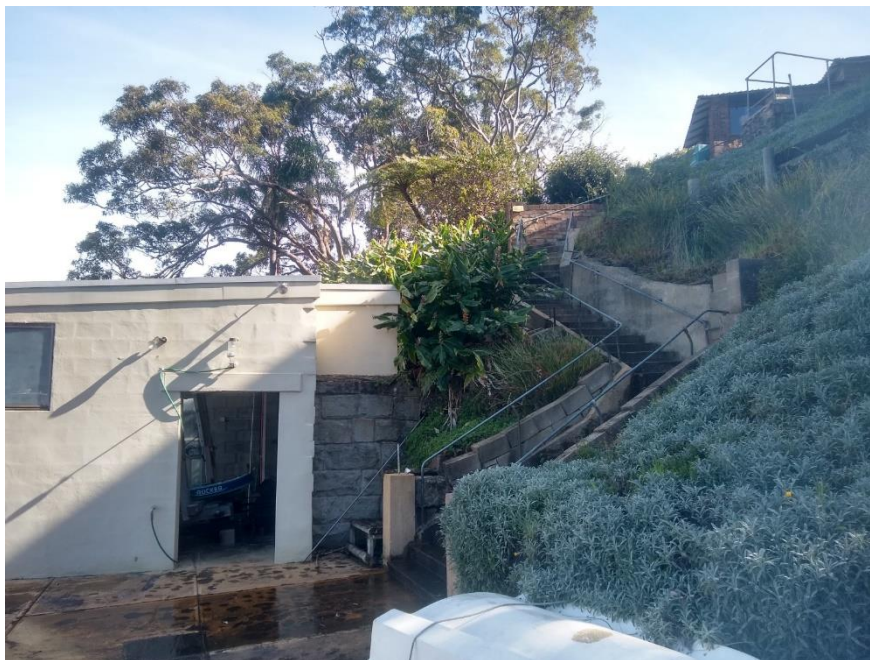
**Photograph 1: Boatshed looking west**

At the location of the boatshed, the ground slopes from about RL<sup>1</sup> 4 to RL 1.0 below sea level. Steps adjacent to a retaining wall lead down from the rear garden of the property to the boatshed (see Photograph 1). There is an existing boatshed with a jetty where the proposed new structure will be located.

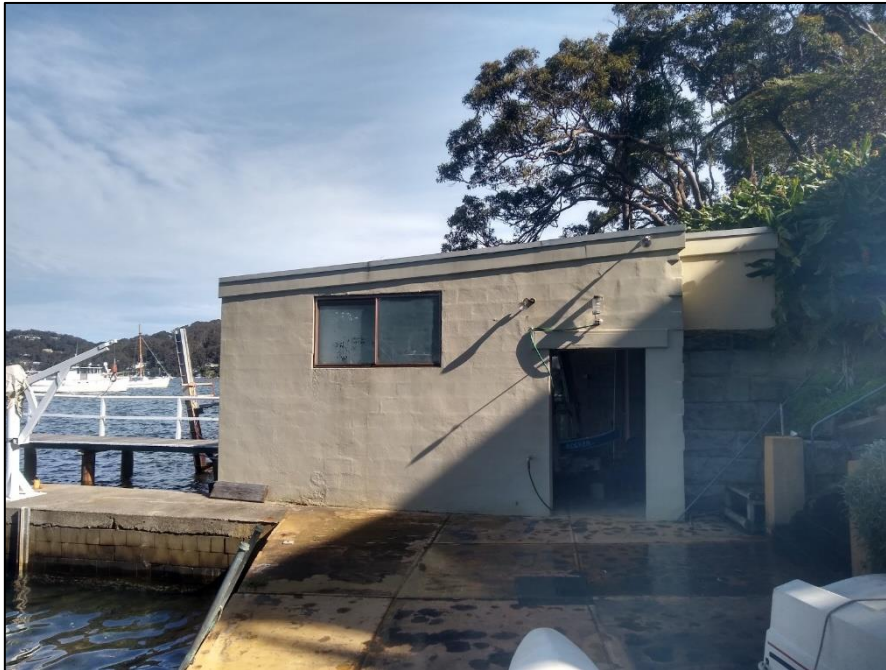
**Photograph 2: Boatshed looking west**

- The boatshed is founded on an existing concrete slab supported in part by either sandstone bricks or concrete cinder blocks possibly founded on rock (see Photograph 2);
- The existing boatshed slab is in relatively good condition with no visible cracking;
- The boatshed walls are made from concrete cinder blocks and have no visible signs of distress or cracking;
- An existing sandstone block retaining wall forms the northern wall of the boatshed. There appears to be some minor cracking with some crack repair in places (see Photograph 3). The existing sandstone block wall is proposed to remain in place;
- The existing wooden jetty appears to be in good condition and constructed in the last 10 years;
- A slipway consisting of steel tracks extends from the boatshed into the water;

It should be noted that the existing foundations of the boatshed and slipway were not exposed nor investigated during the site walk-over. The condition and suitability of the foundations to support the proposed new boatshed and decking should be assessed and commented on by the structural engineer. Further investigation maybe required to confirm their suitability.

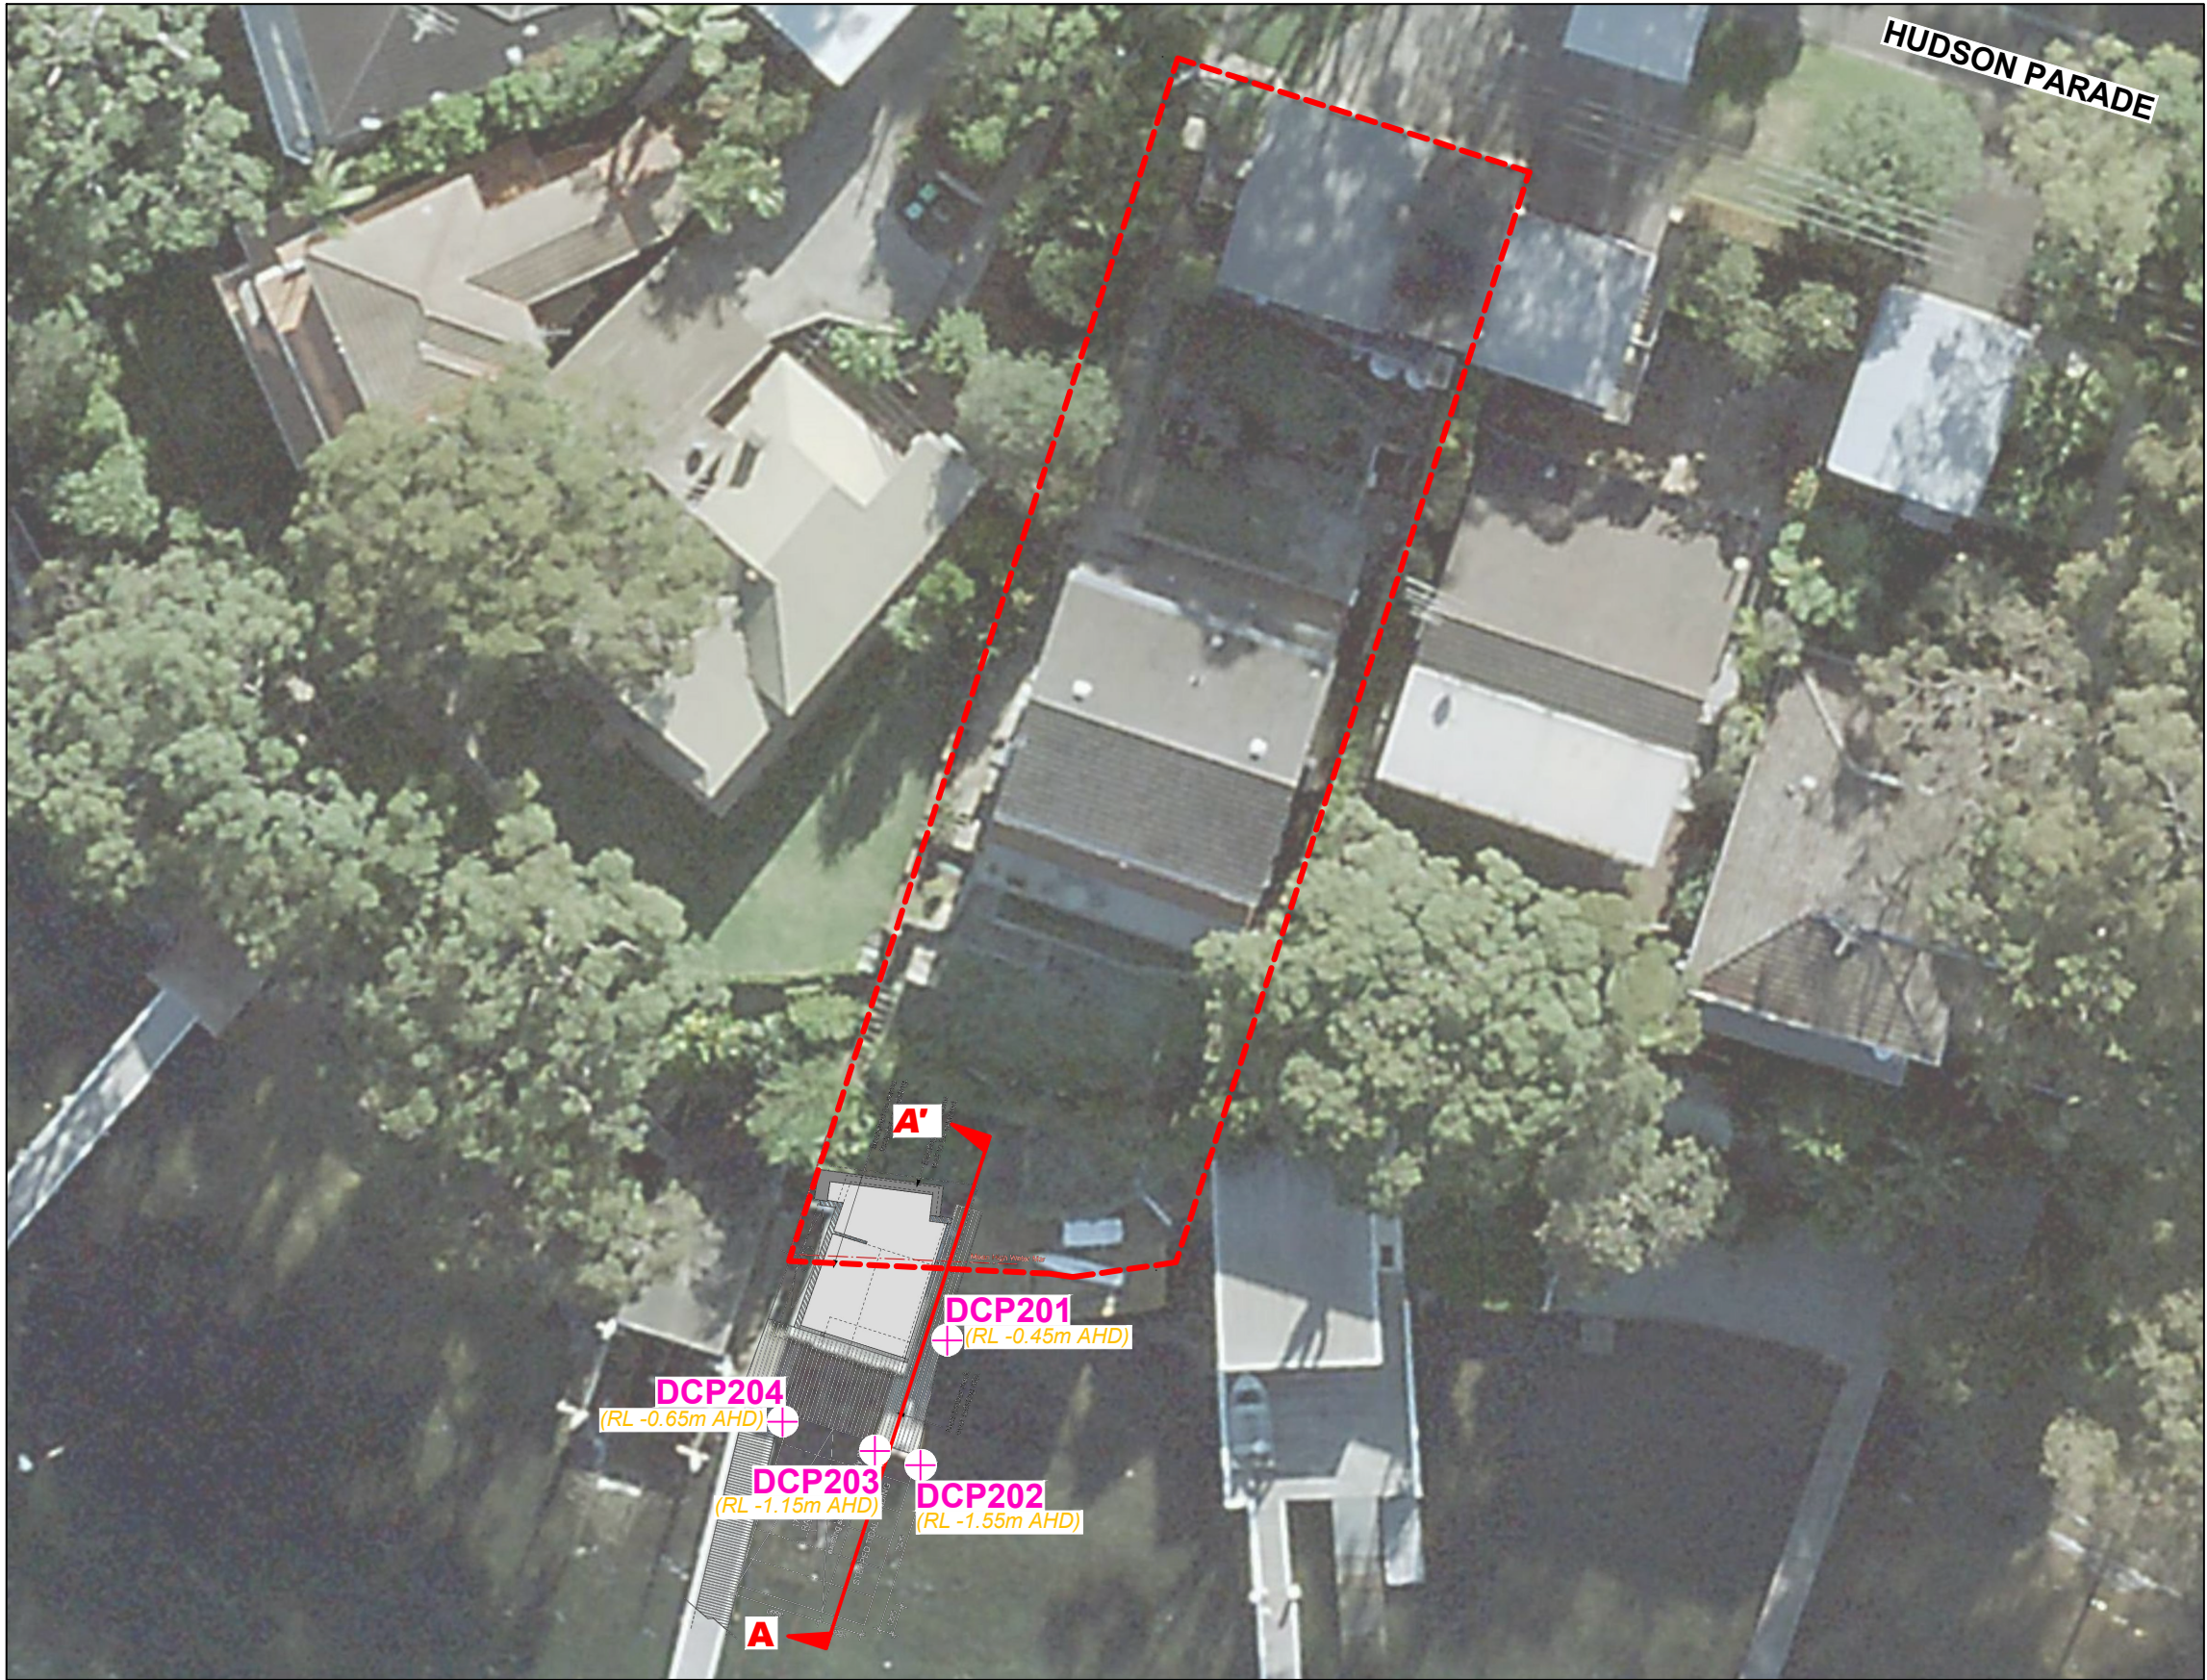
| <b>Douglas Partners</b><br><i>Geotechnics Environment Groundwater</i> | CLIENT: UTZ Sanby Architects | | TITLE: <b>Test Location Plan</b><br><b>Alterations and Additions to Boatshed</b><br><b>214 Hudson Parade , Clareville</b> | | PROJECT No: 205400.01 |

The boatshed was inspected by an engineering geologist on 15 August 2022 and the field assessment comprised detailed geological inspection of the boatshed and areas below the high tide mark as well as four DCP tests. The locations of the DCP tests, are shown on Drawing 1.

DCPs were carried out at four locations. Refusal depth is inferred to represent the top of bedrock at depths between RL-0.45 to -1.55 m.
