Re: Preliminary assessment of site conditions

Advice Reference: WittC-MGC-BDA-2-R-1.0

Witt Consulting has prepared this preliminary geotechnical assessment for the property at 6 Joalah Rd, Duffys Forest, NSW, at the request of Siobhan Berkery, acting on behalf of Mr Gary Crannage. The assessment aims to evaluate the site's preliminary geotechnical conditions in relation to the proposed addition and whether a detailed geotechnical report is required.

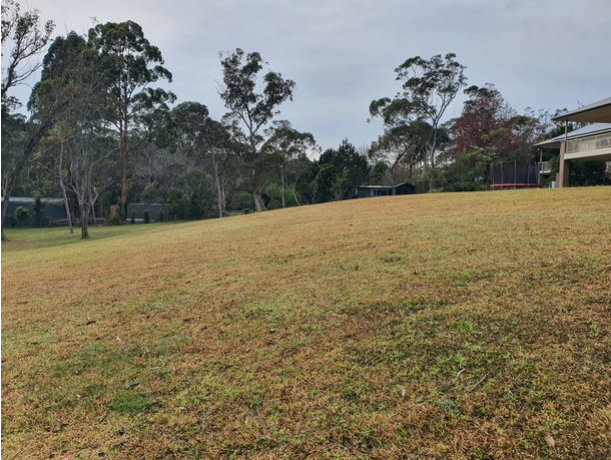
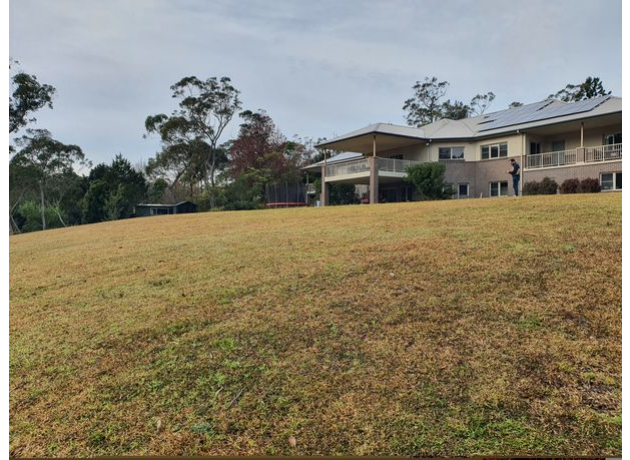
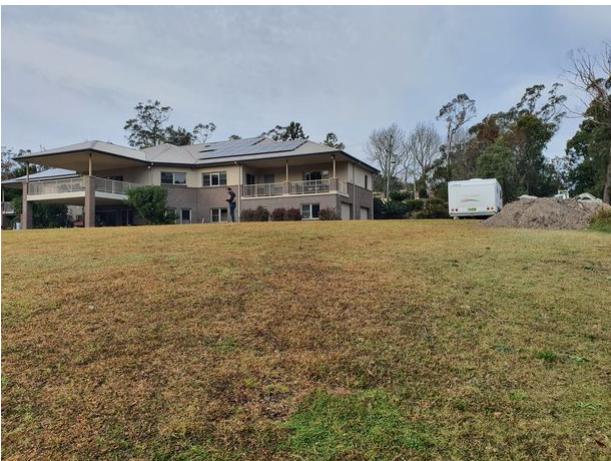
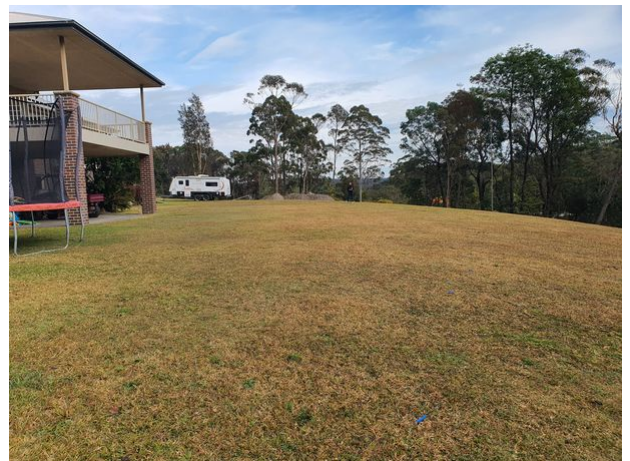
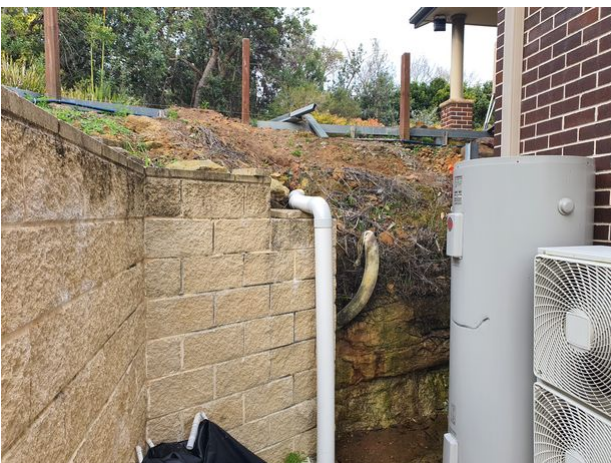
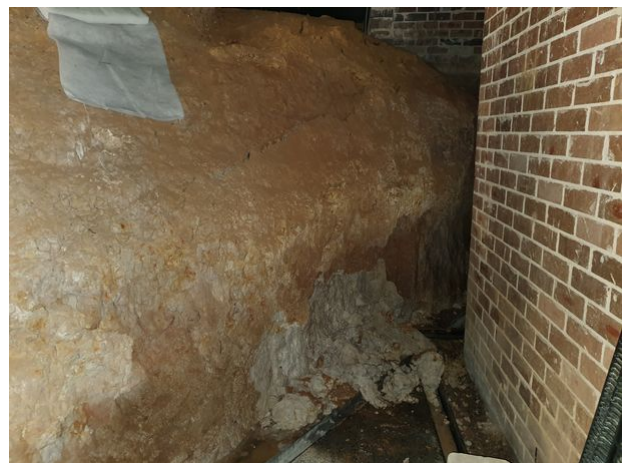
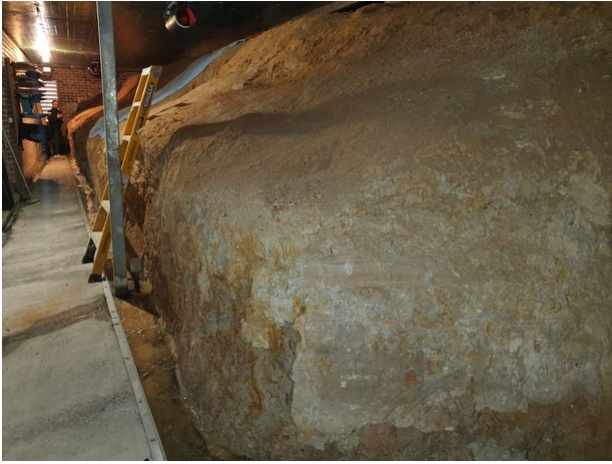
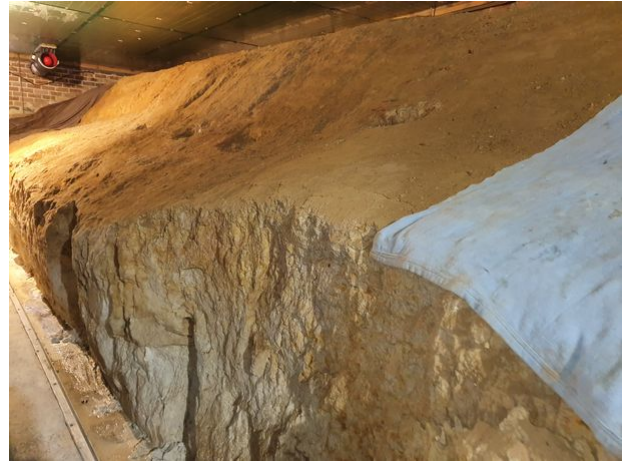
Appendix B. Site Inspection Photos

A site inspection conducted on 09 Aug 2024 revealed Hawkesbury Sandstone as the underlying geology. The overlying soil within the site was observed to be a yellow/light-brown sandy clay. The ground surface gently slopes from the northern facade of the existing development downwards along the new proposed addition area.

As per Mr Gary Crannage's description, the land had been cut for the building construction and filled in the backyard during the construction phase of the existing residential development. Outcrops of Hawkesbury Sandstone were found across the site during the existing development construction works. This information was confirmed during the site inspection, and documented in **Appendix B**.

In summary, the current ground geological profile comprises three distinct layers: a surface fill cover, underlain by a relatively shallow stratum of sandy clay soil, supported by Hawkesbury sandstone bedrock.

No evidence of past landslides or ongoing slope instability was observed during our site inspection indicating that the existing development is geotechnically stable.

Based on our assessment of the site conditions and the expected load magnitudes associated with the proposed works, we recommend that new structures are founded on residual soil (minimum Hard Clay), or Low strength Rock.

If these materials are not encountered at the proposed foundation depth, we suggest that the designer consider the implementation of piles or mass concrete pads to support the pool and other structures. Pile foundations should be founded below the fill areas and into sandstone bedrock to mitigate the potential of differential settlement.

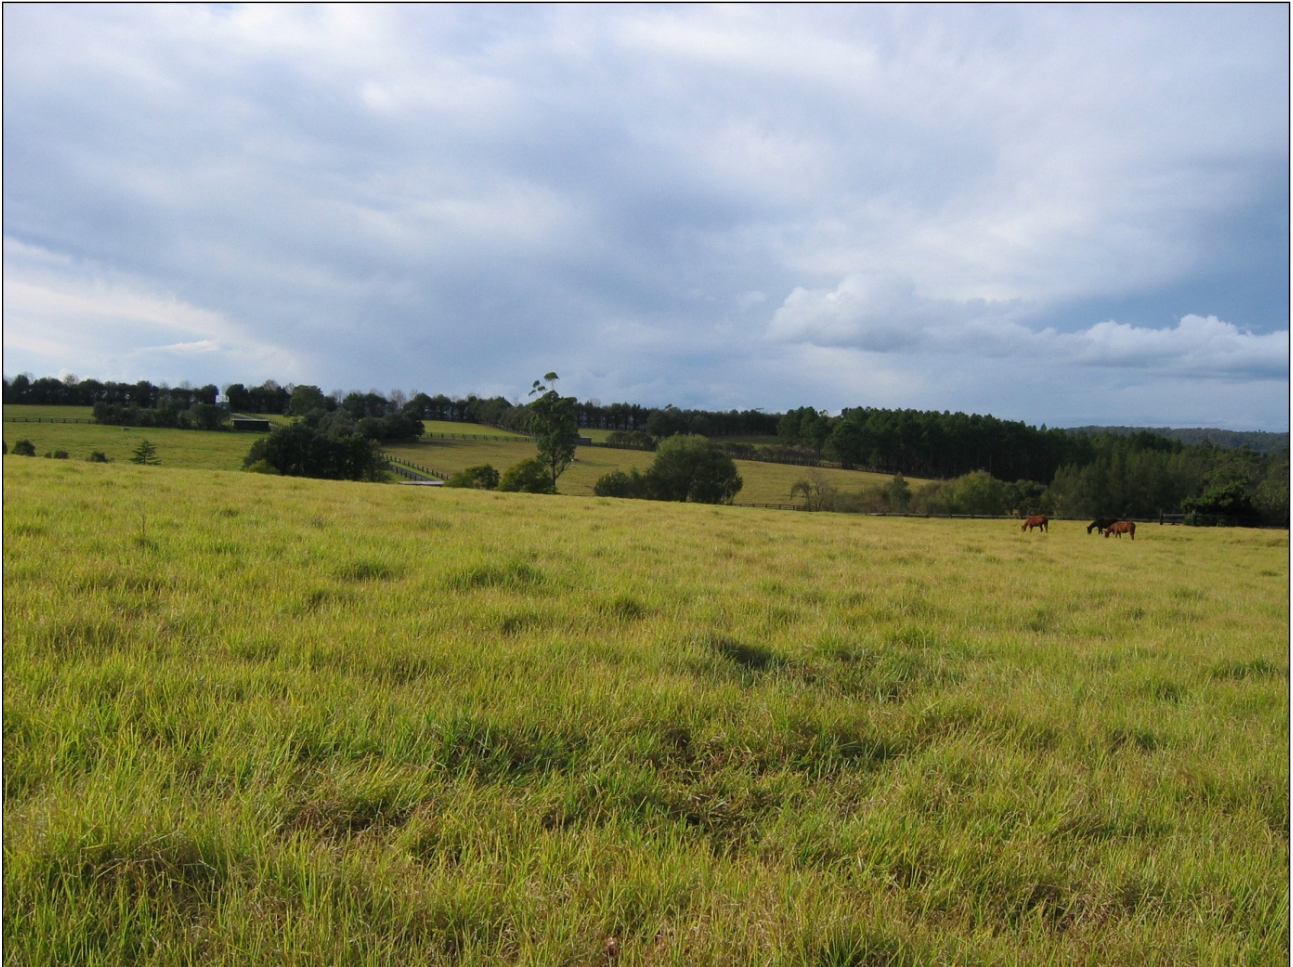
Landscape—gently undulating to rolling rises in deeply weathered Hawkesbury Sandstone plateau. Local relief to 40 m, slopes <15%. Rock outcrop is absent. Crests are broad and convex, valleys are narrow and concave. Extensively cleared, low eucalypt open-woodland and scrubland.

Soils—moderately deep to deep (100–300cm) Red Earths (Gn2.14) and Yellow Earths (Gn2.24, Gn2.21) overlying laterite gravels and clays on crests and upper slopes; Yellow Earths (Gn2.21, Gn2.24) and Earthy Sands (Uc5.11, Uc5.22) on mid-slopes; Grey Earths (Gn2.81), Leached Sands (Uc2.23) and Siliceous Sands (Uc1.22) on lower slopes and drainage lines; Gleyed Podzolic Soils (Dg3.82, Dg4.51) in low lying poorly drained areas.

Limitations—localised permanently high watertables, areas of laterite and stony soil, very low soil fertility, highly permeable soil.

An excerpt of the eSPADE web application showing the location of the site with the associated soil landscapes is presented in **Appendix C**.

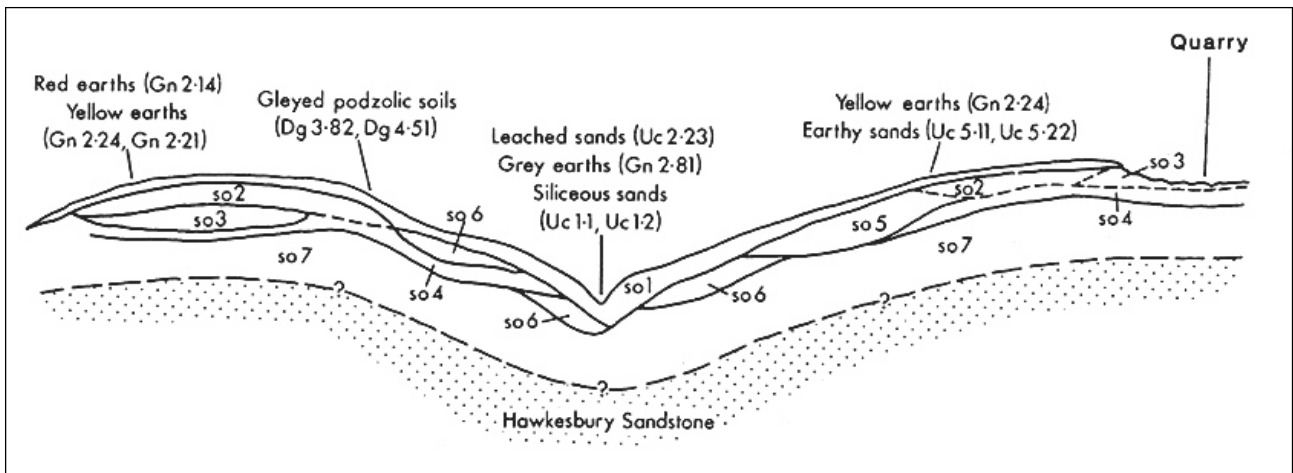
Crests and upper sideslopes. Up to 40 cm of loose, dark brown sandy loam topsoil (**so1**) overlies up to 2 m of earthy, bright brown sandy clay loam (**so2**). Usually **so1** and **so2** on crests overlie 30–150 cm of hardsetting, cemented ironstone gravels (**so3**). In many areas, the **so1** and **so2** materials have been removed to quarry the gravelly **so3** for road base. Pallid grey, sandy clay (**so4**) underlies **so3** and may be up to several metres thick. Total soil depth is >150 cm. The boundary between soil materials is usually gradational [Yellow Earths (Gn2.24, Gn2.21) and occasional Red Earths (Gn2.14)].

Schematic cross-section of Somersby soil landscape illustrating the occurrence and relationship of the dominant soil materials.

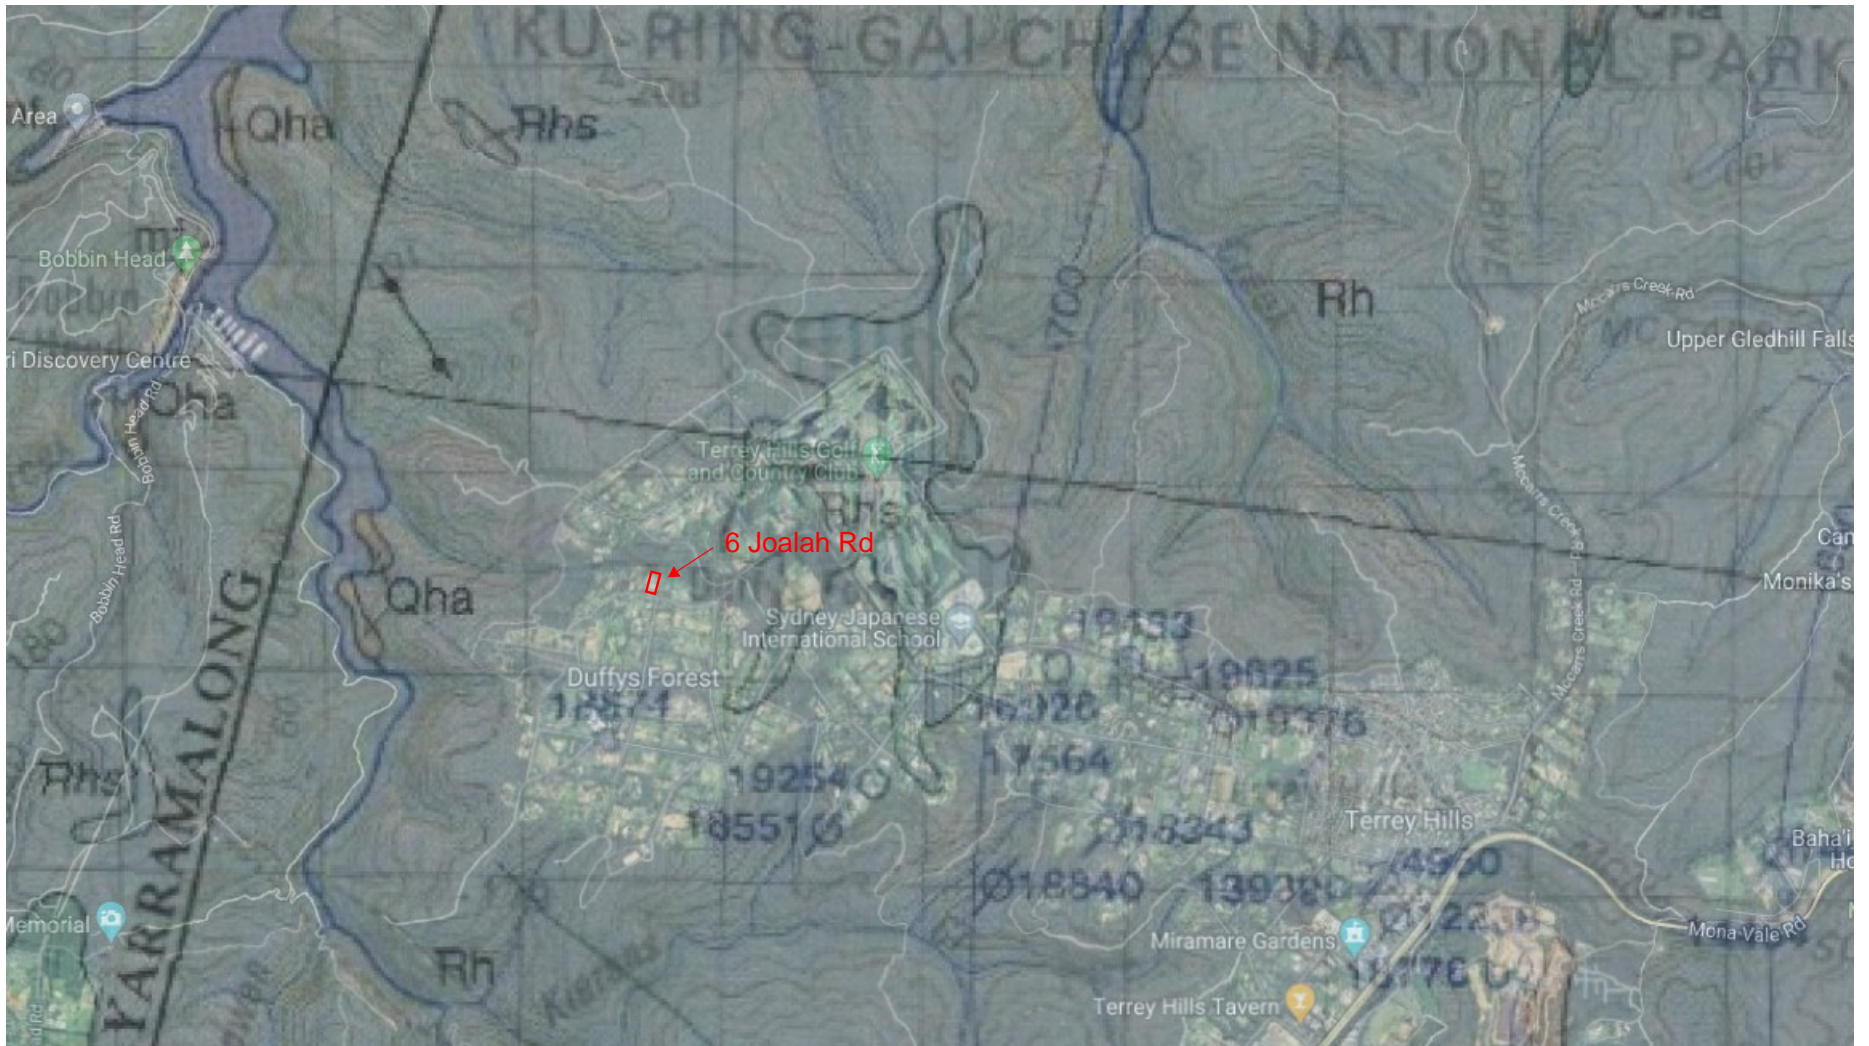
Appendix D. Geological Mapping Sheet

The Sydney 1:100,000 Geological Series Sheet 9130, indicates that the site is in an area underlain by Hawkesbury Sandstone from the Triassic period. The geological series sheet describes the lithology of Rh as *quartz sandstone with minor shale lenses*.

An excerpt of the 1:100,000 Geological Series Sheet 9130 with the location of the site is presented in **Appendix D**.
