Address of site 23 Park Avenue, Avalon Beach

Report Title: Geotechnical Report 23 Park Avenue, Avalon Beach
Report Date: 28/9/21

GEOTECHNICAL INVESTIGATION: **Alterations and Additions at 23 Park Avenue, Avalon Beach**

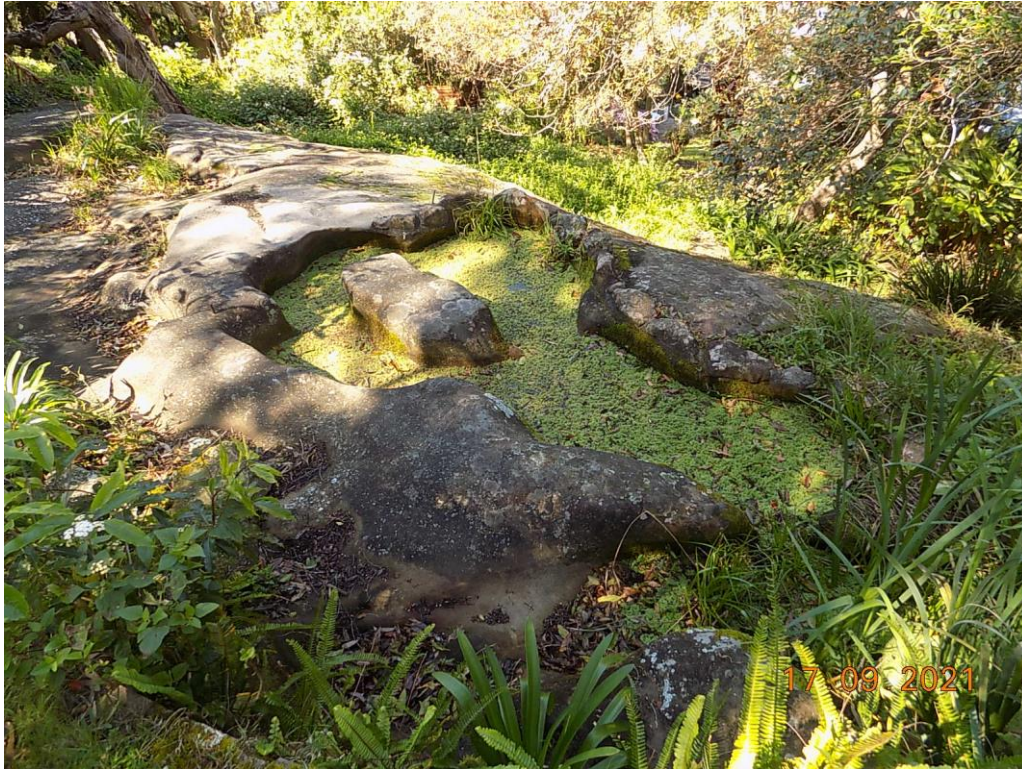
Photo 5

- 2.3** At the road frontage, a gravel driveway runs across the slope to a timber framed carport on the uphill side of the property (Photo 1). The part two-storey brick and timber clad house is supported on brick walls and brick piers. The brick walls show no significant signs of movement and the brick piers stand vertical (Photo 2). Some of the supporting piers were observed to be supported directly onto outcropping Medium Strength Sandstone (Photo 3). A gently sloping lawn extends from the downhill side of the house to the lower common boundary (Photo 4). Sandstone can be seen outcropping through the slope in several places (Photo 5).

Sandstone bedrock outcrops under the house and through the slope below the property. This is an unusually thick sandstone bed within the Narrabeen Group of rocks. The rock is overlain by silty soils and clayey sands that fill the bench-step formation. In the test locations, the depth to Medium Strength Sandstone ranged between 0.3 to 0.9m below the current surface, being deeper due to the stepped nature of the underlying bedrock. The sandstone underlying the area of the proposed development is estimated to be medium strength. See Type Section attached for a diagrammatical representation of the expected ground materials.

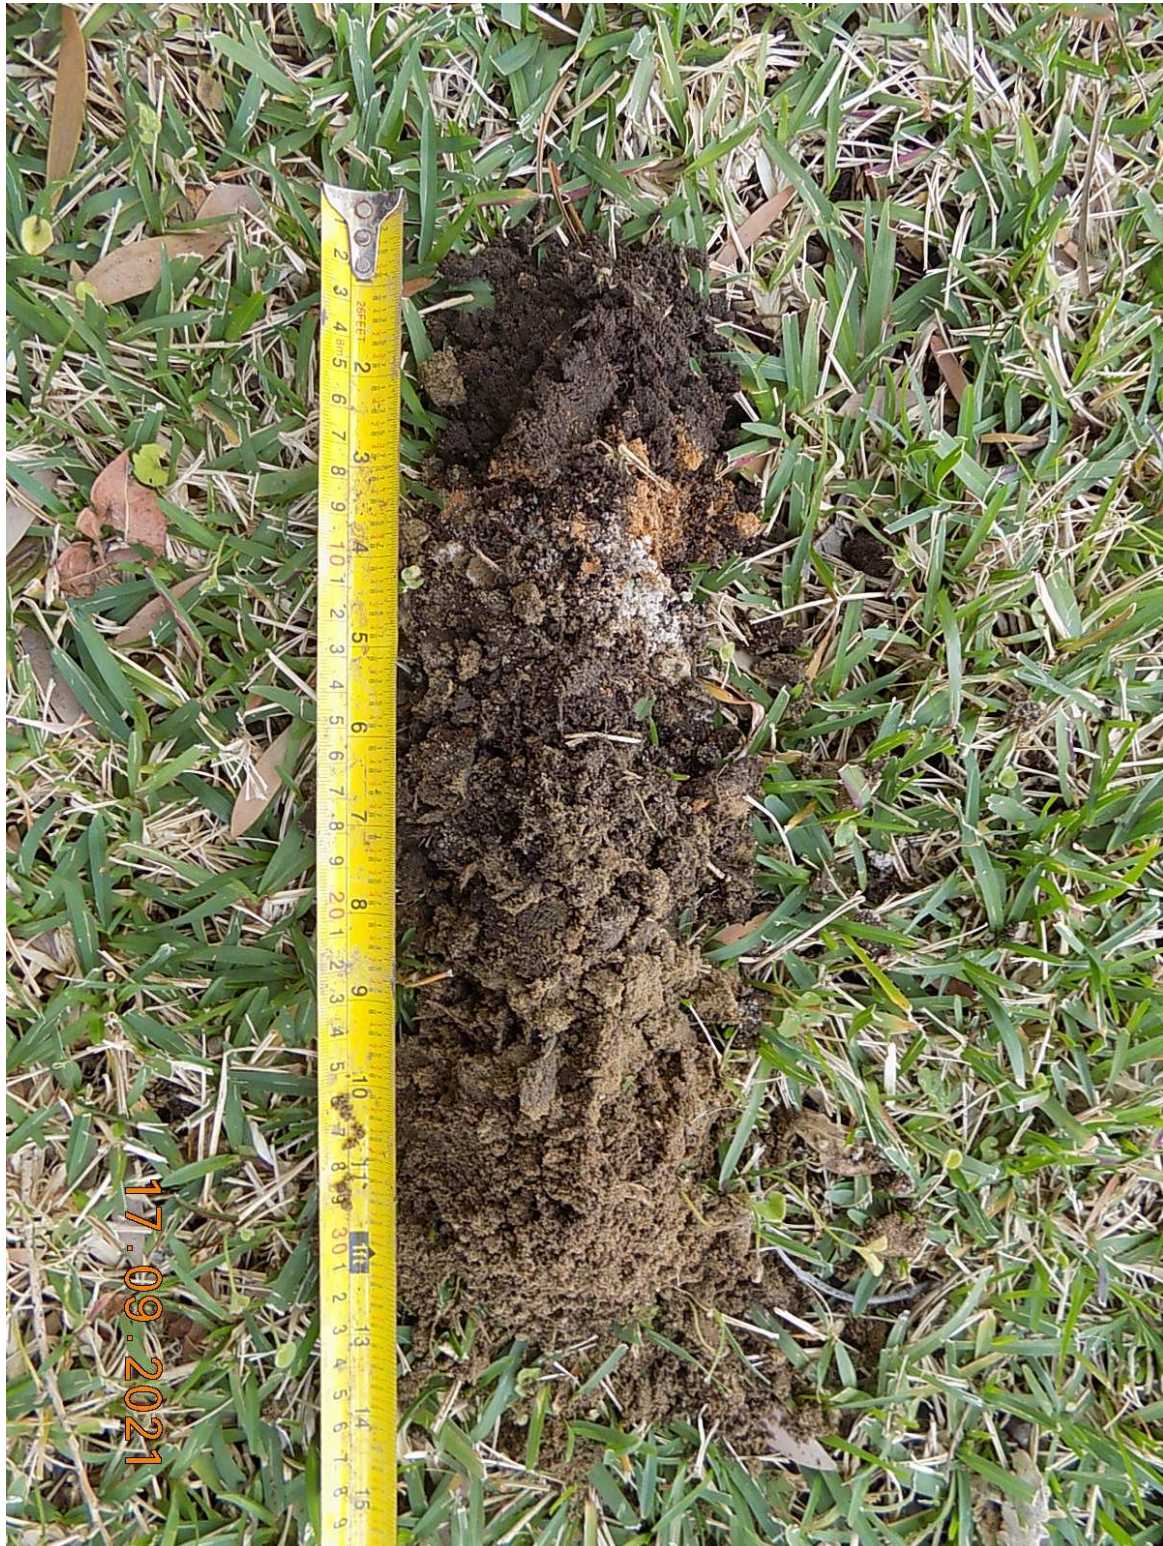
Photo 6 (Top is top of hole)

AUGER HOLE 1 (~RL37.8) – AH1 (Photo 6)

Depth (m)	Material Encountered
0.0 to 0.15	SILTY SOIL , dark brown, orange, grey, fine to coarse grained, loose to medium dense, dry.
0.15 to 0.3	CLAYEY SAND , brown, rock fragments, fine to medium grained, medium dense, dry.

Refusal on rock @ 0.3m. No water table encountered.
