Report Title: Geotechnical Report 16A Ruskin Rowe, Avalon Beach  
Report Date: 13/12/21

## **GEOTECHNICAL INVESTIGATION:**

### **Alterations and Additions and New Pool at 16A Ruskin Rowe, Avalon Beach**

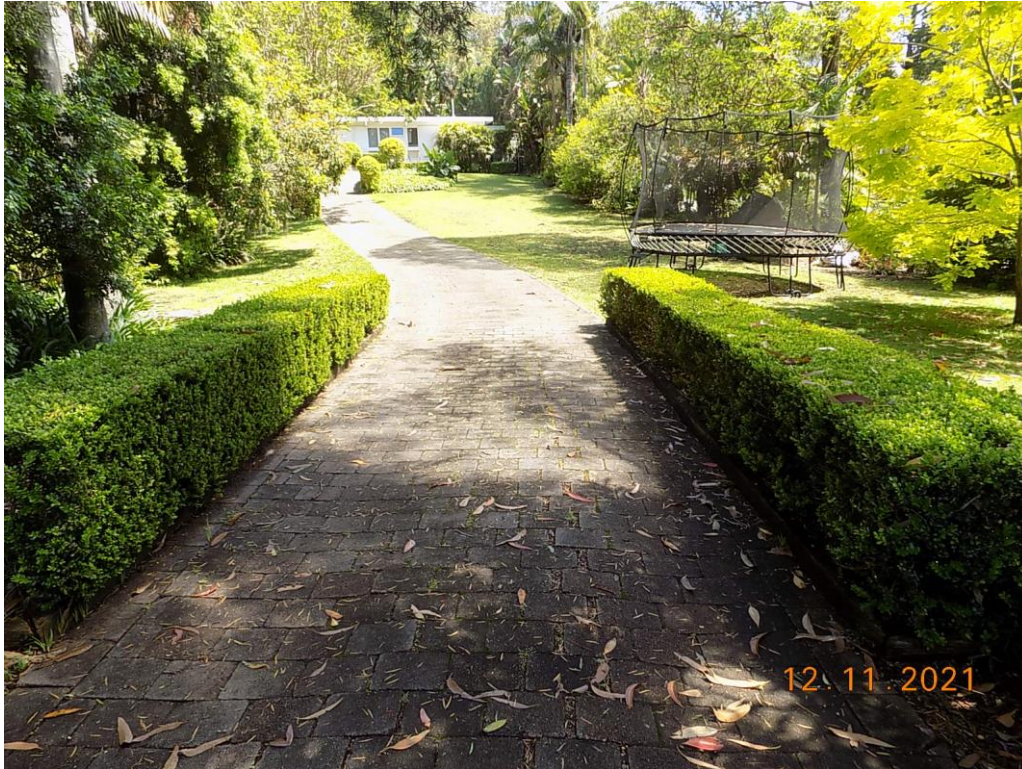
Photo 1

- 2.3** At the road frontage, a gravel and brick-paved driveway runs up the slope to a garage attached to the downhill side of the house (Photos 1 & 2). The garage will be demolished as part of the proposed works. Between the road frontage and the house is a gently sloping lawn (Photo 3). A gently-sloping stone-paved fill extends off the S corner of the house. The fill is supported by a stable stack rock retaining wall that will also be demolished as part of the proposed works (Photo 4). The single-storey brick

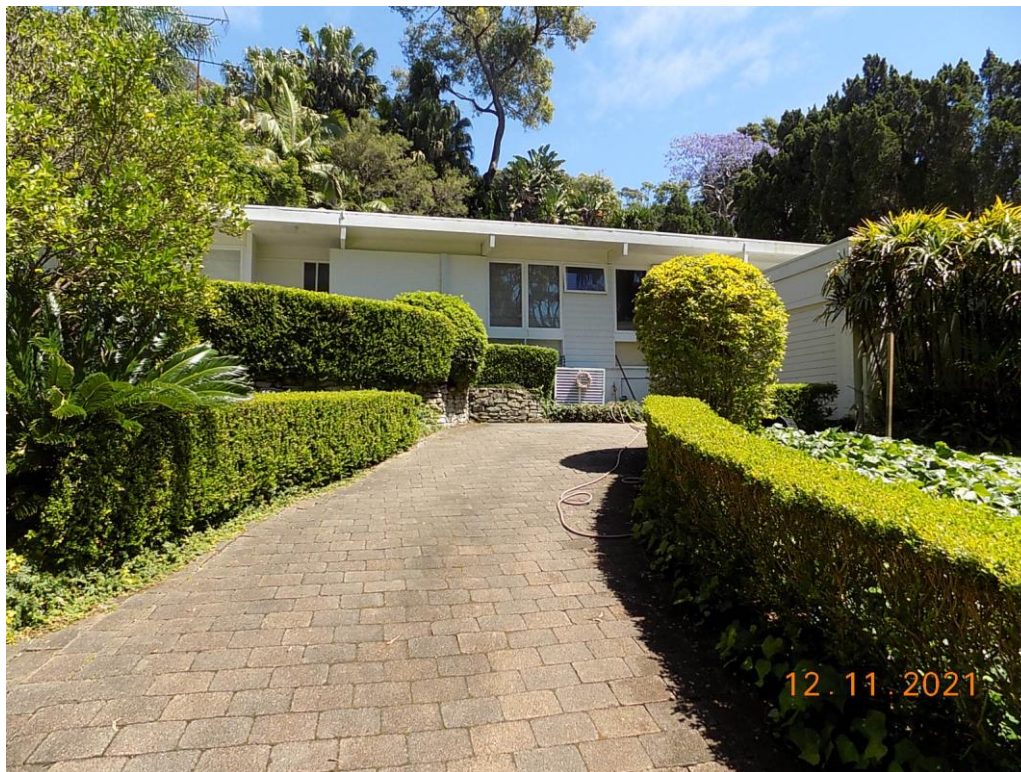
Photo 5

house is supported on brick walls (Photo 5). No significant signs of movement were observed in its supporting brick walls. An excavation has been made in the slope to create a level platform for the house. The cut is supported by a stable stack rock retaining wall ~1.2m high (Photo 6). Competent Medium Strength Sandstone outcrops through the SW end of this wall (Photo 7). We think it is likely this is a floater that has rolled down from the slope above although it could be an exposed band of sandstone through the shale-dominated profile. Another gently sloping lawn extends off the uphill side of the wall to the upper common boundary (Photo 8).

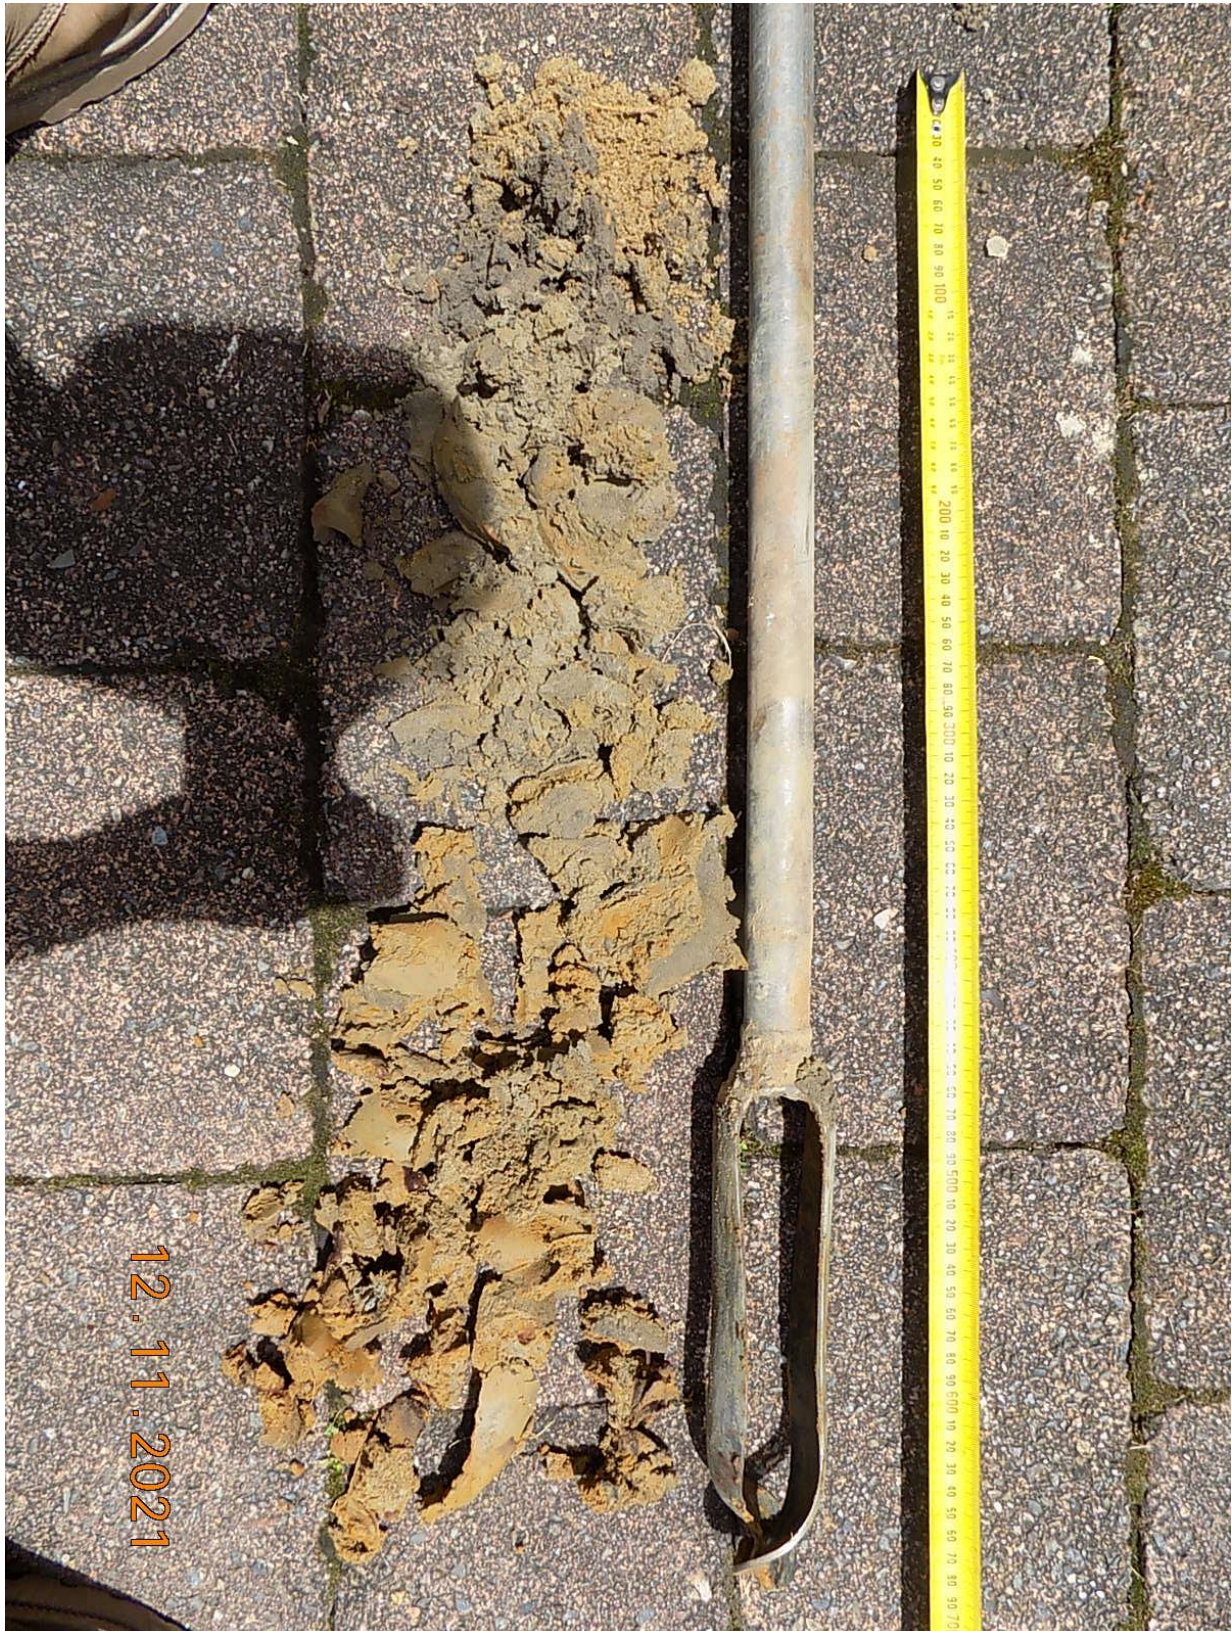
## AUGER HOLE 1 (~RL22.1) – AH1 (Photo 9)

Depth (m)	Material Encountered
0.0 to 0.1	<b>FILL</b> , gravelly sand, brown, medium dense, dry, medium to coarse grained.
0.1 to 0.2	<b>SAND</b> , grey, medium dense, dry, coarse grained.
0.2 to 0.3	<b>SANDY CLAY</b> , brown, firm, dry, fine to coarse grained.
0.3 to 0.7	<b>CLAY</b> , derived from weathered shale, brown and mottled orange, very stiff, dry, fine grained.

End of test @ 0.7m in clay derived from weathered shale. No water table encountered.

Photo 9: AH1 – Downhole is from top to bottom
