Geotechnical Assessment:
Lot 1 DP 408800,
62 Hillside Road, Newport, NSW

P1203617JR04V01
June 2016

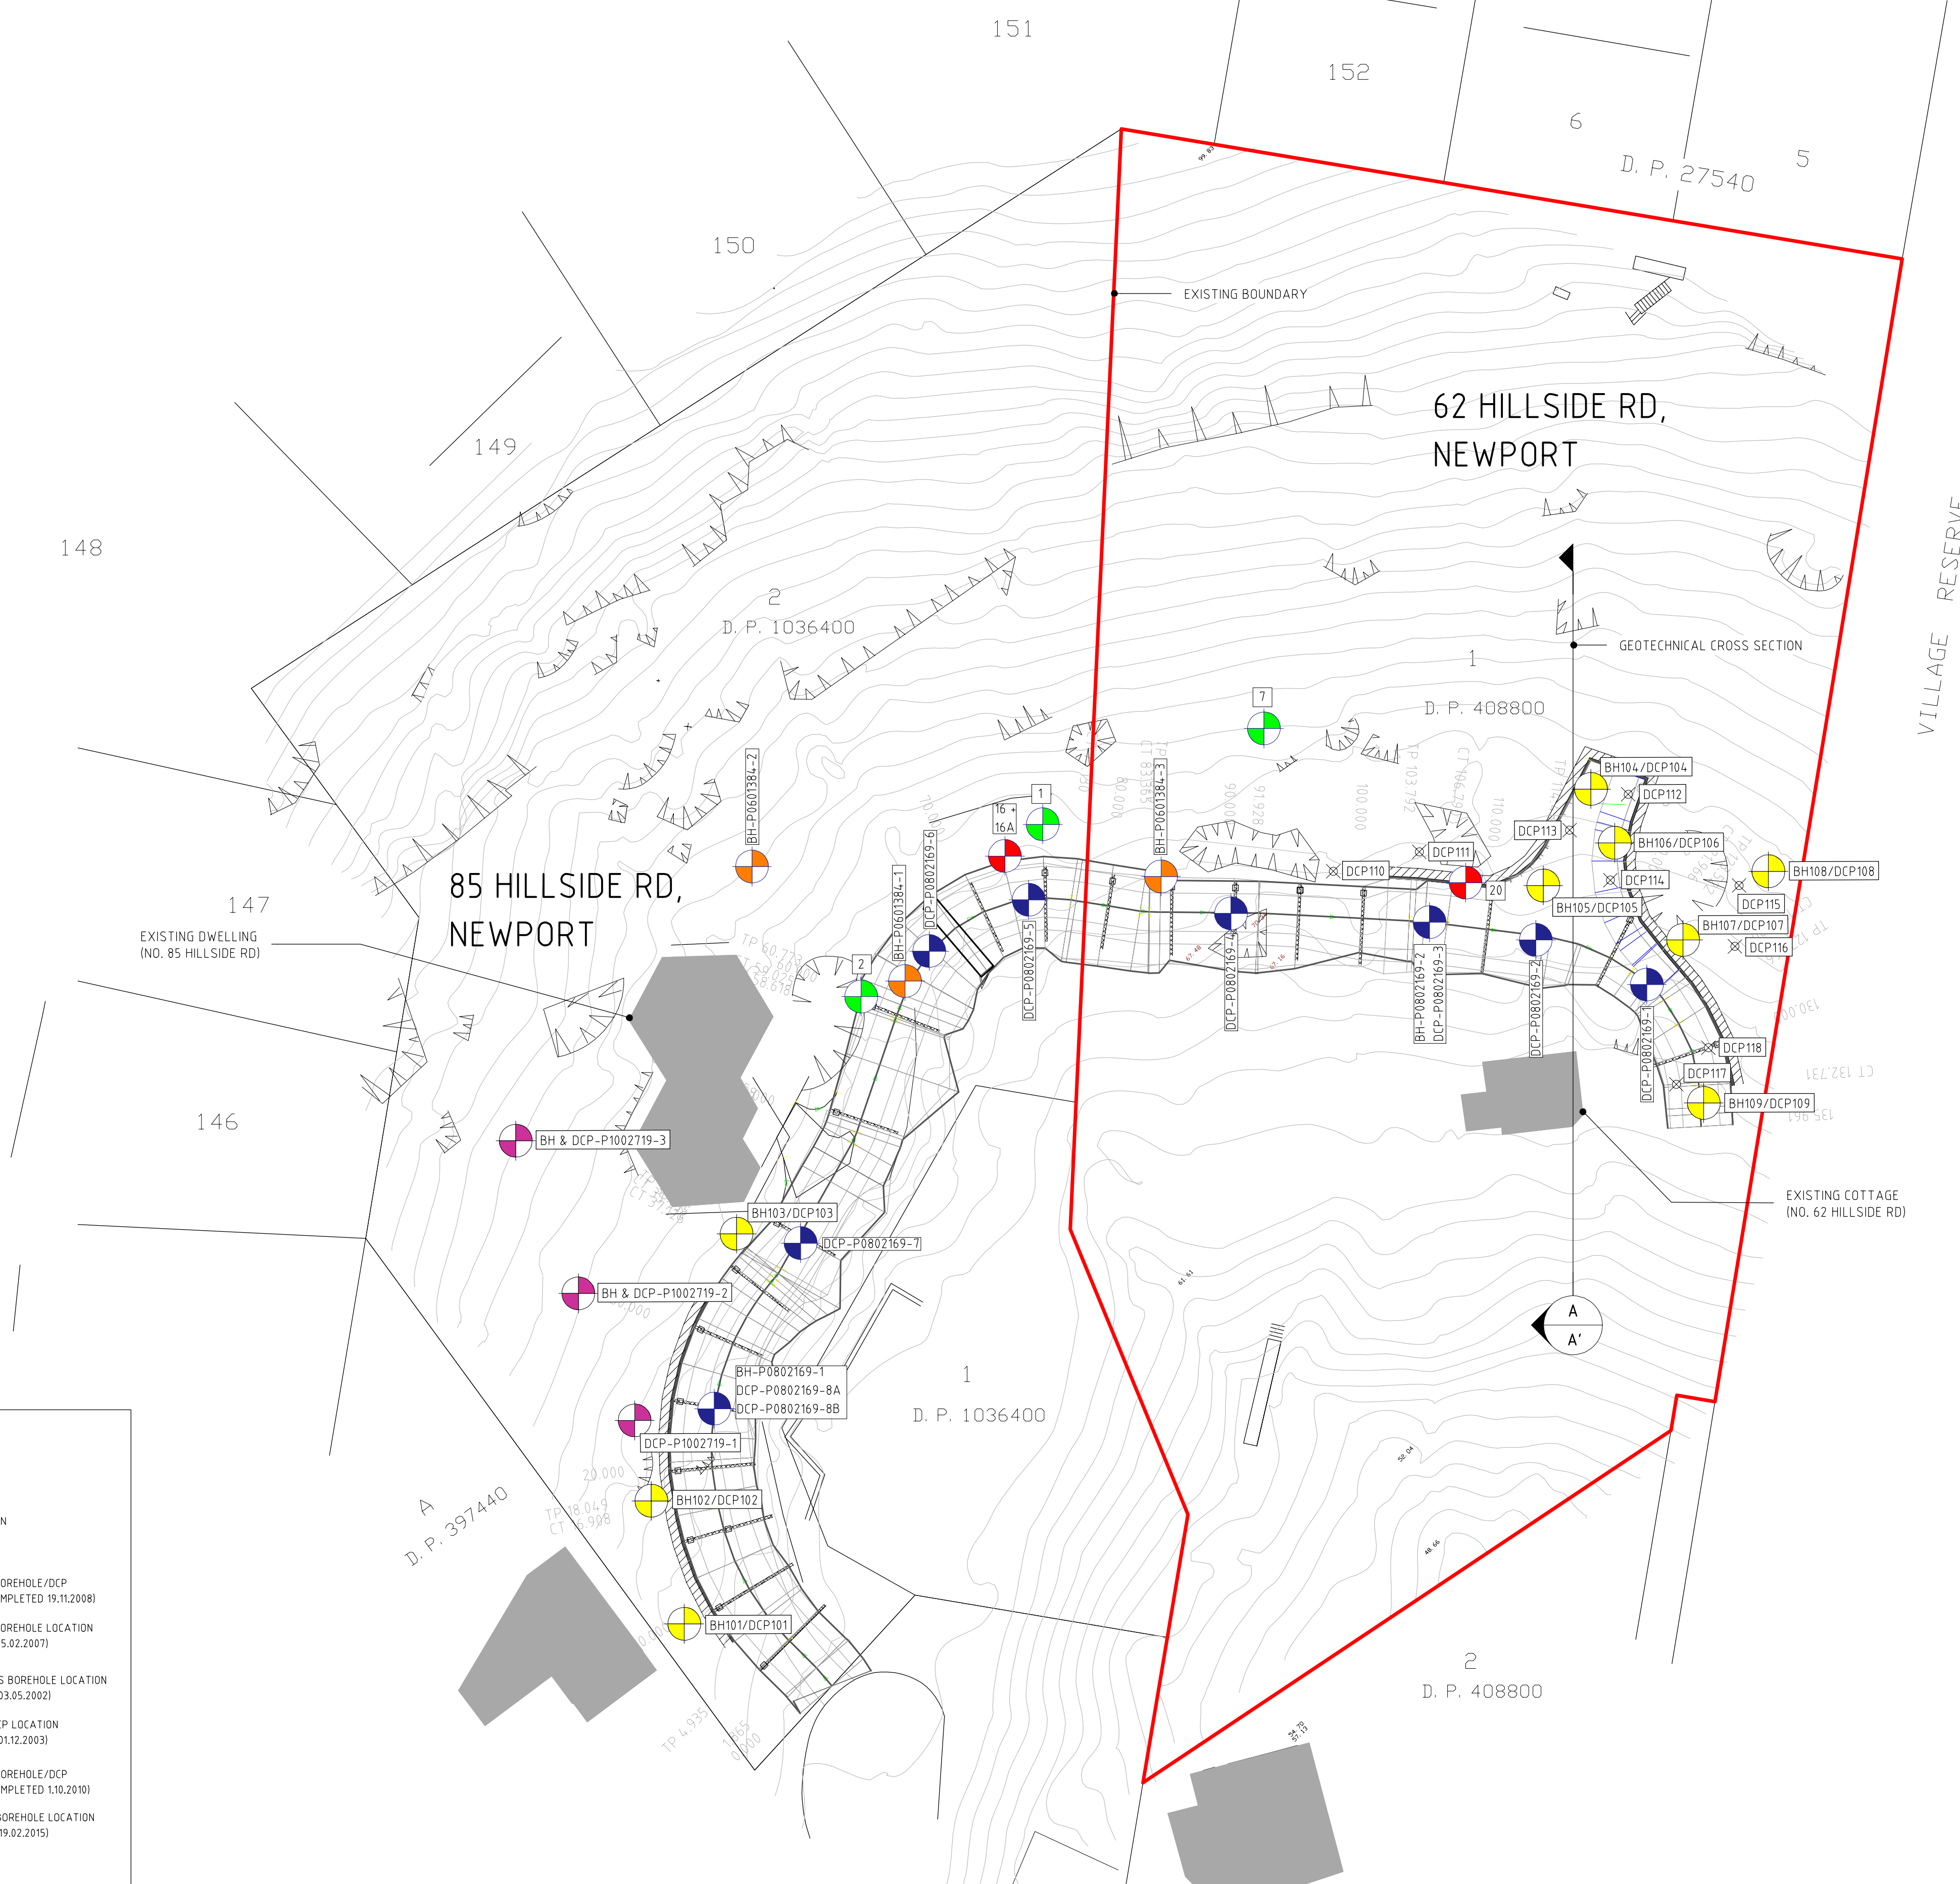
7 Attachment A – Site Plan

GEOTECHNICAL CROSS SECTION
