J2513. 10<sup>th</sup> December, 2019 Page 1.

# **INFILTRATION TESTING:**

# For Proposed Infiltration Trench at 17 Carew Street, Dee Why

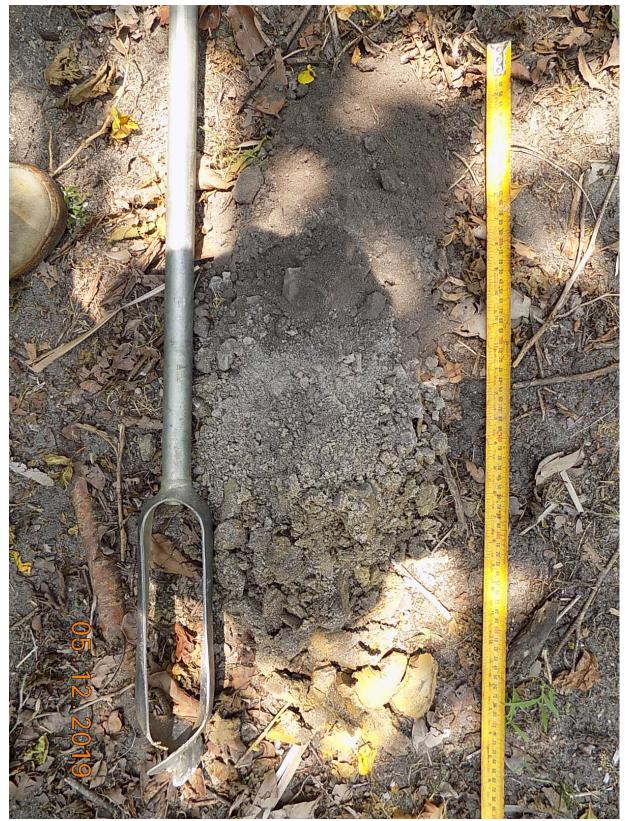
Photo 1: STANDPIPE1 – Downhole is from top to bottom.

# AUGER HOLE 1 – STANDPIPE 1 (~RL54.2) – (Photo 1)

Depth (m)	Material Encountered
0.0 to 0.3	<b>TOPSOIL</b> , sandy soil, dark brown, loose, dry, fine to medium grained with fine trace organic matter.
0.3 to 0.5	SAND, brown, medium dense, coarse grained.
0.5 to 0.7	<b>CLAY</b> , orange and mottled grey, soft to very stiff, dry, fine grained.

End of Test @ 0.7m in very stiff clay. No watertable encountered.
