Geotechnical Investigation Report

Project
**Proposed Land Rezoning
15-17 Mona Street, Mona Vale NSW**

Date
06 April 2022

Report No
14803-GR-1-1

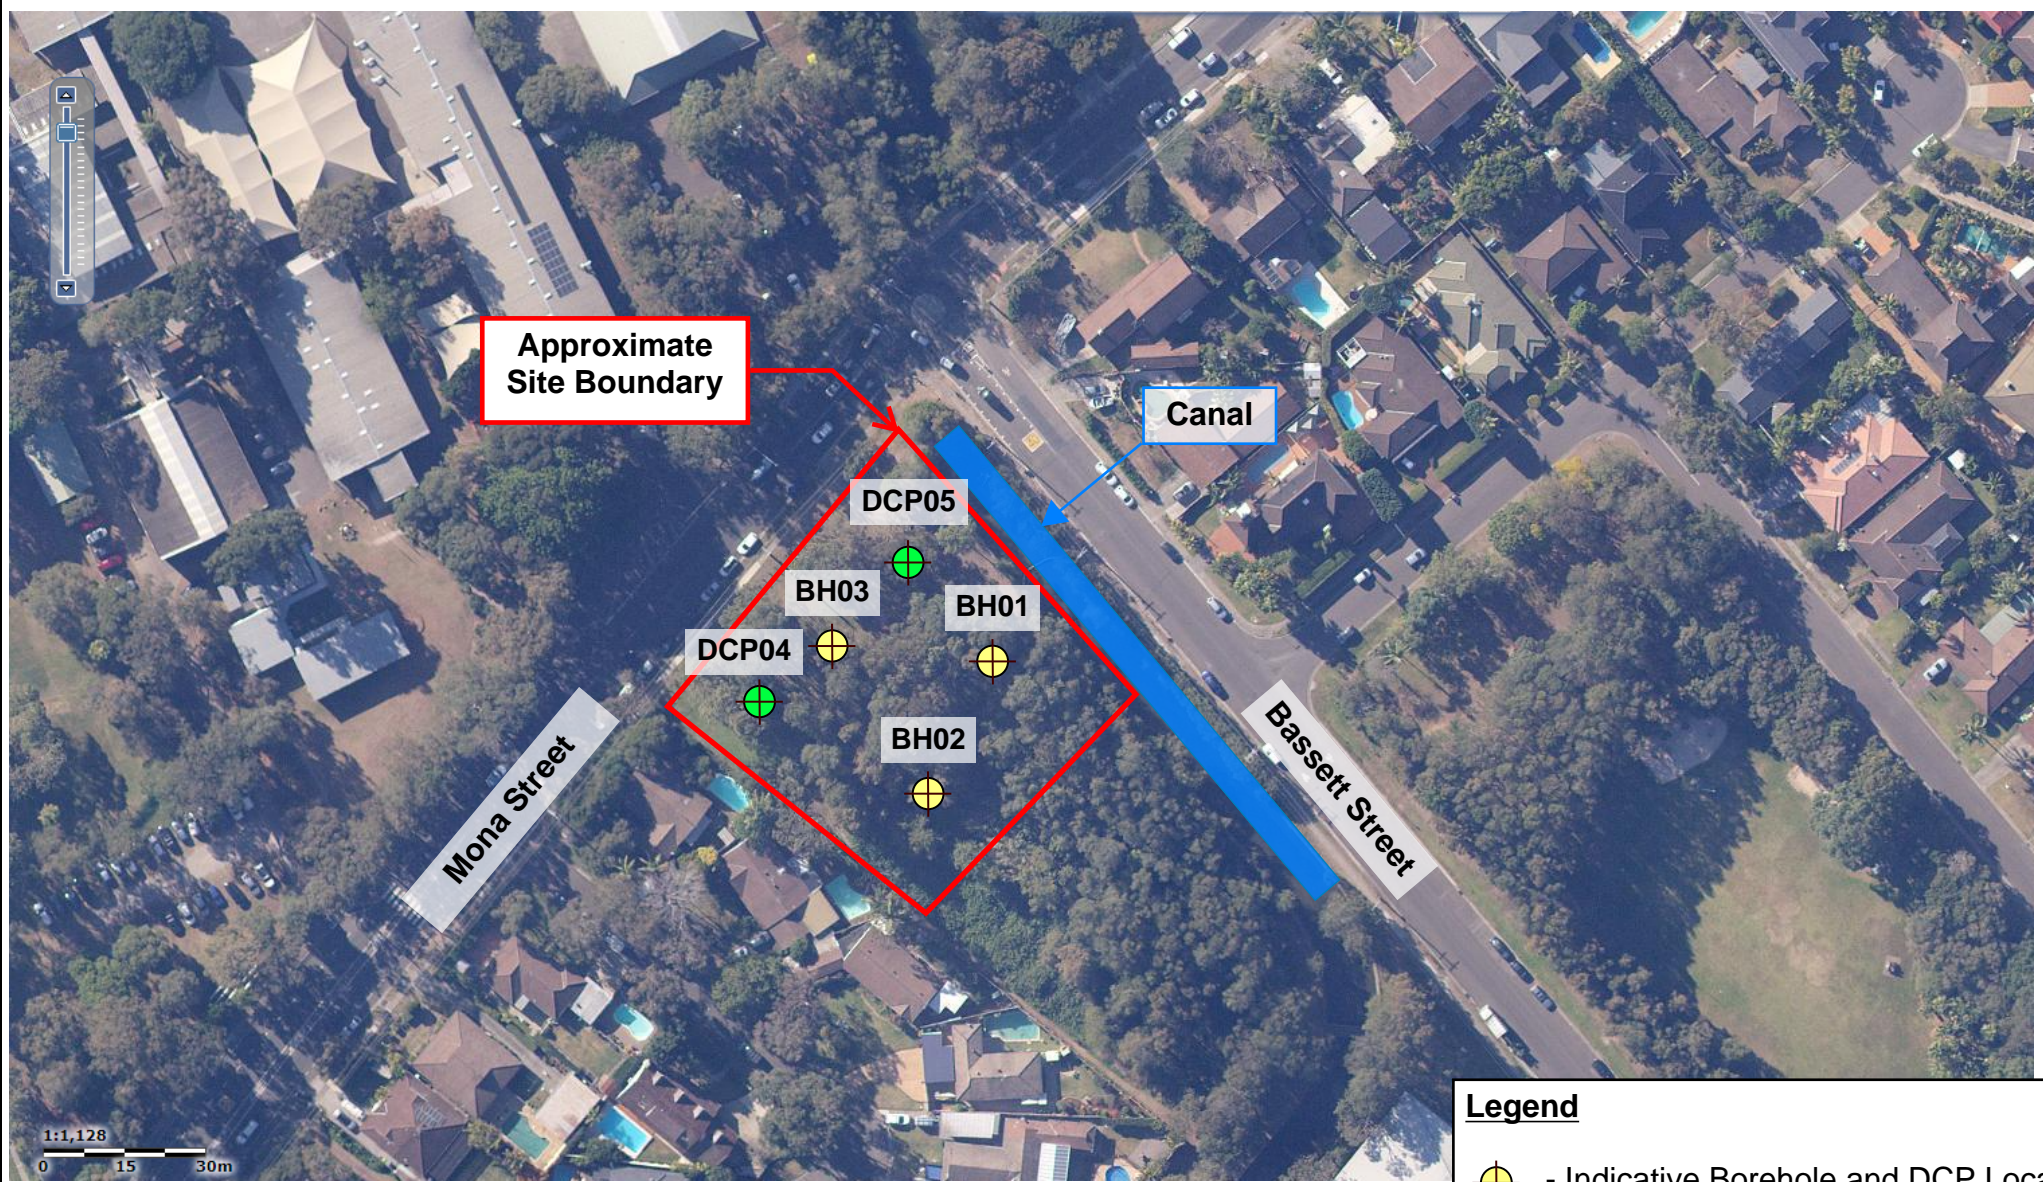
Client Name:	Sydney Water Corporation	Figure / Drawing Number:	14803-GR-1-A

- Indicative Borehole and DCP Location
-

- Indicative DCP Location

Geotechnical Investigation Plan

Details of the subsurface conditions encountered in the boreholes are given in the borehole logs in Appendix C and are summarised below. BH01 and BH03 were drilled to a depth of 6.0m while BH02 was drilled to a target depth of 5.0m using a ute-mounted drilling rig with a 100mm auger attachment. The borehole locations are shown on Drawing 14803-GR-1-A in Appendix B.
