Report Title: Geotechnical Report 45 Hillcrest Avenue, Mona Vale
Report Date: 16/12/24

GEOTECHNICAL INVESTIGATION:

Balcony Extension at **45 Hillcrest Avenue, Mona Vale**

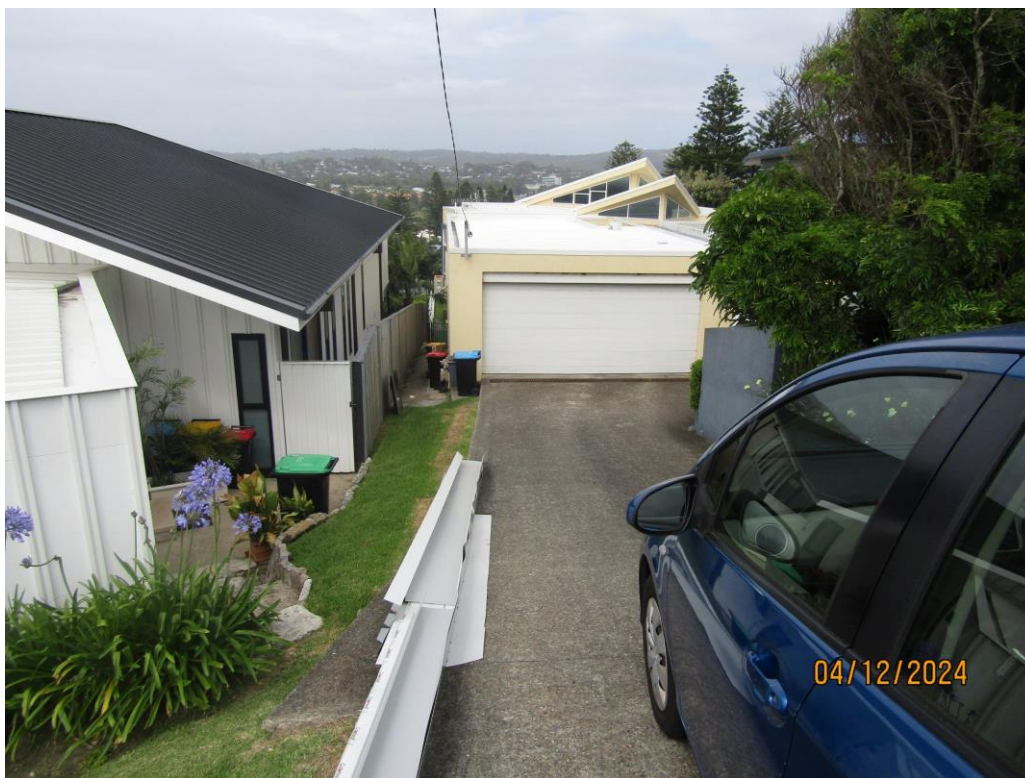
Photo 1

- 2.3** At the road frontage, a concrete driveway runs down the slope to a garage attached to the house (Photo 1). Between the road frontage and the house is a garden area. The fill for the garden area is supported by a stable low rendered masonry retaining wall. The part two storey house is supported on masonry walls (Photos 2 & 3). The external supporting walls show no significant signs of movement. A cut provides a level platform for the N side of the house. The cut is lined by low sandstone flagging retaining wall or is supported by a stable sandstone block retaining wall up to ~1.6m high (Photo 4). A pool that shows no significant signs of movement is located downslope of the house (Photo 5). Stable rendered masonry and keystone retaining walls up to ~3.6m high support fills for lawn and paved areas across the

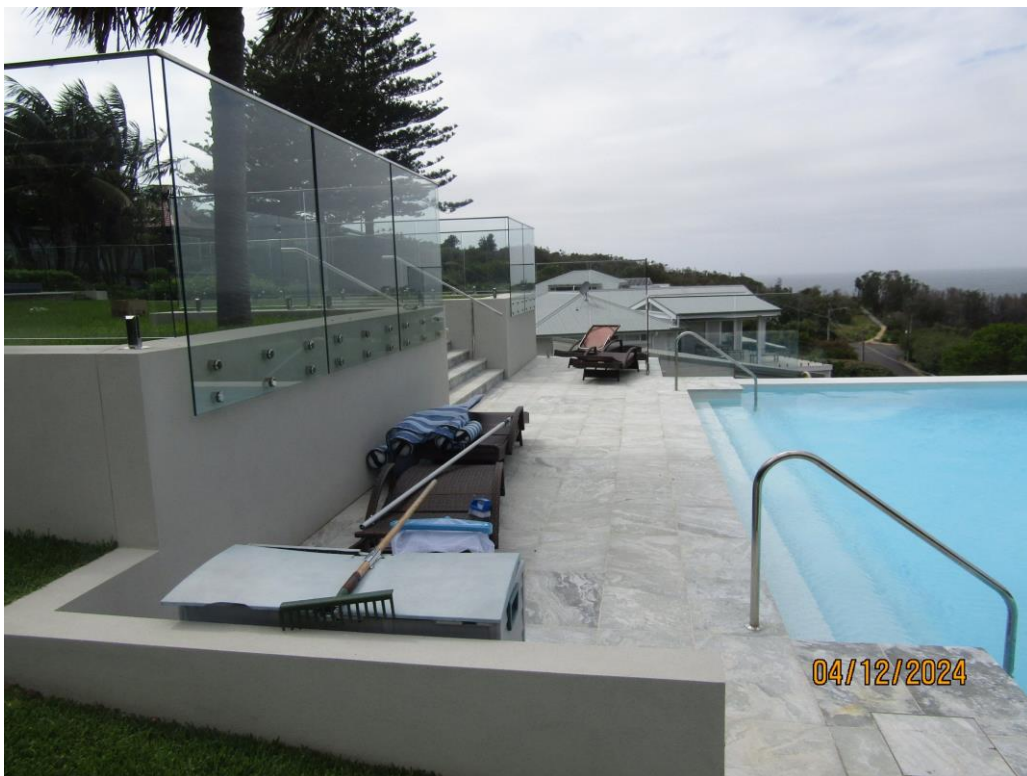
Photo 6

downhill side of the property (Photos 6 to 8). No signs of slope instability were observed on the property. The adjoining neighbouring properties were observed to be in good order as seen from the street and subject property.
