**GEOTECHNICAL RISK MANAGEMENT POLICY FOR PITTWATER  
FORM NO. 1 – To be submitted with Development Application**

Address of site 14 PRINCE ALFRED PARADE, NEWPORT

Report Title: RISK ANALYSIS & MANAGEMENT FOR PROPOSED ALTERATIONS AND ADDITIONS AT 14 PRINCE ALFRED PARADE, NEWPORT – PX 00040D

**RISK ANALYSIS & MANAGEMENT REPORT  
FOR  
PROPOSED ALTERATIONS AND ADDITIONS  
AT  
14 PRINCE ALFRED PARADE, NEWPORT**

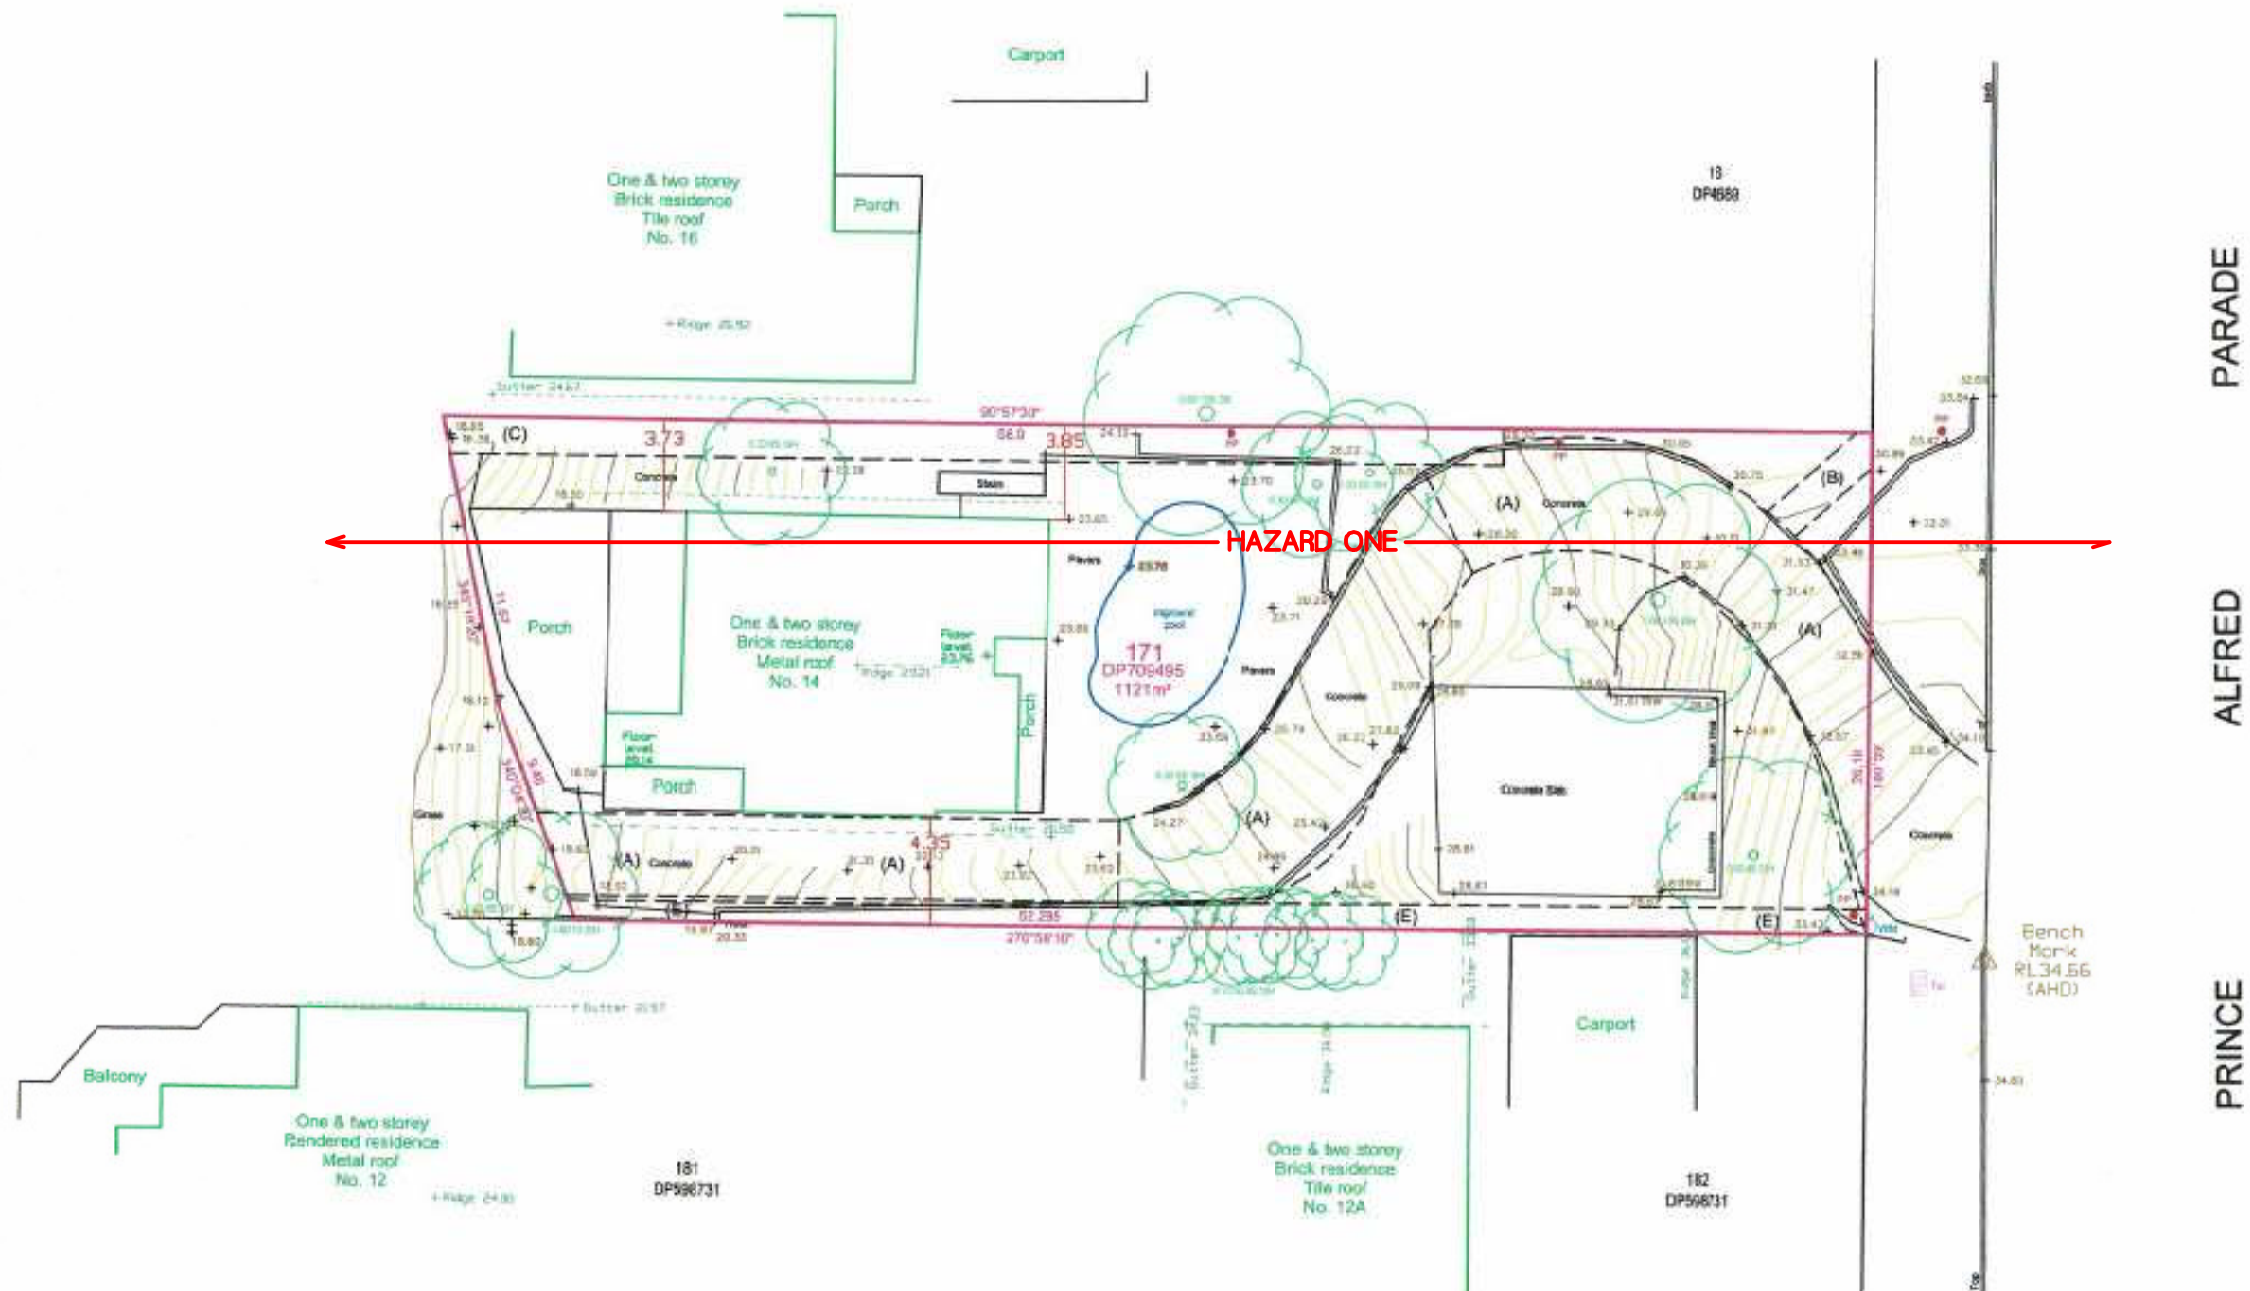
TYPE SECTION

NOTE  
INTERPRETED SUB SURFACE SECTION ONLY.  
ACTUAL GROUND CONDITIONS MAY VARY.

Fill	Narrabeen Group Rocks
Sandy Topsoil	Hawkesbury Sandstone
Sandy Loam

**4.2** The slope materials are colluvial at the surface and residual at depth. They consist of sandy loam topsoil over sandy clays and clays with rock fragments and some floaters throughout the profile. The sandy clays and clays merge into the weathered zone of the under lying rocks at depths expected to be in the range 0.9 to 2.5 metres.

**10.2.2** The foundations for the proposed alterations and additions will require excavation for the piered footings. These piered footings will encounter fill and soil material and clays overlying the weathered rock of the Narrabeen Group to approximate depths of 1.0 to 2.0 metres or deeper where filling has been carried out. The piered footings are to be socketed into a minimum of 0.3 metres into weathered rock.
