Manly Hospital
150 Darley Road, Manly
Stage 1: Heritage Assessment
Report

April 2018

prepared by Paul Davies Pty Ltd
for NSW Health Infrastructure

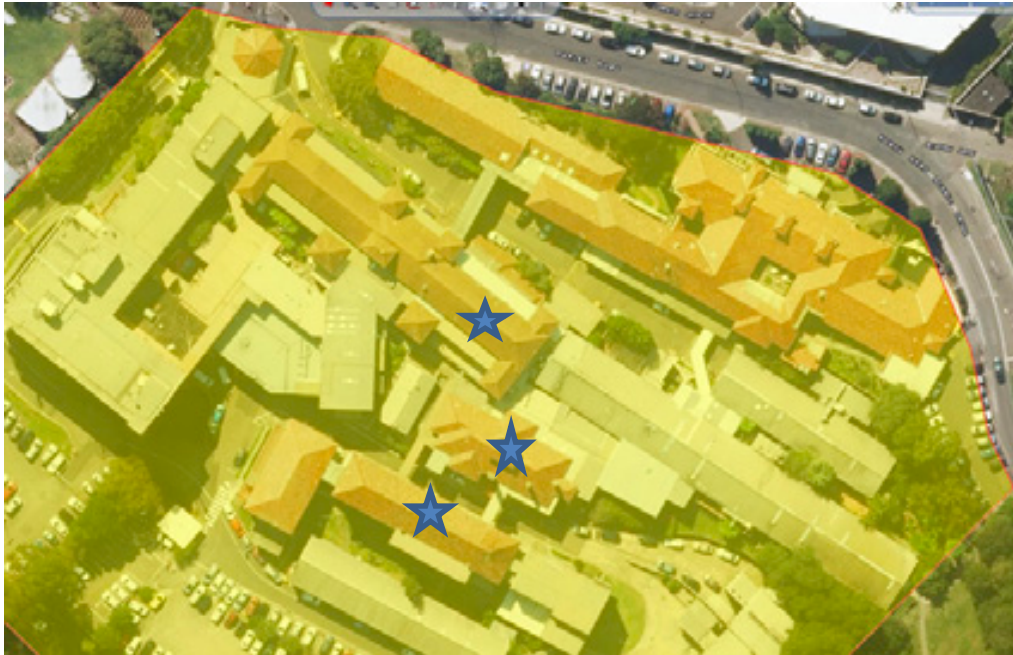
Figure 3: Close-up satellite view of part of Lot 2619, DP752038 of the hospital site, with the three pre-1943 hospital buildings on this lot indicated with blue stars (see 1943 aerial photo at Figure 4 below for reference).

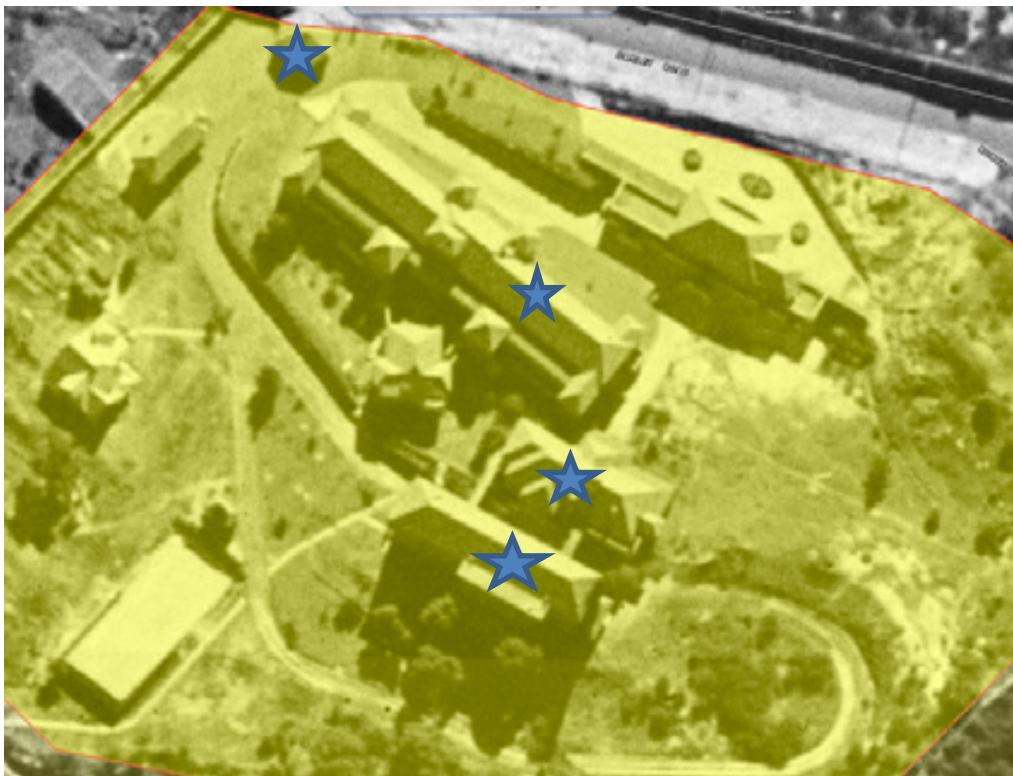
Figure 4: 1943 aerial photo of part of Lot 2619, DP752038 of the Manly Hospital showing the pre-1943 buildings on this lot (shaded yellow, outlined in red). This shows that in 1943 there were a number of buildings on the site. The buildings indicated with blue stars are those pre-1943 buildings which remain on the site today in their entirety. Source: NSW LPI Six Maps

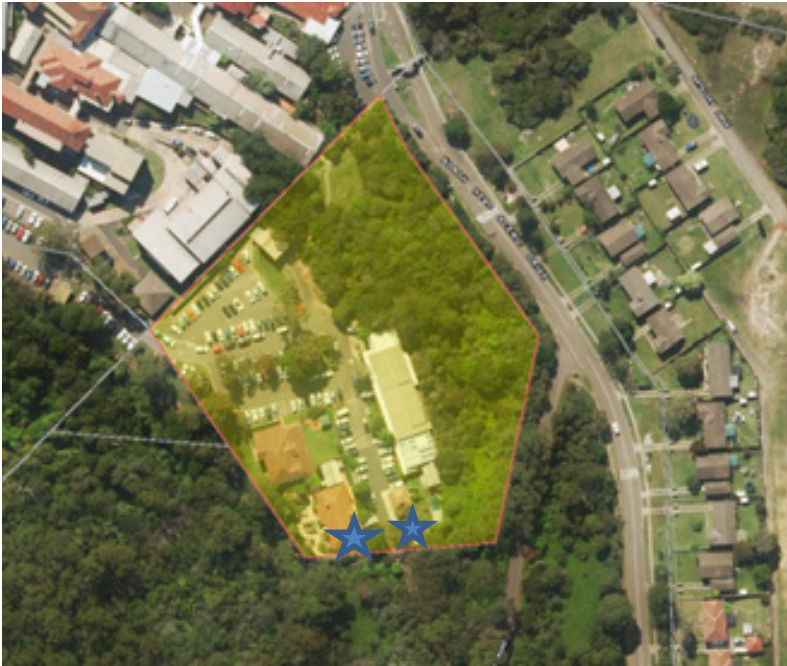
Figure 5: Close-up satellite view of Lot 2728, DP752038 (southern-most lot of the hospital site), with the two pre-1943 buildings on this lot indicated with blue stars (refer also to figure below)

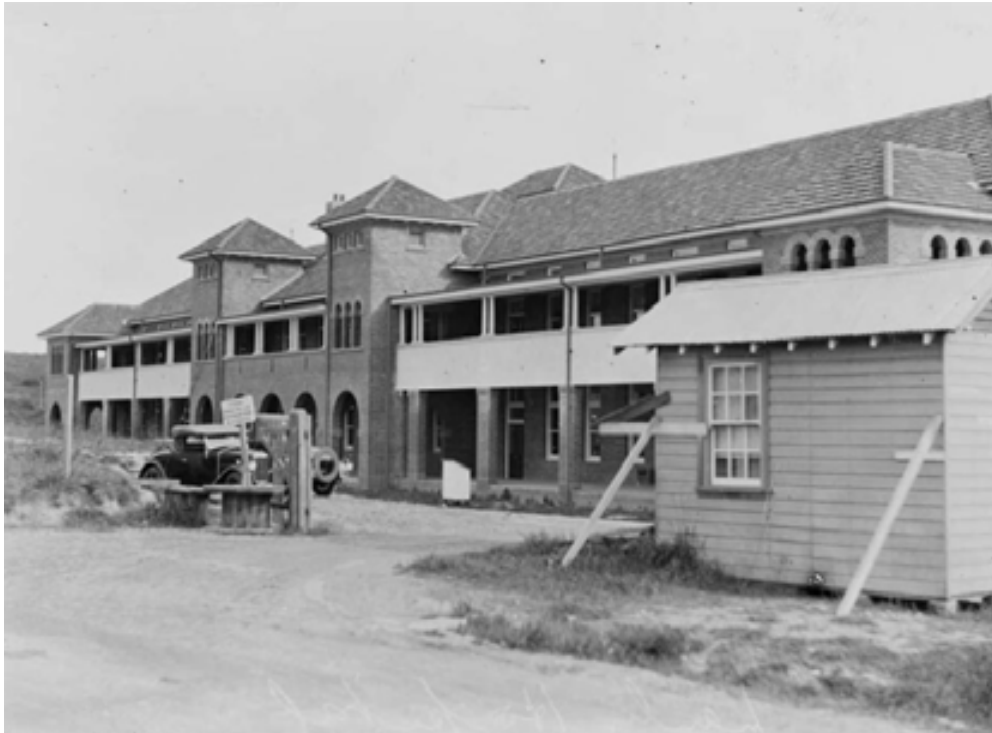
Figure 13: 1928 photo of the rear of the Main ward block (Building 2). Source: Fairfax photo sourced from NLA Trove

Like many public buildings of the time, the Manly hospital buildings were generic in their interior design, with a series of small spaces opening off long central corridors. The exception was the lengthy balconies of the Ward block, which may suggest some familiarity with contemporary European hospital architecture or more probably an adherence to the contemporary belief in the health-giving qualities of fresh air.

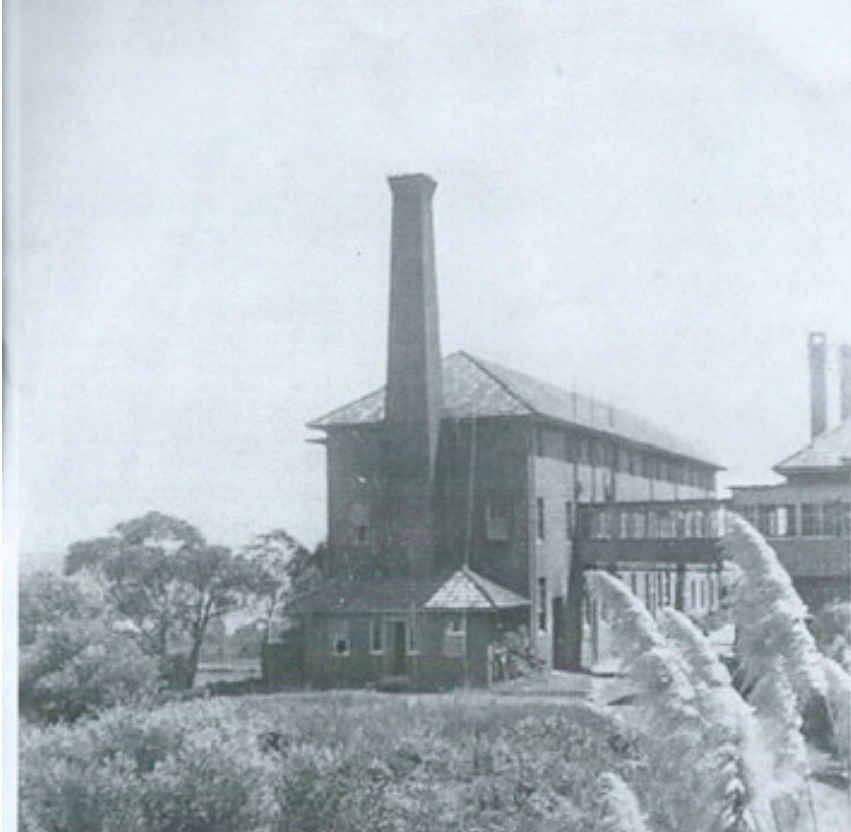
Figure 17: A 1949 photo of the eastern end of the 1931 Nurse's home showing the Boiler House and chimney and the northern elevation. Source: Local Studies Collection, Manly Library

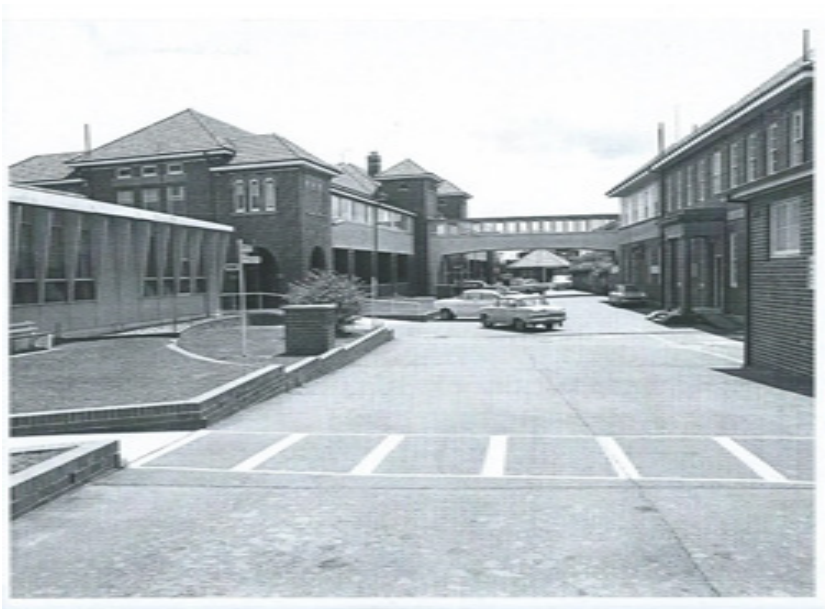
Figure 20: Main Ward Block (Building 2) and Maternity Ward (building 11) in 1969, (at left) with the rear of the 1928 Administration & outpatient's building 1 at right (prior to later alteration). This also shows the bridge built prior to 1959 between Buildings 1 and 2. Source: Local Studies Collection, Manly Library.

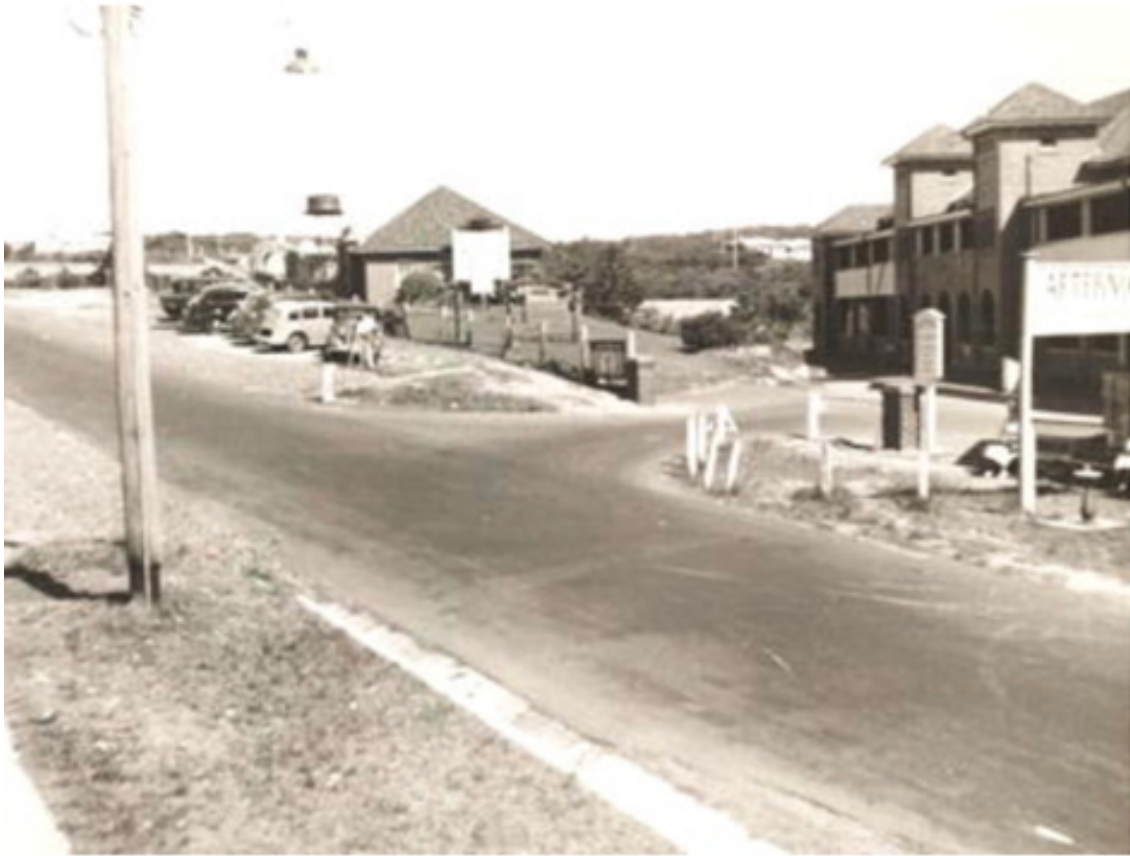
Figure 21: Entrance to Manly Hospital between Buildings 1 and 2 in 1950, prior to the construction of the Thoracic Unit, with Building 1 at left and Building 2 at right. Note the timber fencing along Darley Road and car parking off Darley Road. Source: Manly Library Local Studies image file No. 100\100347, dated 10 January 1950.

It is noted that the nose to kerb parking along the Darley Road frontage of the hospital is in the public road reserve and not within the hospital site. This parking was not evident on the 1943 aerial photo, however is in evidence by 1950 (see entry photo at Figure 21 of this report).

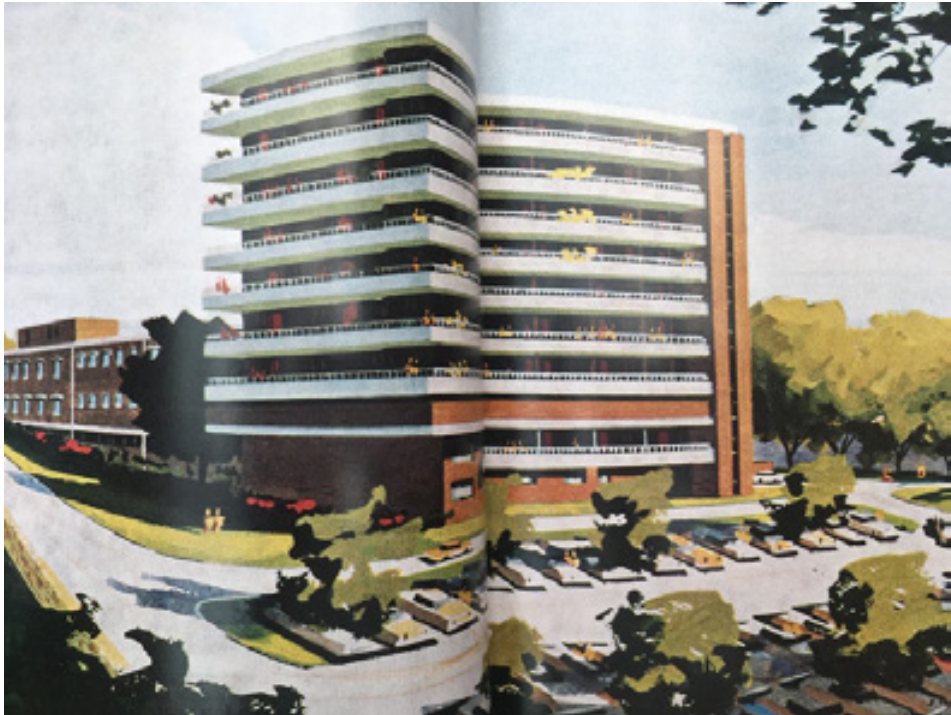
Figure 25: 1969 Architect's elevation, South Wing (Building 4, completed in 1975) Source: Annual Report, Manly District Hospital, 1970.

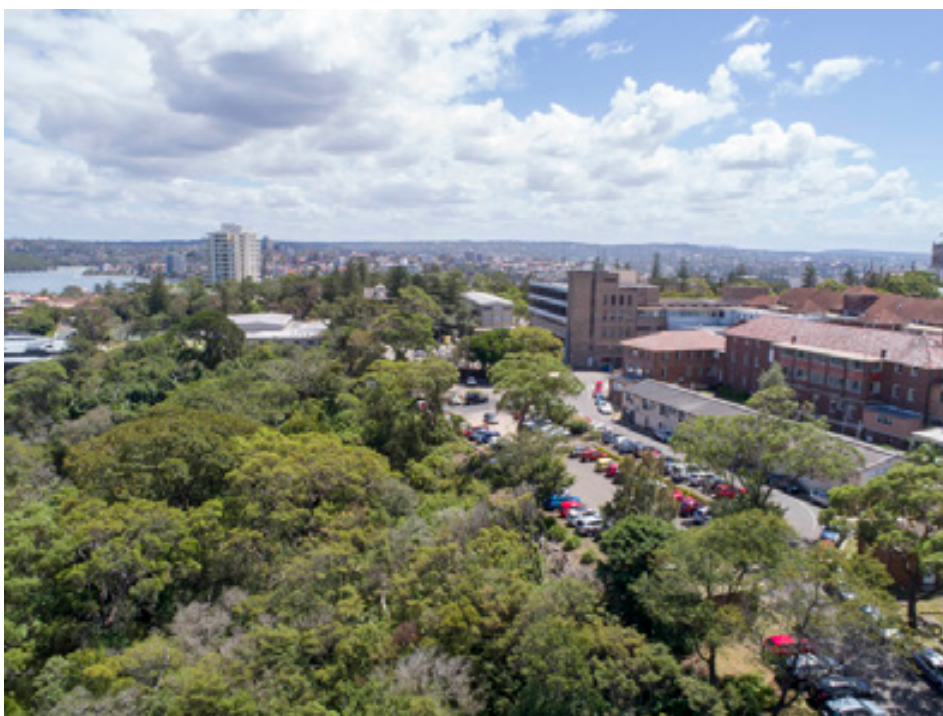
Figure 31: Drone photo of the western end of the Manly Hospital building complex from the south, with Building 22 (3 storeys) and Building 21 (1 storey) at far right, and the 5-storey Building 4 (arrowed) just right of centre.

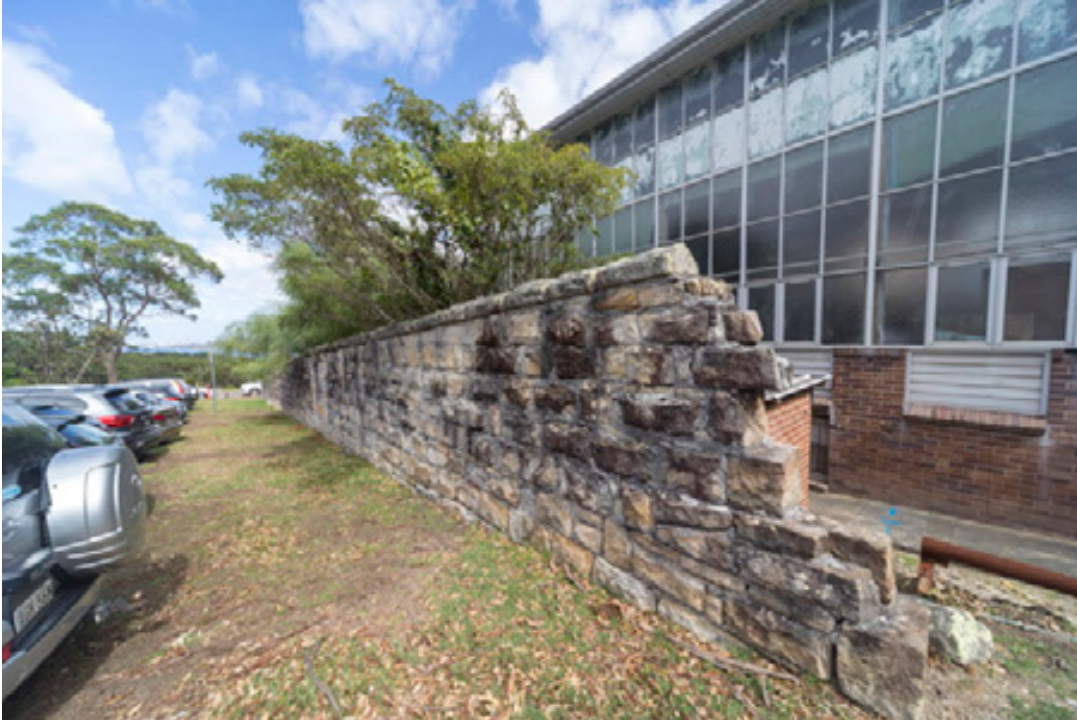
The east boundary wall is missing in sections, however attains its full height adjacent to carpark P6 near Darley Road and in sections east of Building 13, with a section between these two areas where the wall has been reduced in height to function as a retaining wall and is crossed by paths and steps.

Figure 32: The northern end of the Eastern boundary wall of the original hospital site, from the north-east, looking south showing where the wall has been demolished adjacent to Building 13

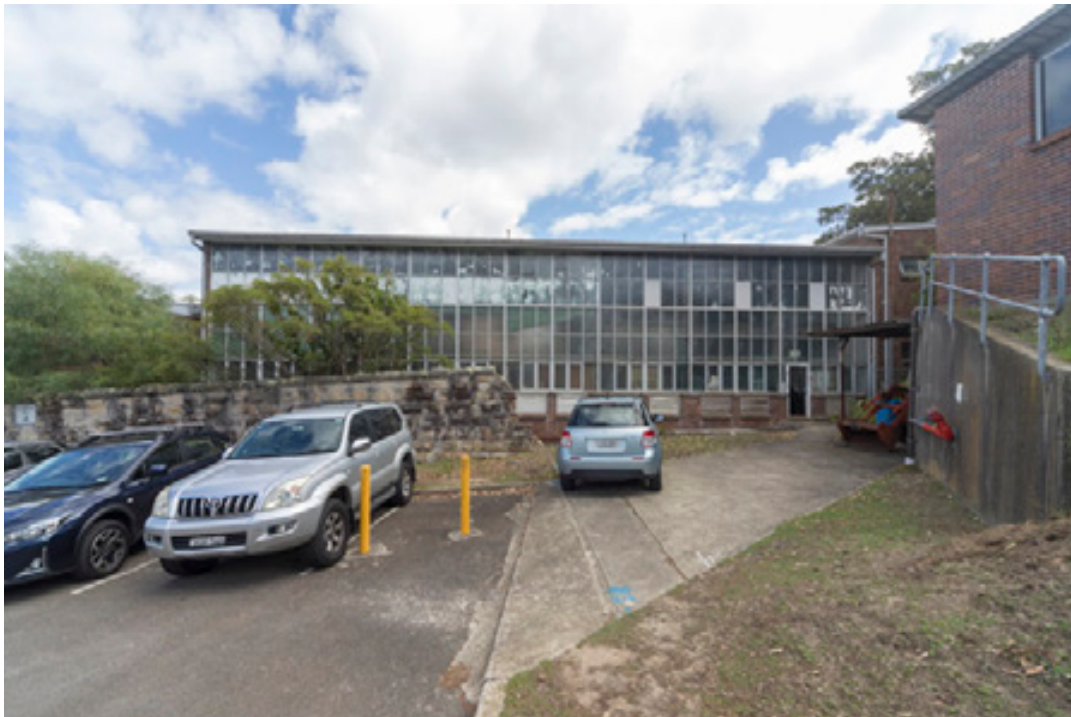
Figure 33: Another view of the eastern boundary wall from the east with Building 13 beyond.

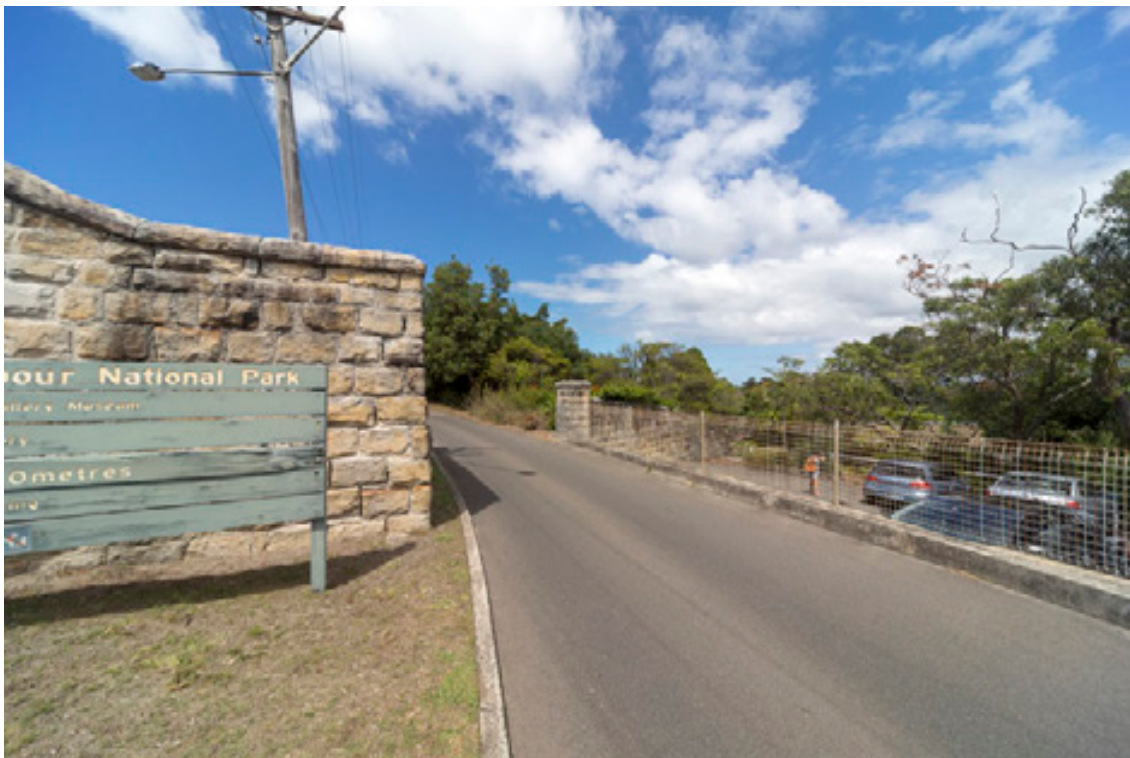
Figure 34: View of the northern end of the eastern boundary wall, adjacent to Car parking area P6 (arrowed)

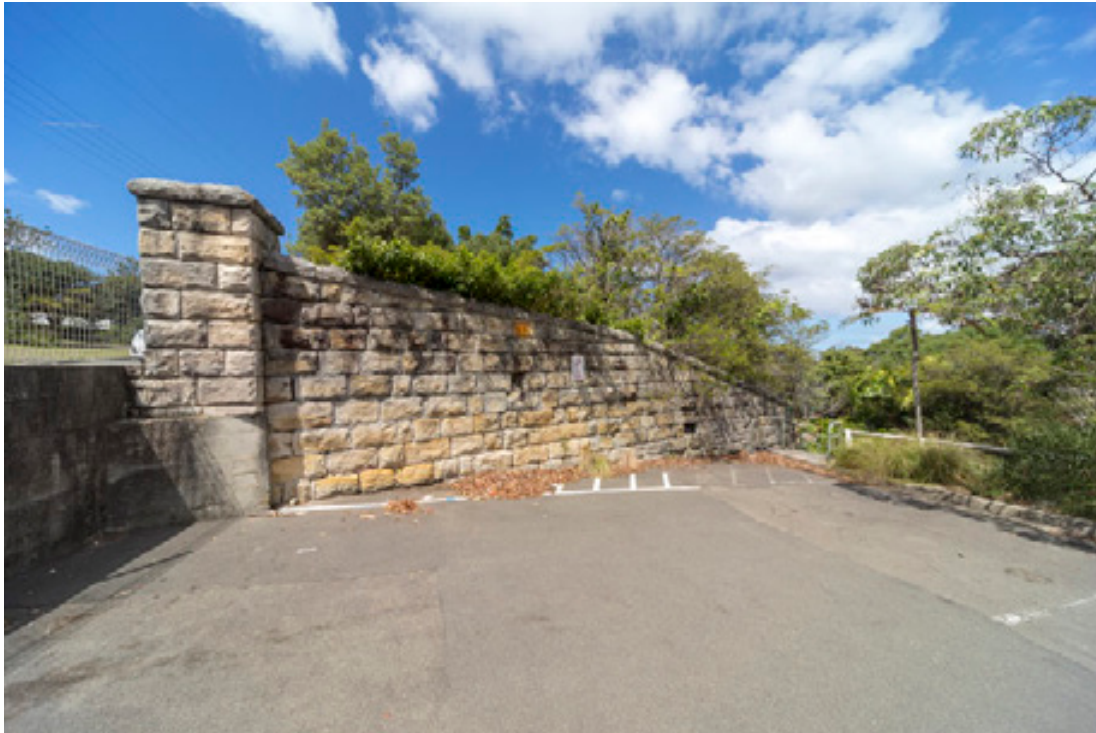
Figure 35: North end of the eastern boundary wall of the core hospital site, adjacent to car park P6. This is a view of the western side the wall.

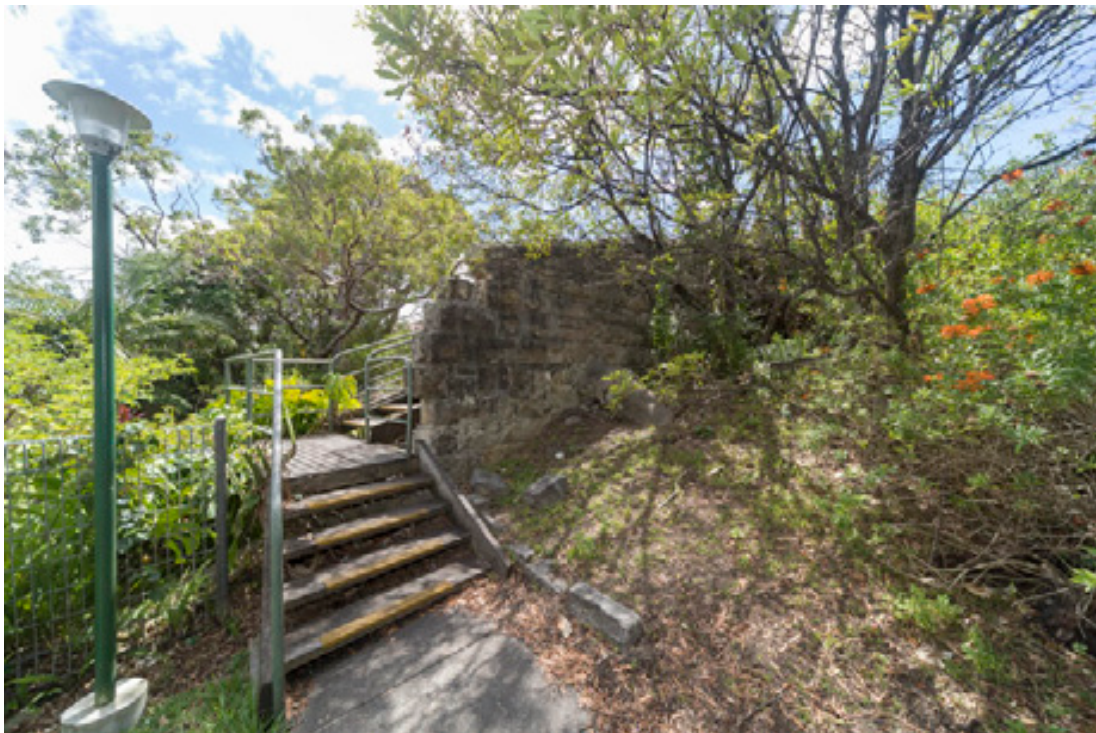
Figure 36: Steps from Car parking area P6 and view of the eastern side of the northern end of the eastern boundary wall of the core hospital site.

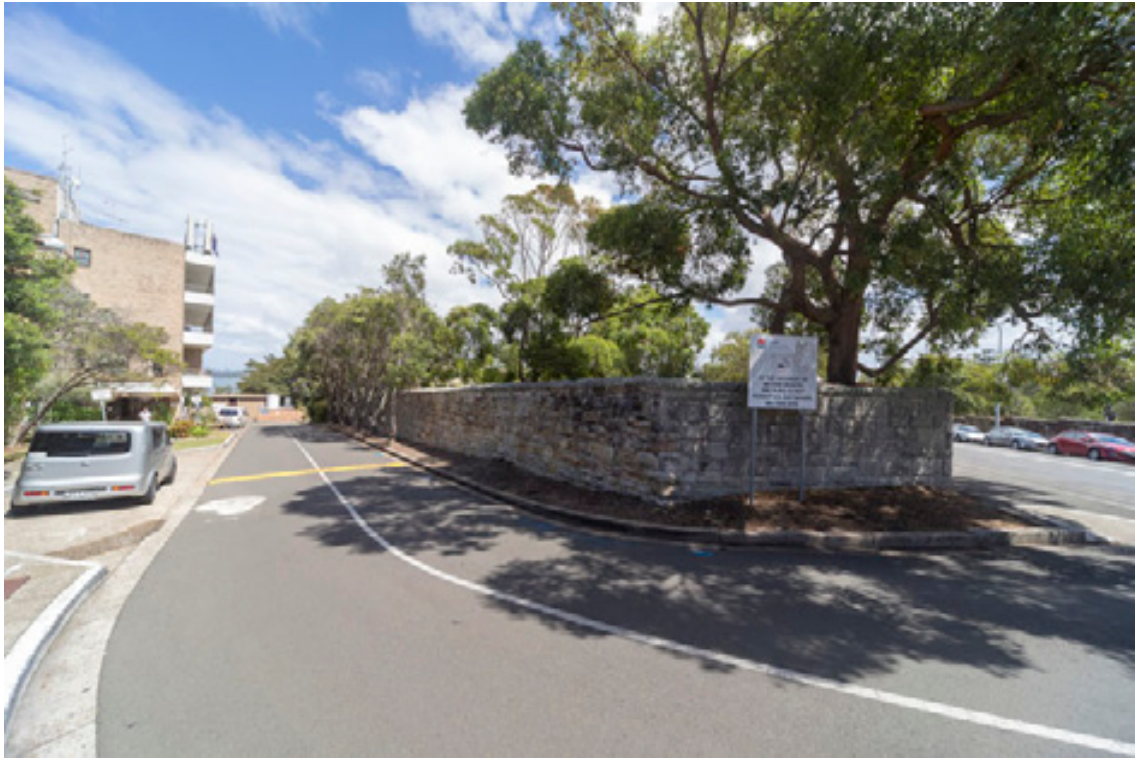
Figure 37: The northern end of the western boundary wall of the core hospital site.

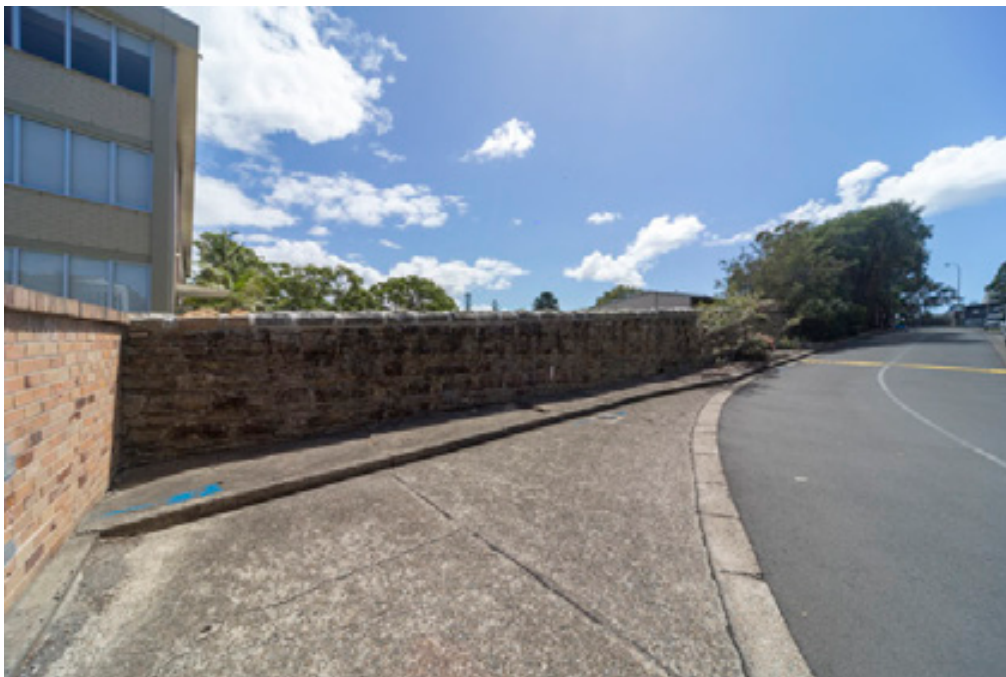
Figure 38: The southern end of the western boundary wall of the core hospital site

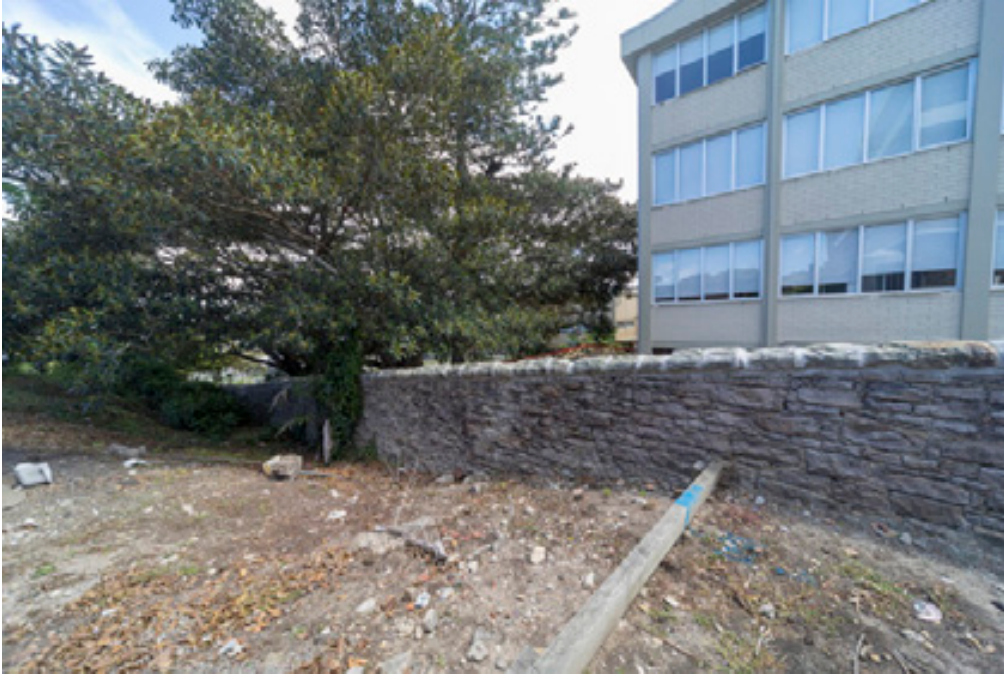
Figure 39: Detail of western boundary wall of the core hospital site, showing use of the hard white cement mortar, particularly to the capping stones.

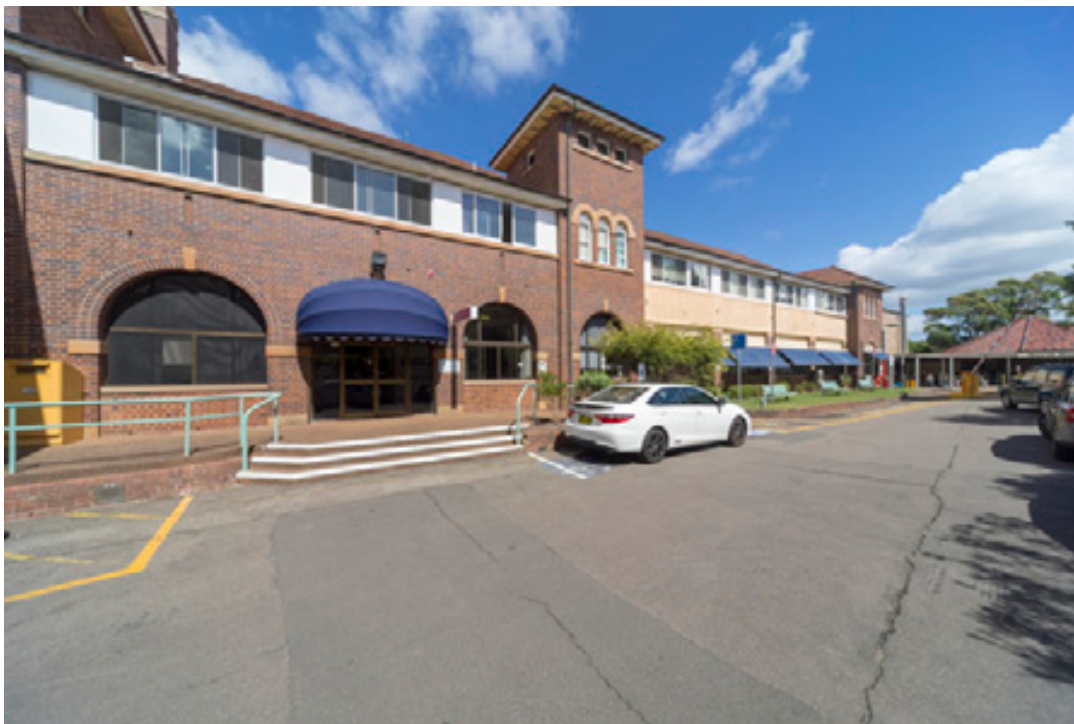
The original colonnade to the north elevation has been enclosed with aluminium framed windows, however the original arched openings remain on the ground floor, along with roughcast stuccoed balustrading to the formerly open 1st floor balcony on the northern elevation. The 1st floor linking bridge through to Building 1 dates from after 1956 when the north wing of Building 1 was constructed. Another obvious alteration is the concrete roof tiling which would have replaced the original unglazed terracotta roof tiling.

Figure 40: The western end of the north elevation of Building 2 with Kiosk (Building 5) at far right. Note roughcast stuccoed balustrading remains to balconies at right, however all balconies have been enclosed, and the arched colonnade infilled with aluminium framed windows.

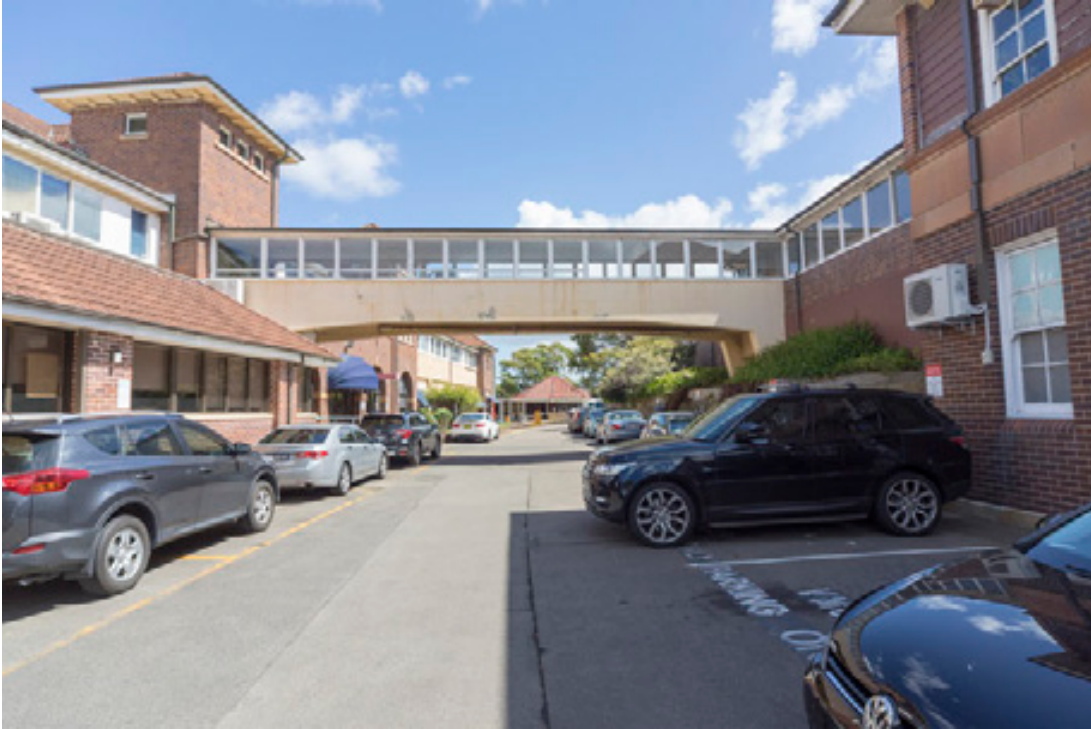
Figure 41: View looking west between Building 2 (Left) and Building 1 (right)

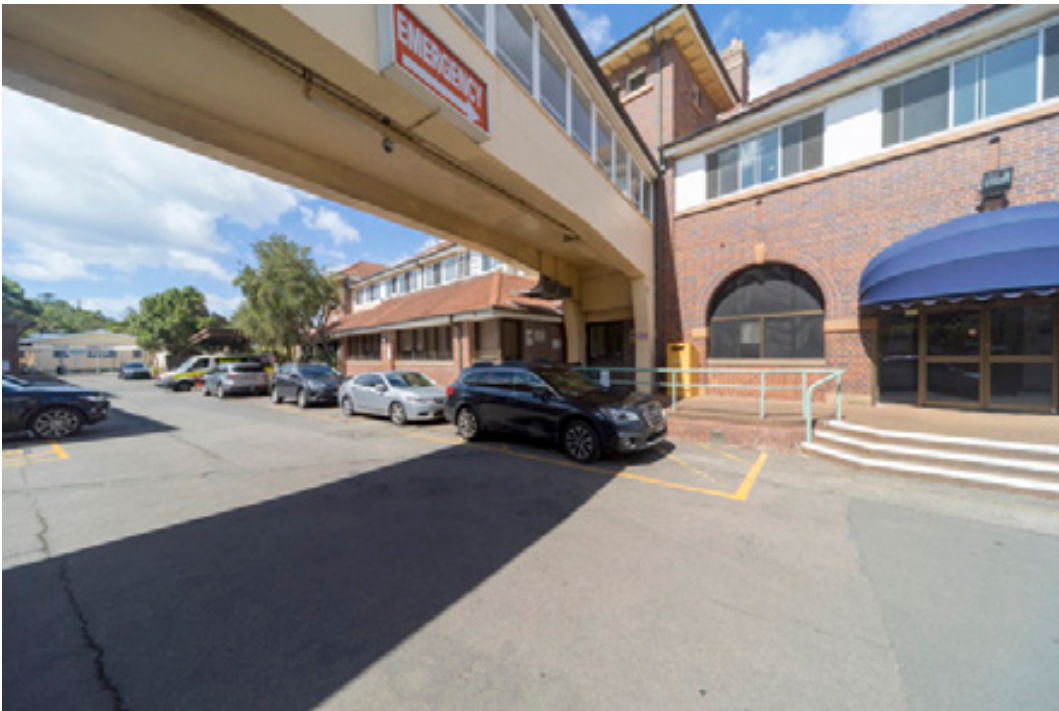
Figure 42: Eastern end of the north elevation of Building 2, taken from the west looking east, with bridge link to Building 1

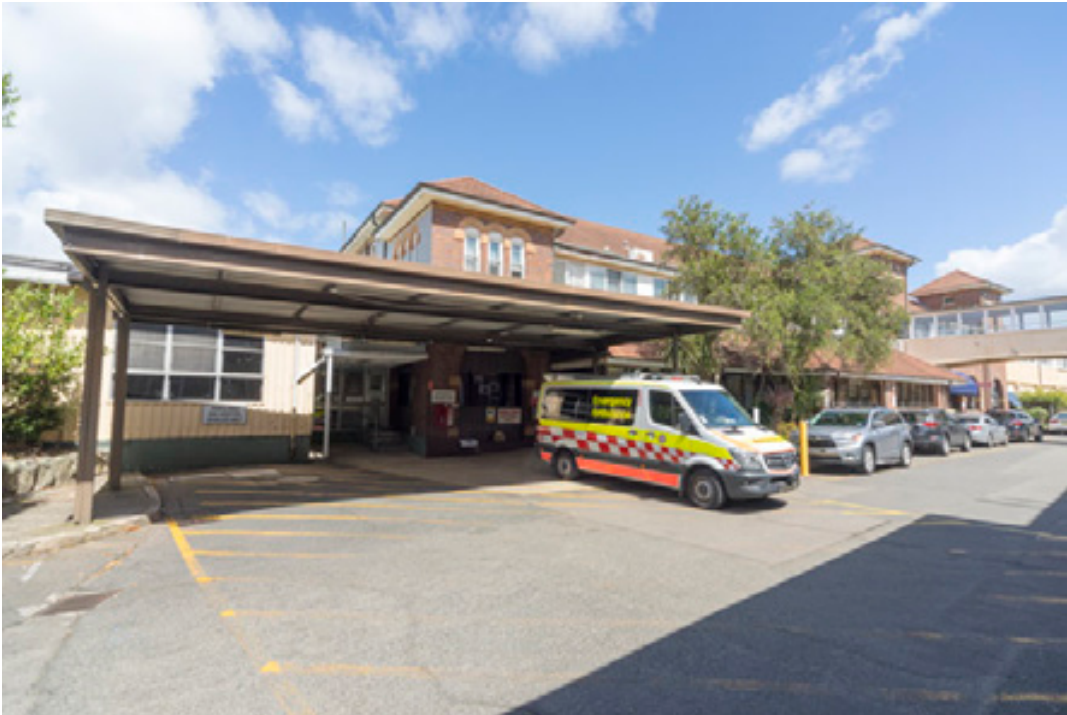
Figure 43: Eastern end of the north elevation of Building 2, looking west, with Building 11 at far left, bridge link to Building 1 at far right

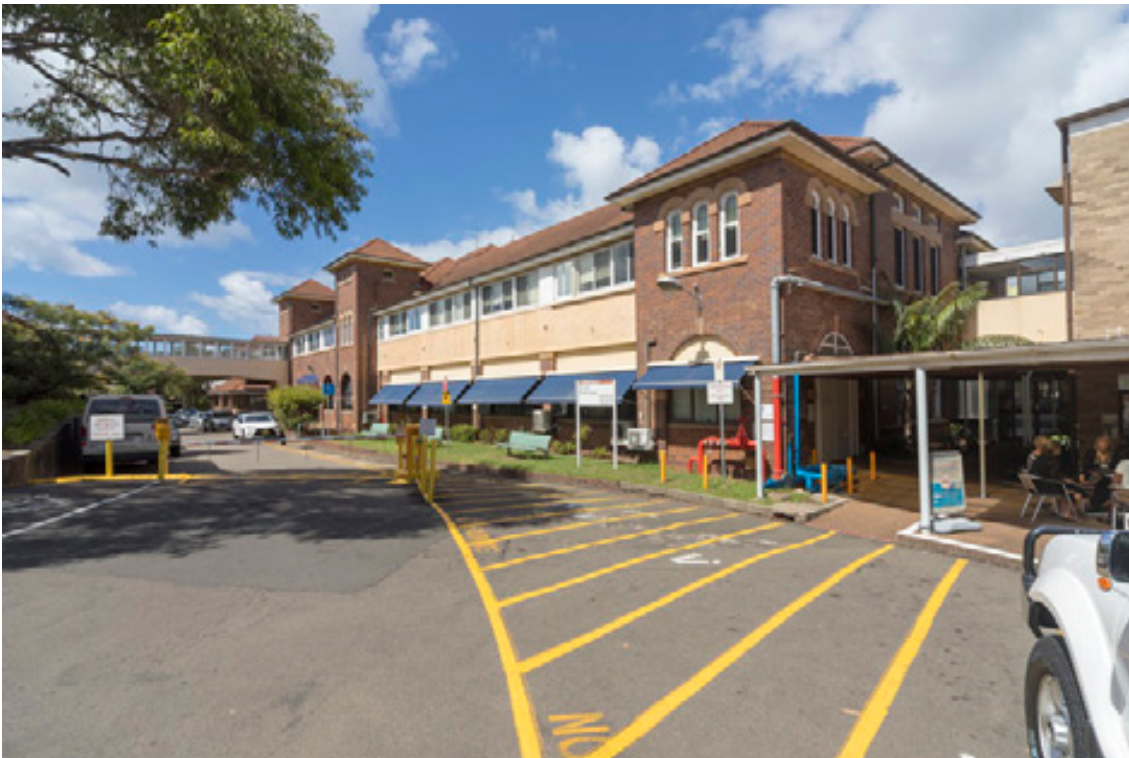
Figure 44: The western end of the north elevation of Building 1 and the west elevation (right) of Building 1, and junction with Building 3

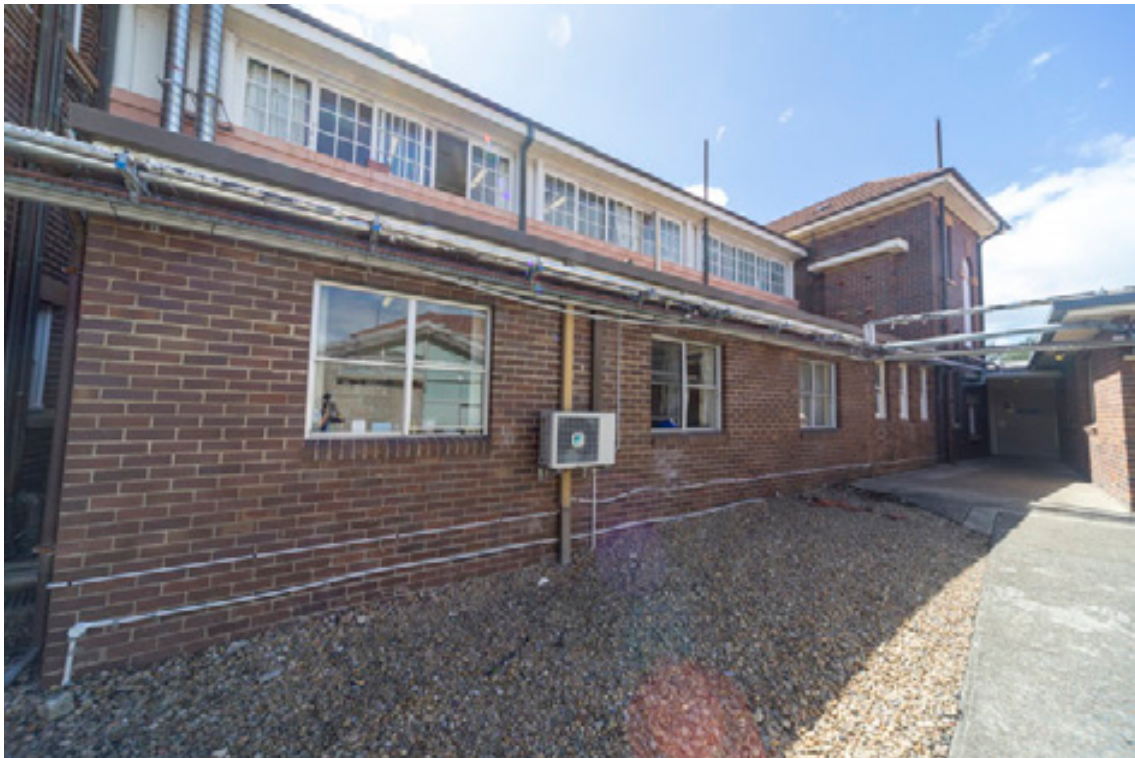
Figure 45; Part of the south elevation of Building 2

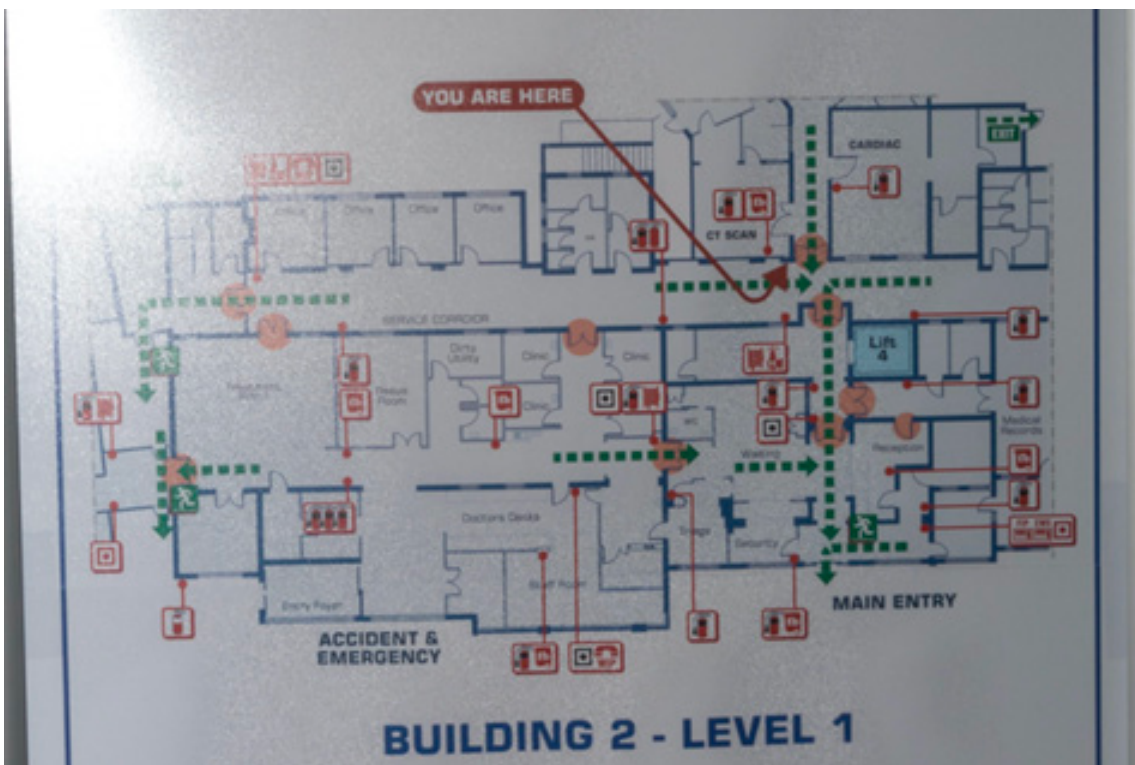
Figure 46: Building 2, Level 1 evacuation plan showing layout of Level 1

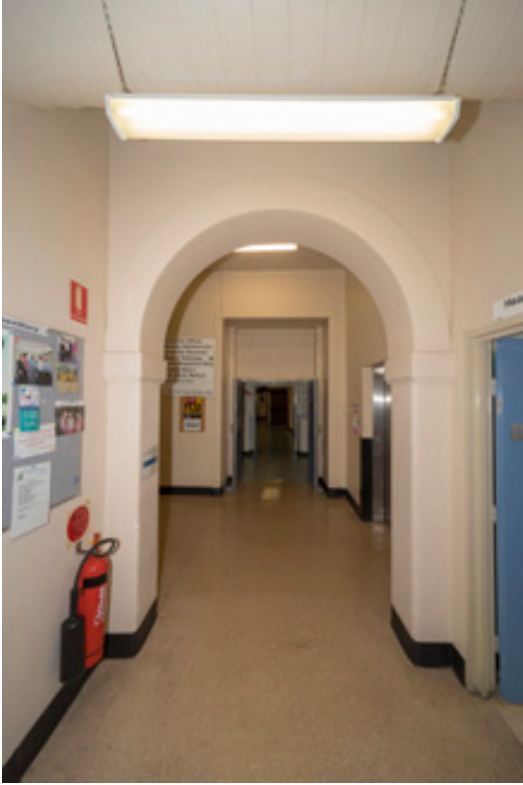
Figure 47: (Left) interior of Building 2, with arched openings, original skirtings

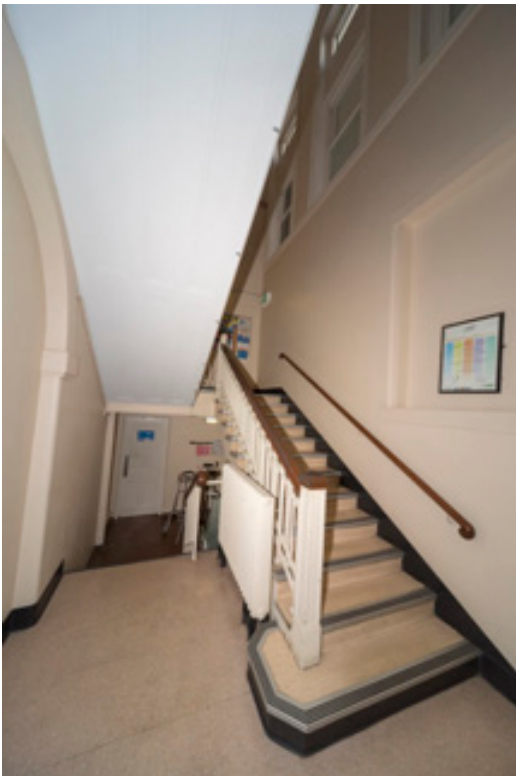
Figure 48: (Left) Original staircase to Building 2

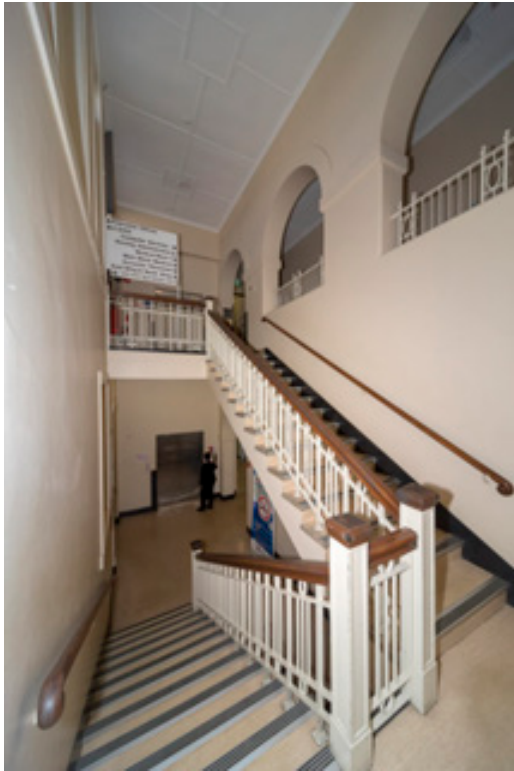
Figure 49: (Left) View of staircase and stair hall from Level 1, Building 2

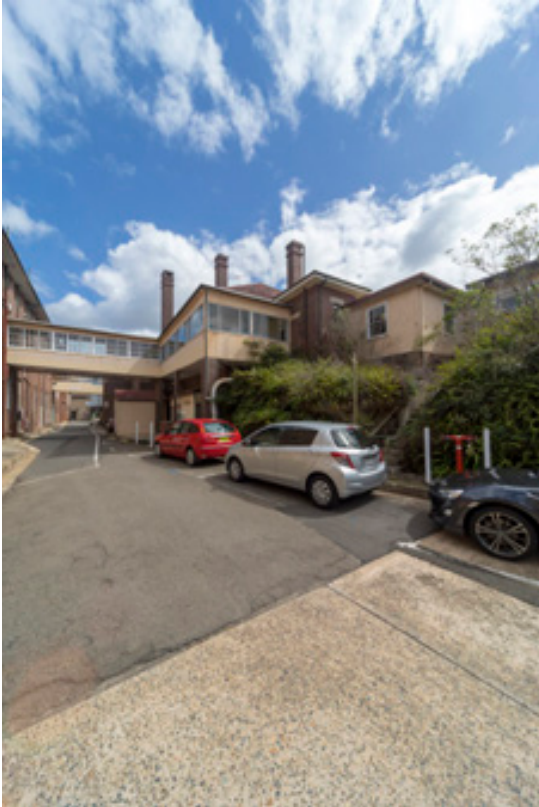
Figure 50: (Left) Building 15 from the east, with bridge link to Building 22 at left

On the northern side (now within a connecting corridor leading to adjacent buildings) the original timber tongue and grooved ceiling to the northern verandah of the building remains however verandahs have been enclosed.

The building has had various additions and interconnections that are not art of its significance.

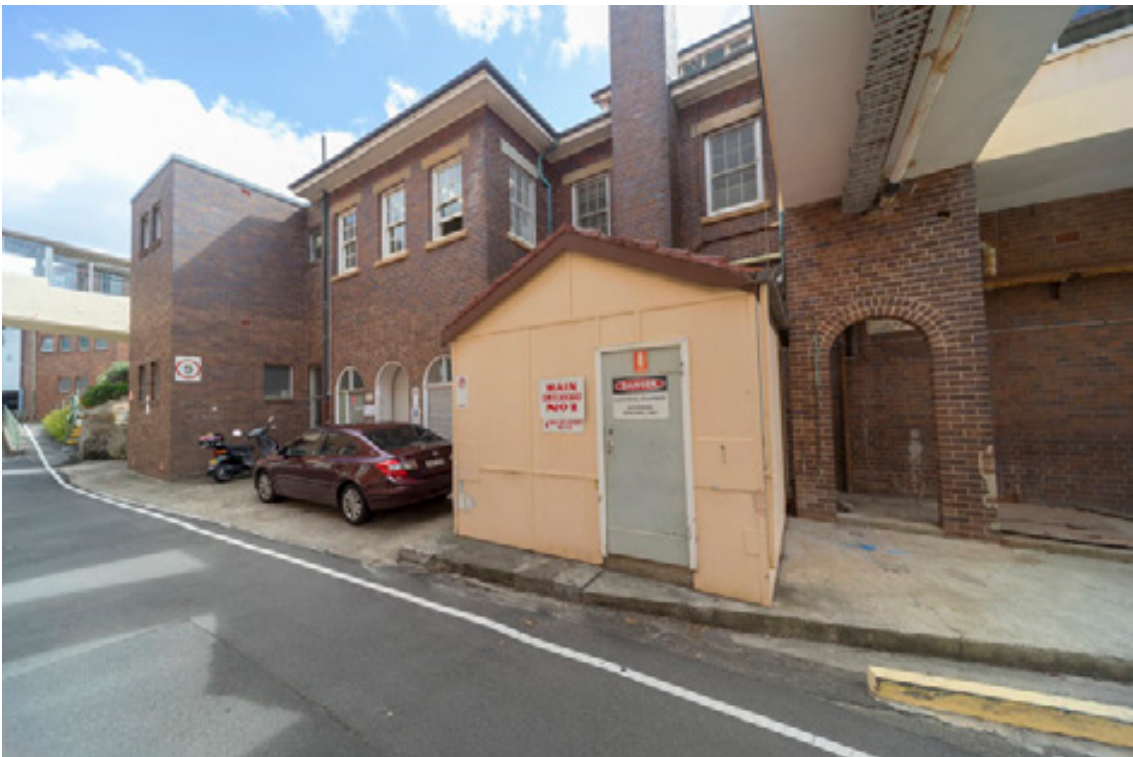
Figure 51: South elevation of Building 15 with underside of bridge link to Building 22.

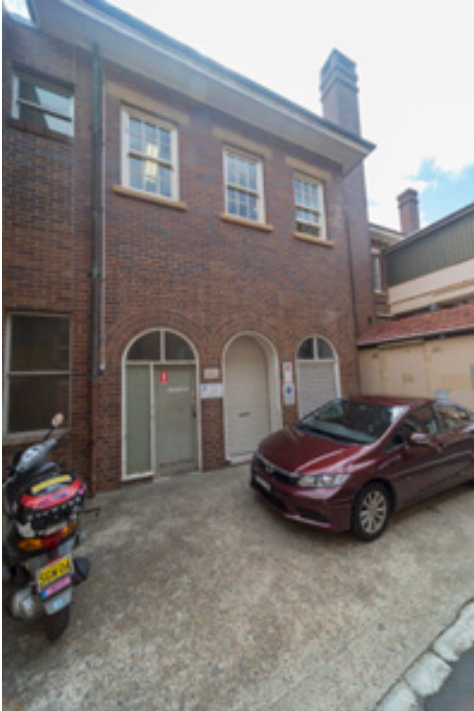
Figure 52: Detail of western end of south elevation of Building 15 with bridge link to Building 22 at far right. Later addition to Building 15 evident at far left.
