Manly Hospital
150 Darley Road, Manly
Stage 1: Heritage Assessment
Report

April 2018

prepared by Paul Davies Pty Ltd
for NSW Health Infrastructure

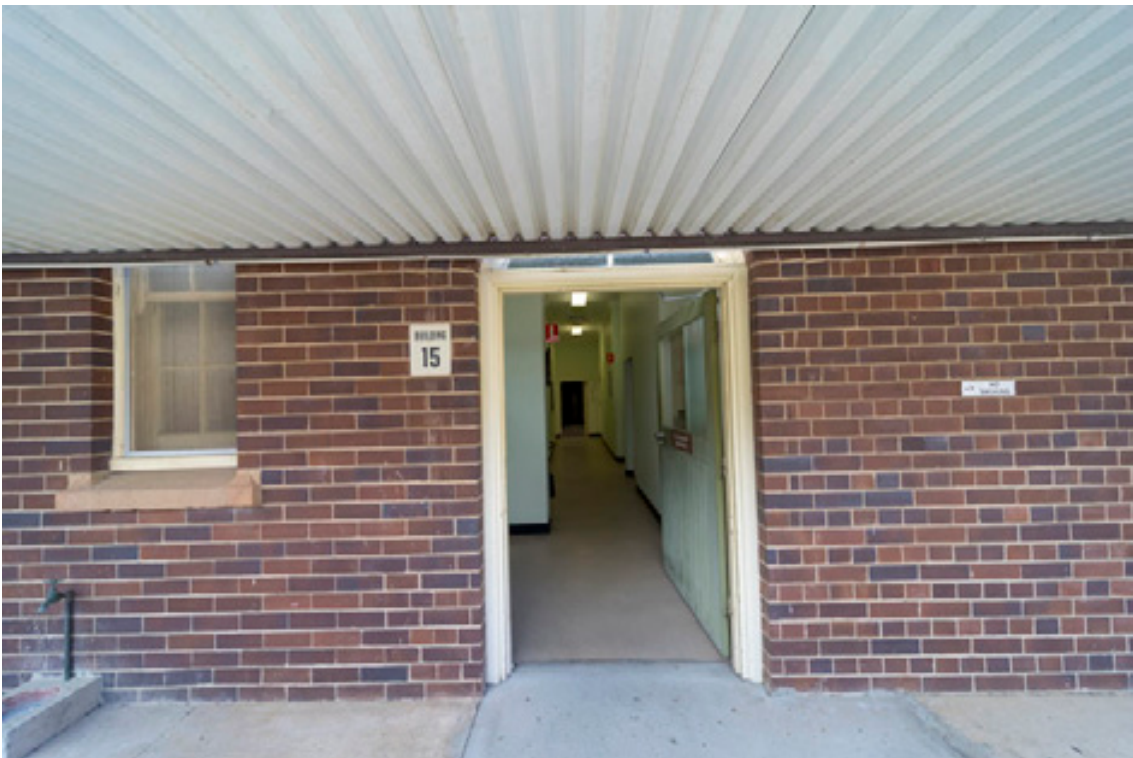
Figure 53: South elevation ground floor entry into Building 15. Note original window at left with sandstone sill.

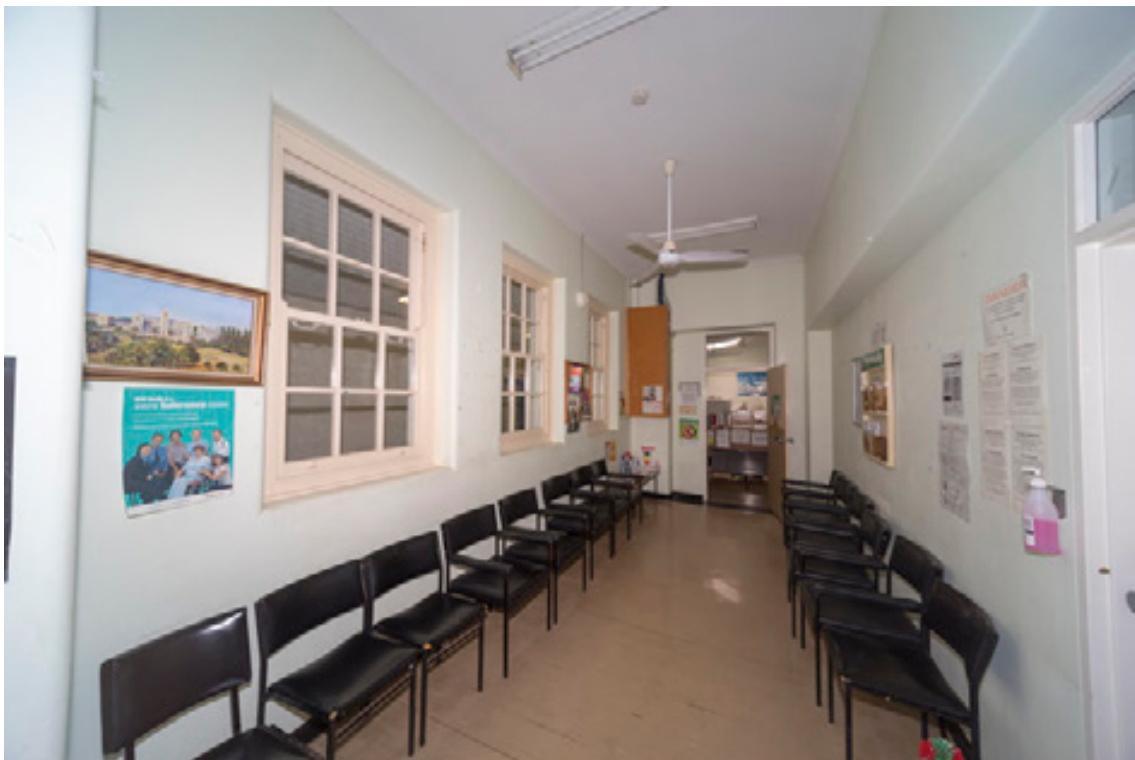
Figure 55: Waiting area on northern side of Building 15 with original windows to the northern wall.

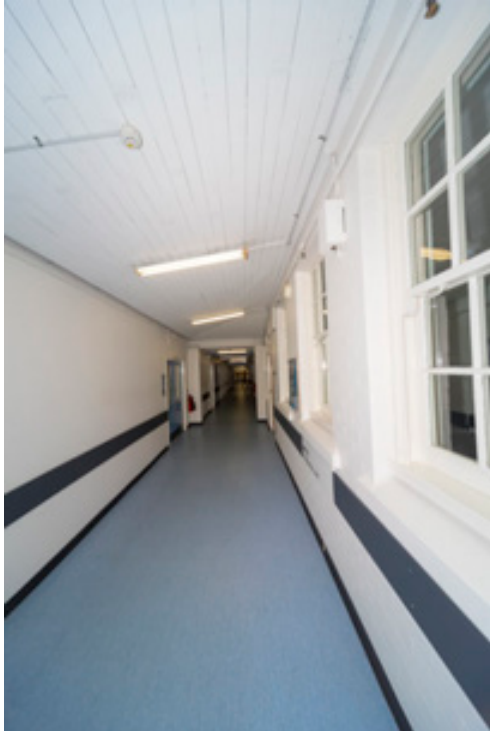
Figure 56: (Left) view on the north side of the wall of Building 15 looking east, with the original windows shown in the Figure above, showing original timber tongue & grooved verandah ceiling to Building 15, now enclosed as a corridor linking to Buildings 11 and 10.

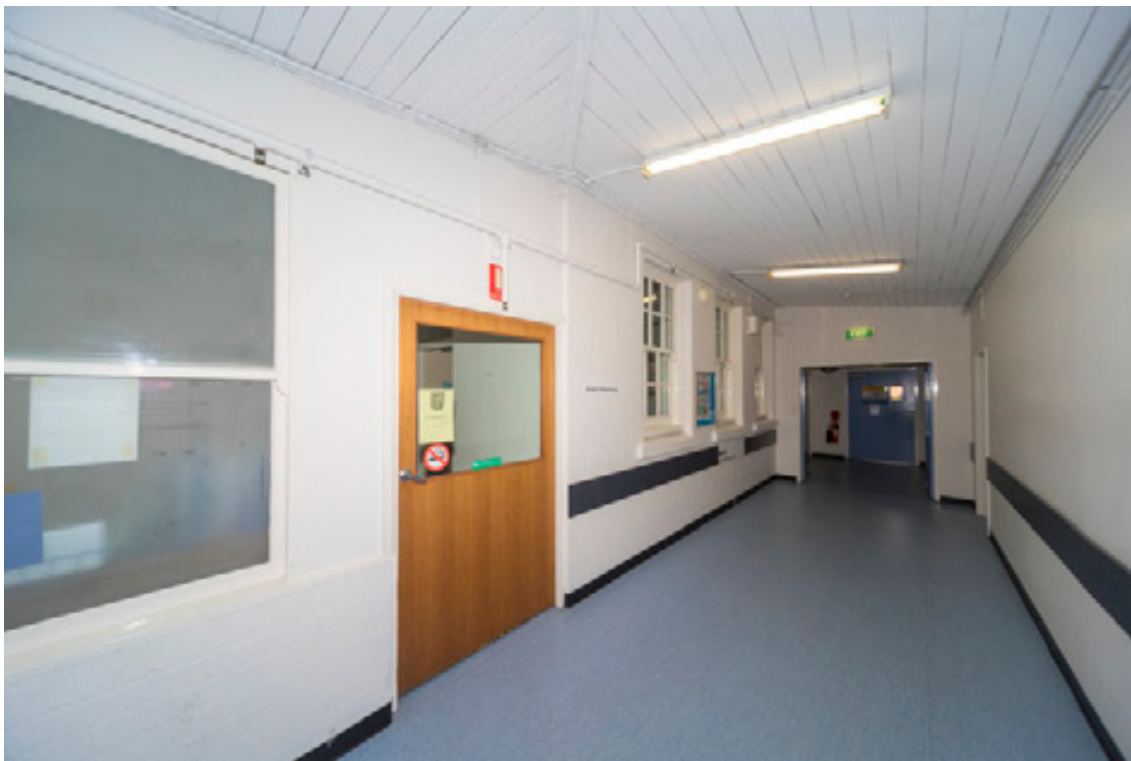
Figure 57: View of the northern wall of Bulding 15, looking west with original windows (centre) and original timber verandah ceiling

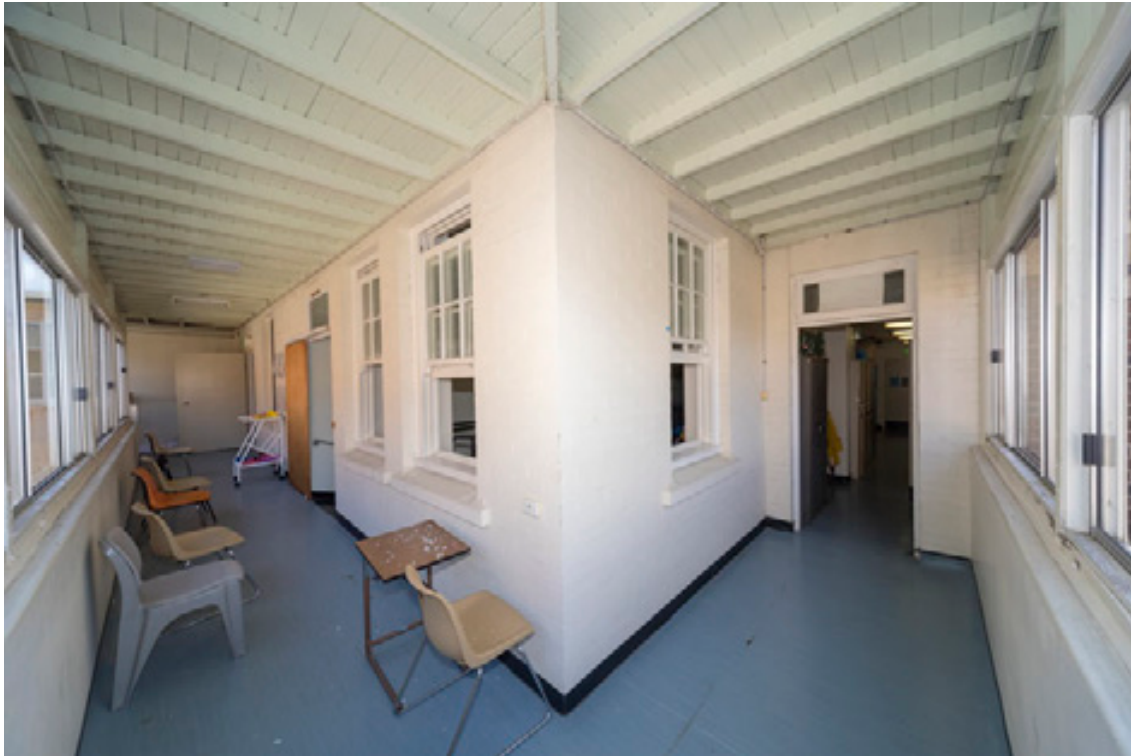
Figure 58: South-east corner of Building 15 with original windows and timber verandah ceilings

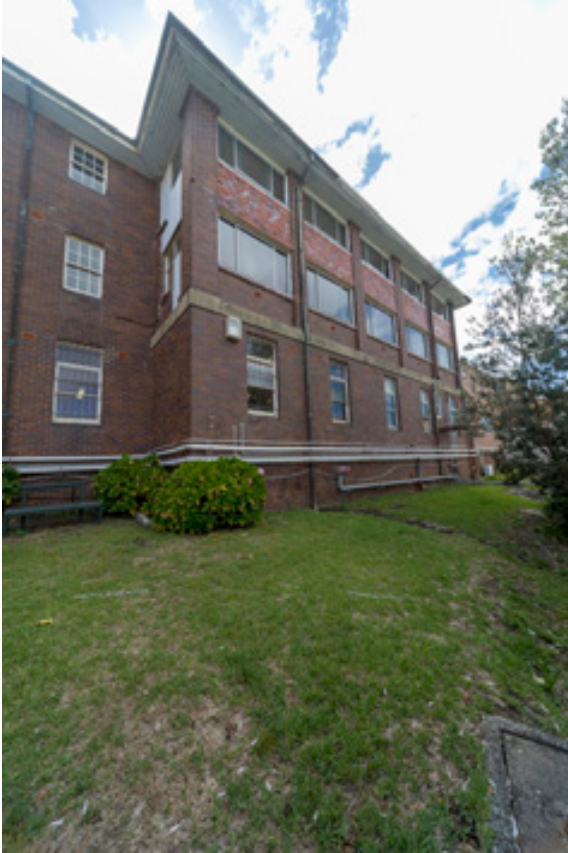
Figure 59: (Left) south elevation of Building 22 Kalori (former nurses' home)

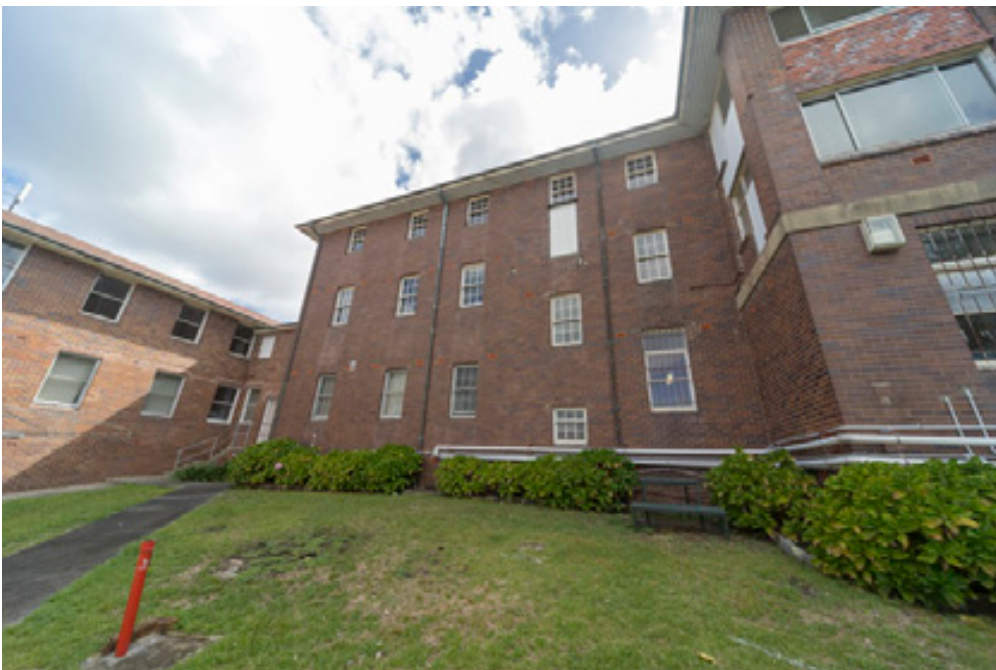
Figure 60: Western end of the south elevation of Building 22 Kalori, showing at left Building 22A and junction with Building 22A

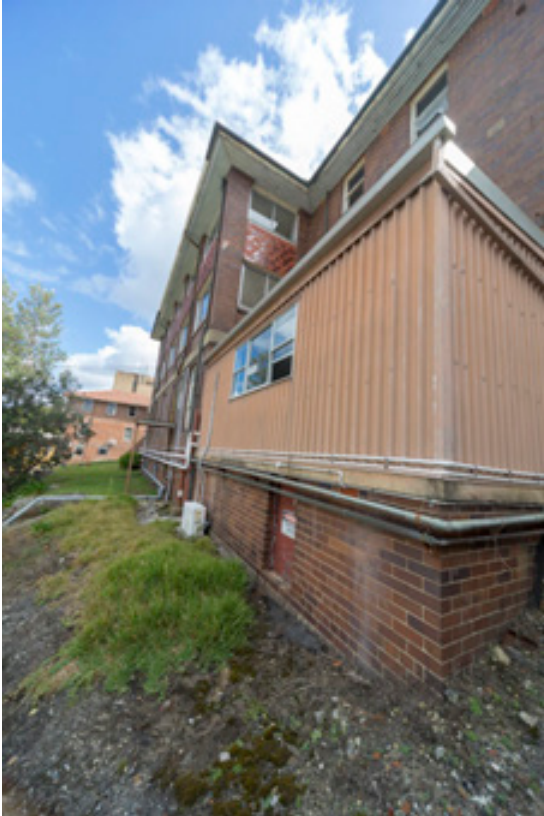
Figure 61: (Left) eastern end of south elevation of Building 22 Kalori (former nurses' home), showing shed addition to south-east corner at right

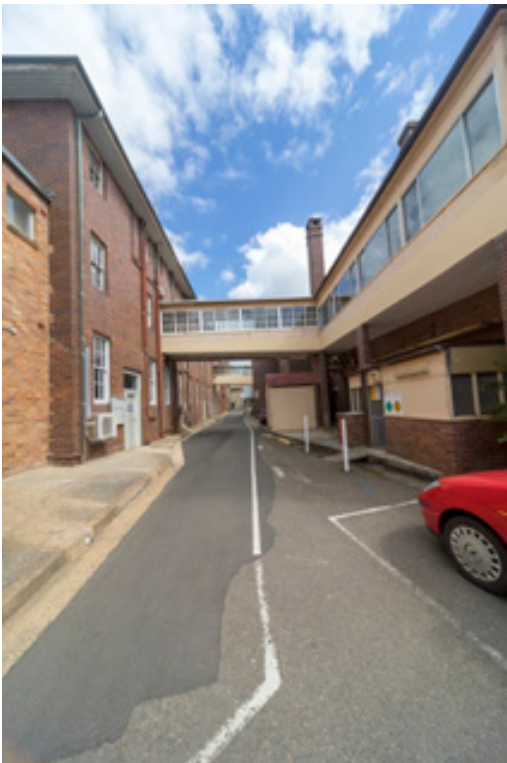
Figure 64: (Left) view looking west with Building 22 at left, Building 22B left foreground, bridge link to Building 15 centre

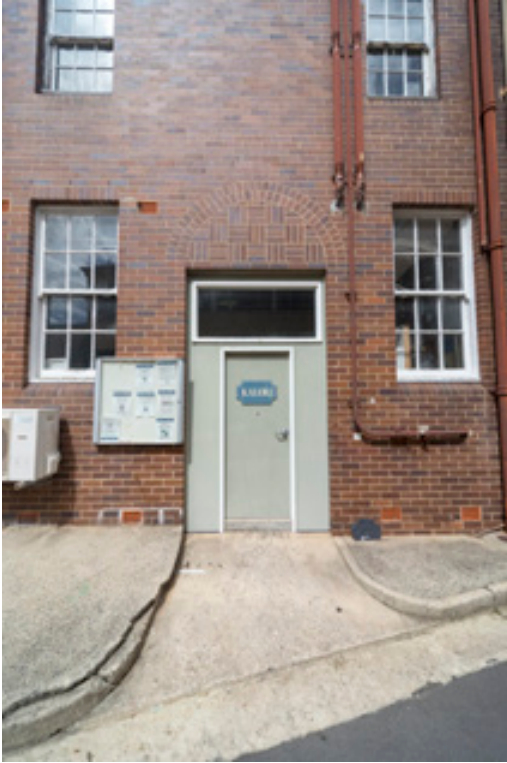
Figure 65: (Left) Detail of doorway with later doors to north elevation of Kalori, Building 22, noting original windows, brickwork including elaborate brickwork over doorway.

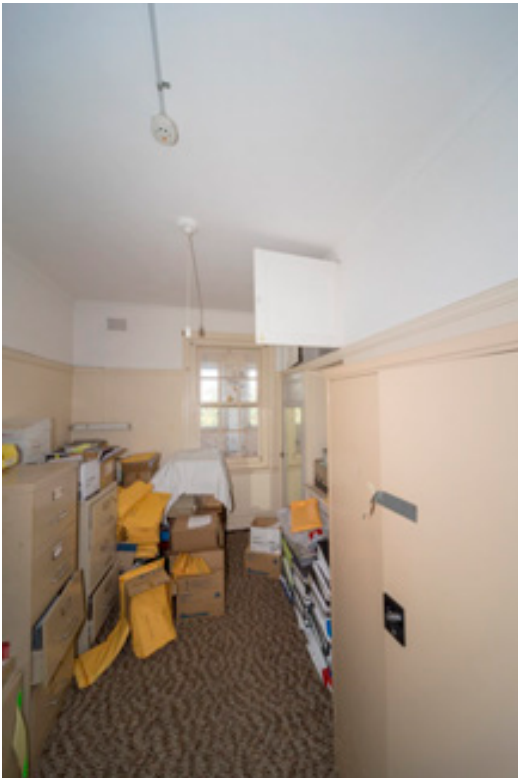
Figure 66: (Left) Typical room within Kalori, Building 22, Level 1, including picture rails, built in wardrobes, plain ceilings, original windows

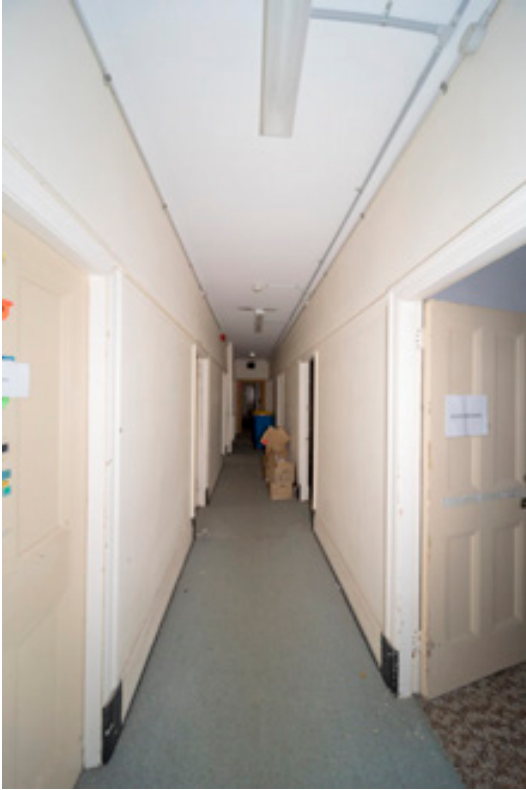
Figure 67: (Left) corridor, Building 22 Level 1 interior including original doors, joinery

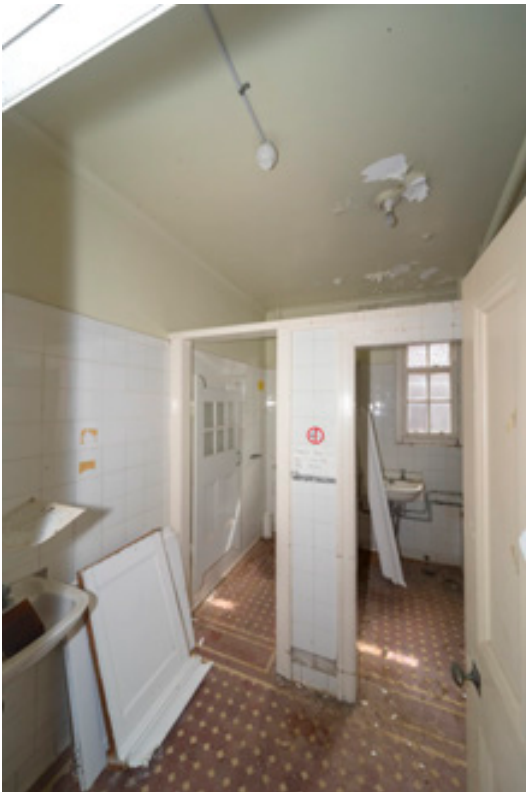
Figure 68: (Left) Original bathrooms to Level 1 Building 22 including tessellated tiling

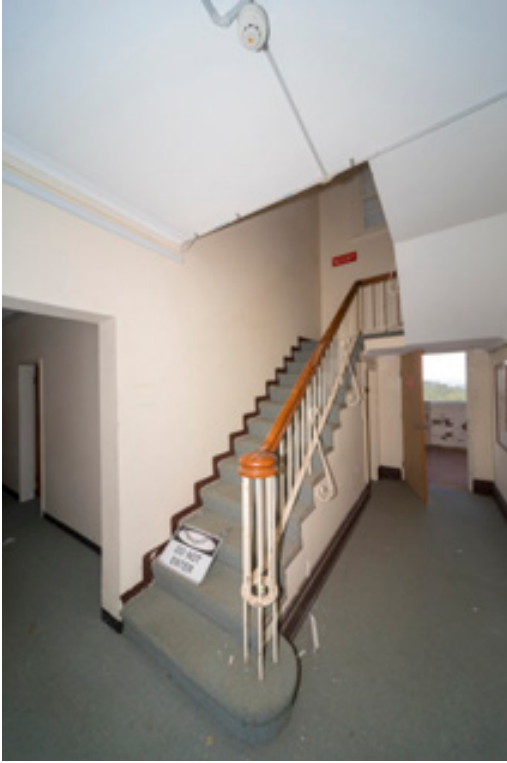
Figure 69: (Left) Original staircase with steel balustrading and timber handrail to Building 22 Level 1 interior

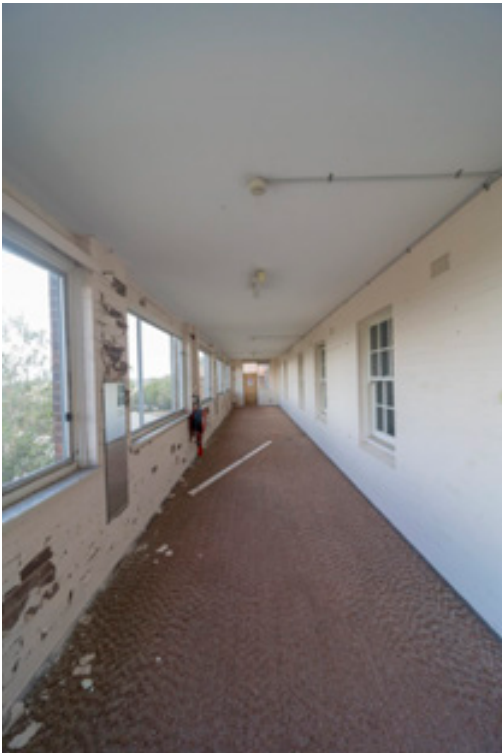
Figure 70: (Left) View of the Level 1 enclosed balconies to building 22 south elevation

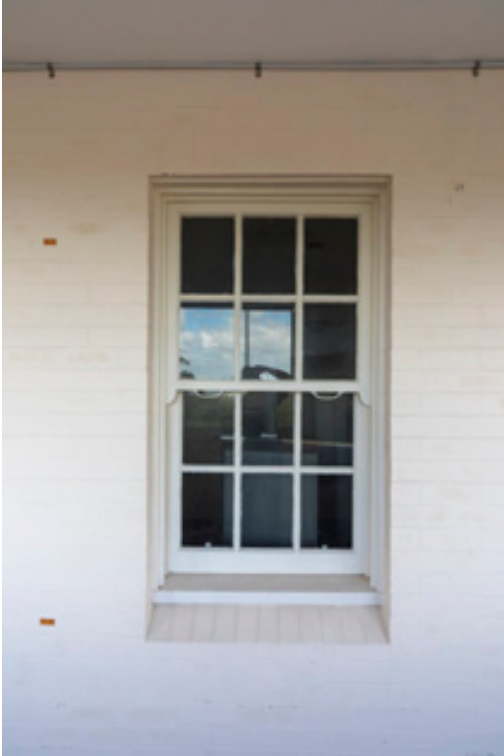
Figure 71: (Left) Typical original window to Building 22

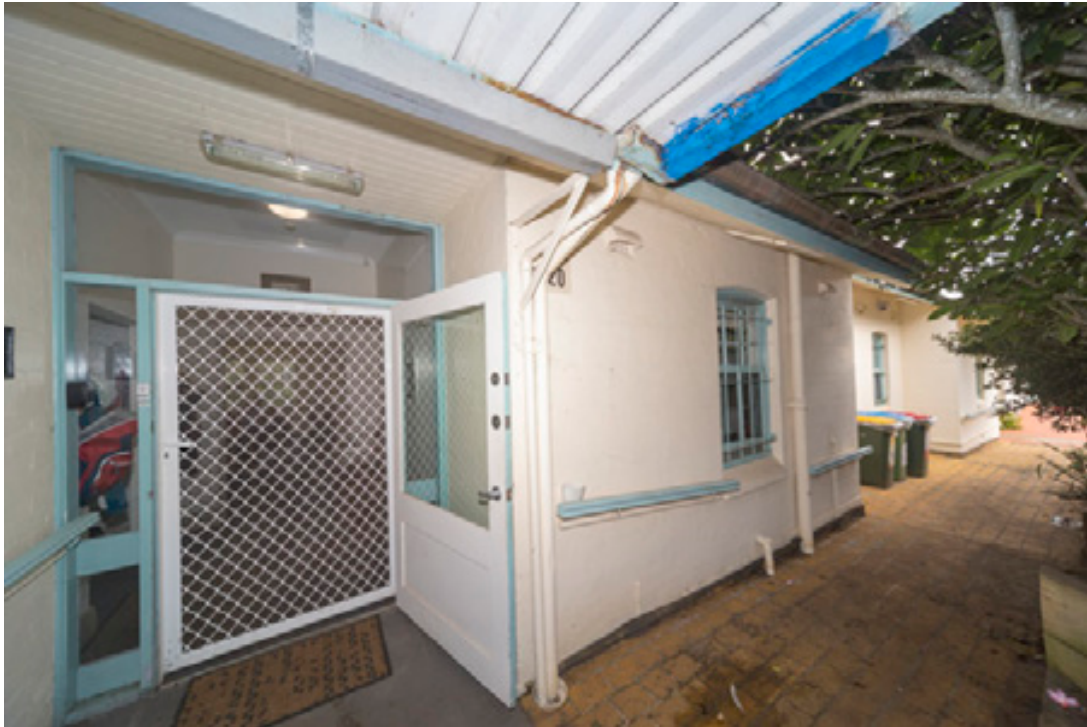
- Detached aluminium shed to the western side of the cottage
- Replacement of original entry doors with circa 1970s aluminium framed doors sidelights and fanlights
- Replacement of many ceilings internally.
- Two fireplaces (though not mantelpieces) remain.

Figure 76: The entry area and western end of the north elevation of Parkhill cottage. Note modern door, fanlights and sidelights to entry area.

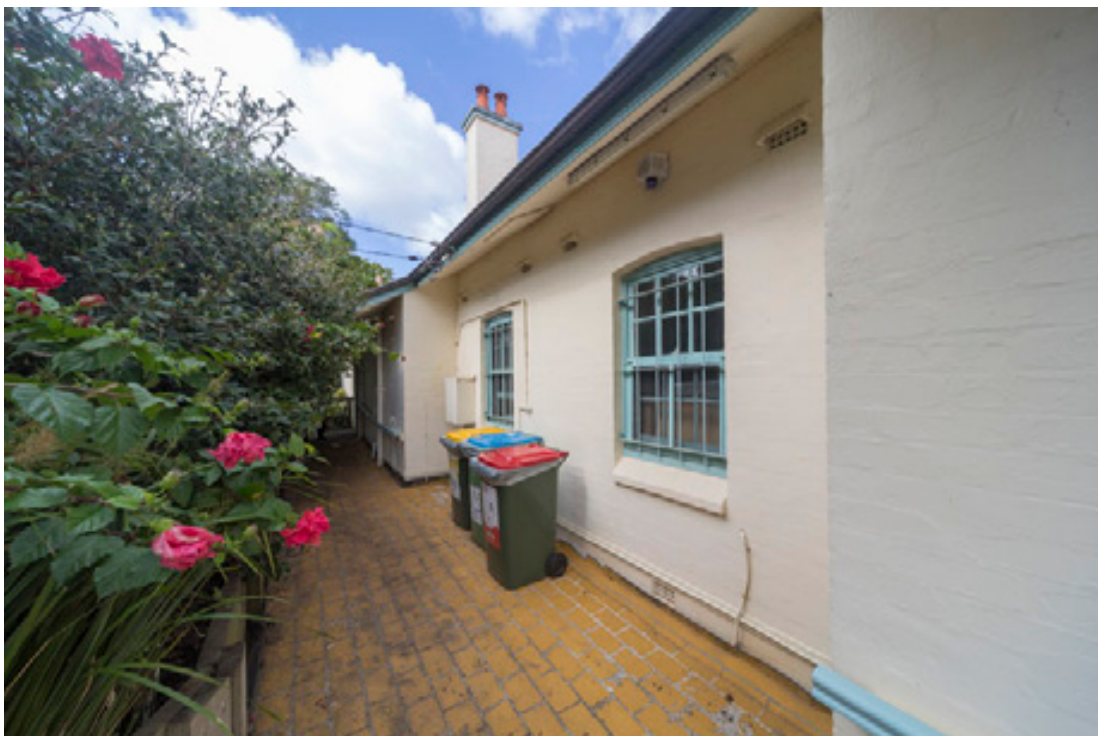
Figure 77: Western end of the north elevation of Parkhill cottage showing original timber framed multi-paned windows.

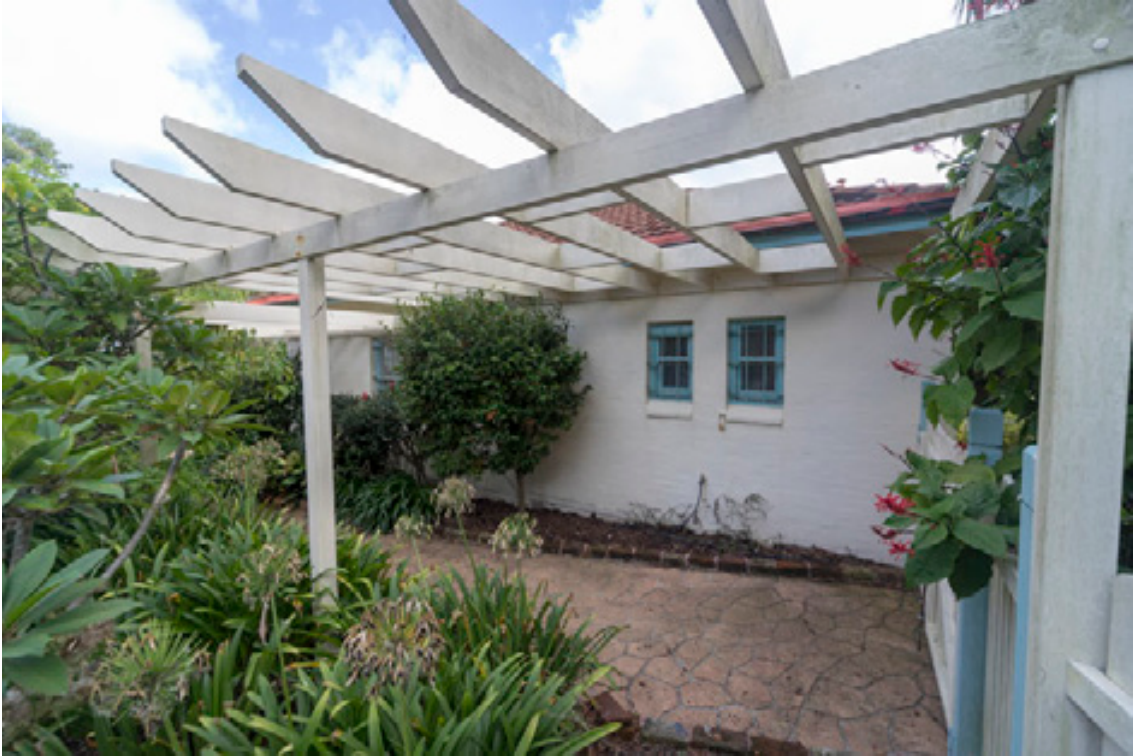
Figure 78: East elevation of Parkhill cottage

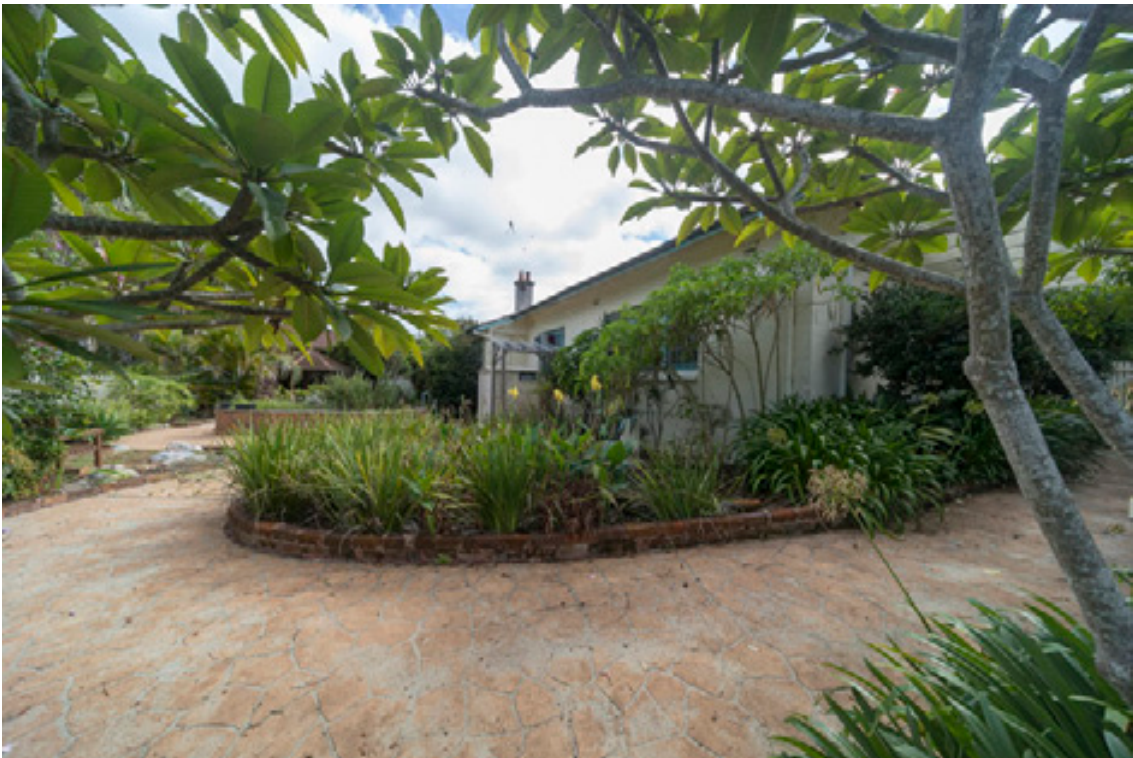
Figure 79: South elevation of Parkhill cottage

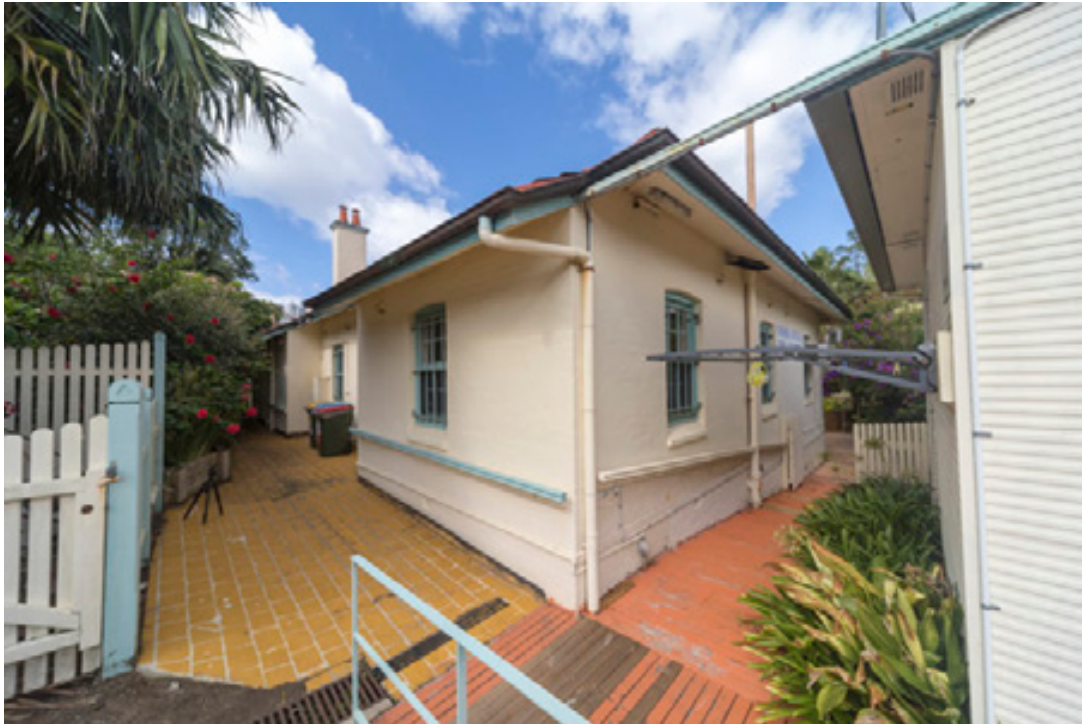
Figure 80: The west and (at left) part of the north elevation of Parkhill cottage. Note metal shed addition at right, to the west of Parkhill house.

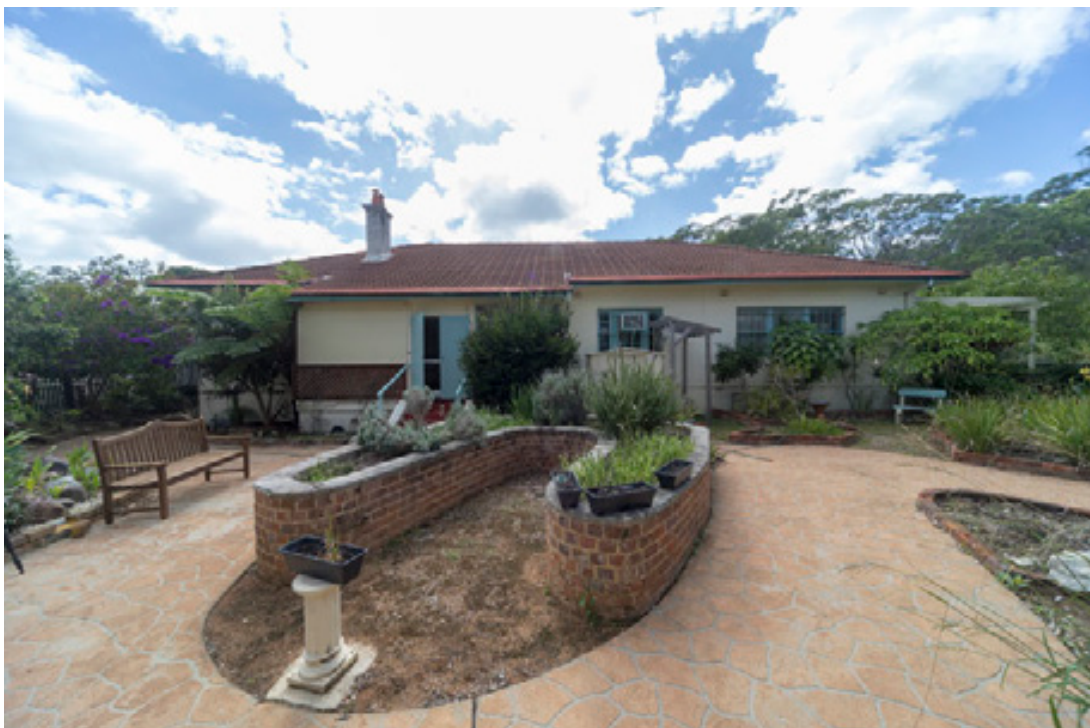
Figure 81: The south elevation of Parkhill cottage. Note concrete roof tiling however the chimney remains.

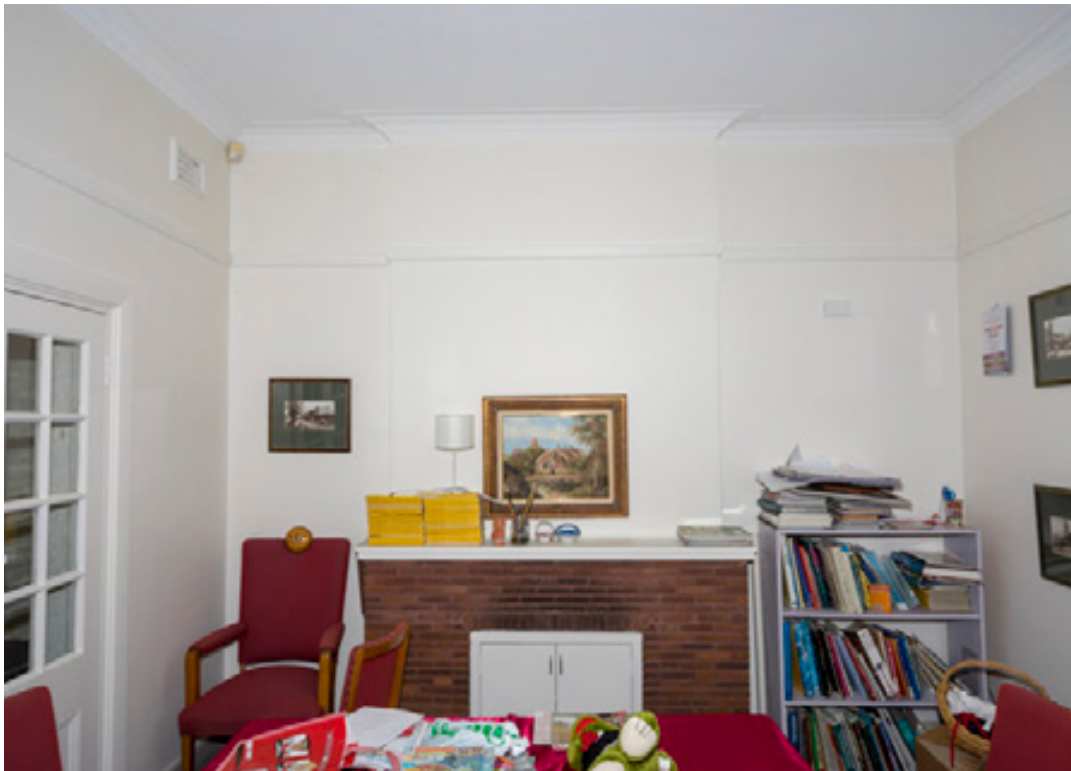
Figure 84: Picture rail, cornices and chimney breast to Parkhill cottage interior

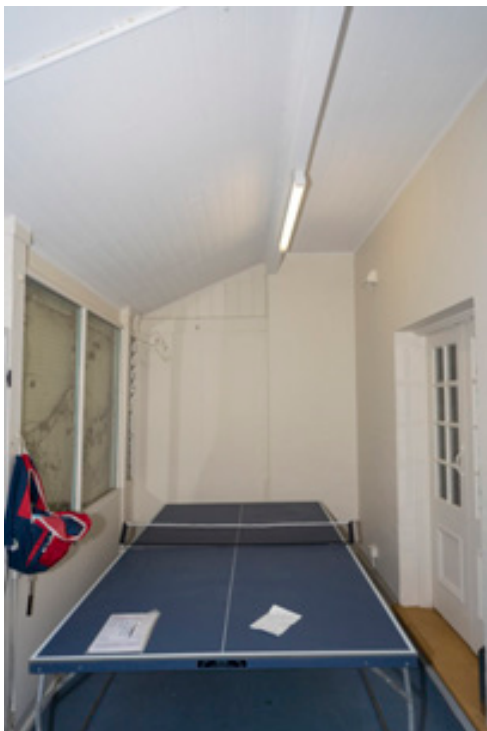
Figure 85: (Left) enclosed south verandah to Parkhill cottage with timber tongue and grooved board ceiling

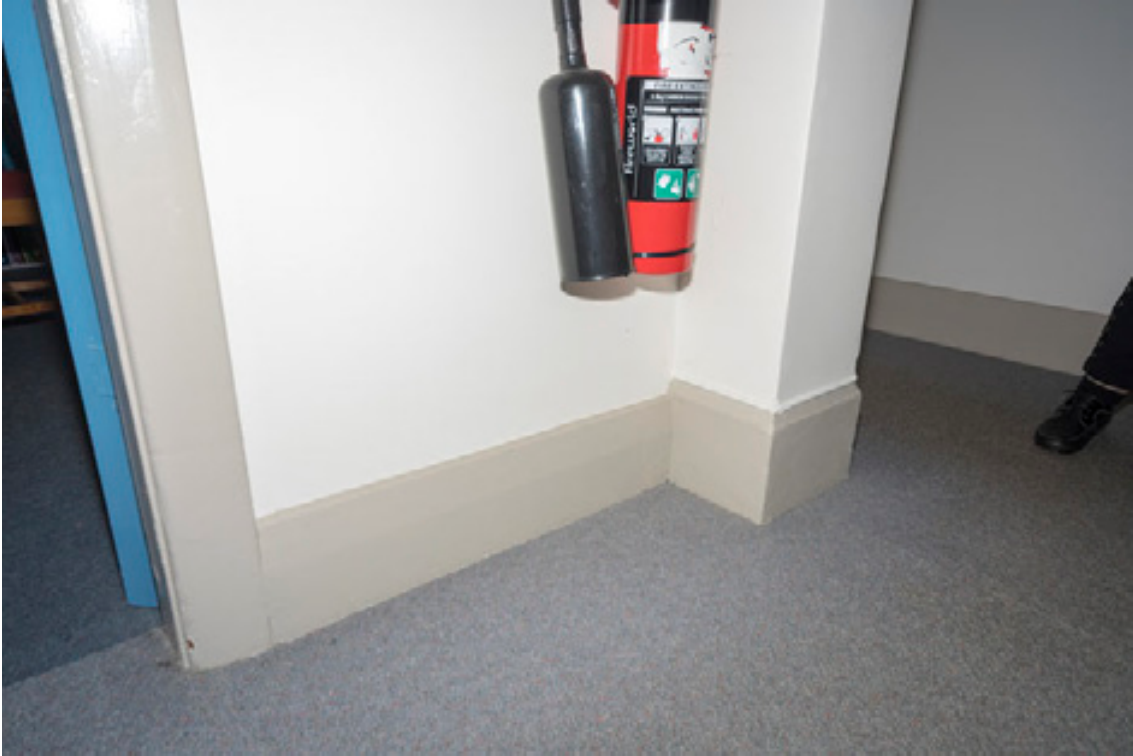
Figure 86: Original architraves and skirting boards to interior of Parkhill cottage

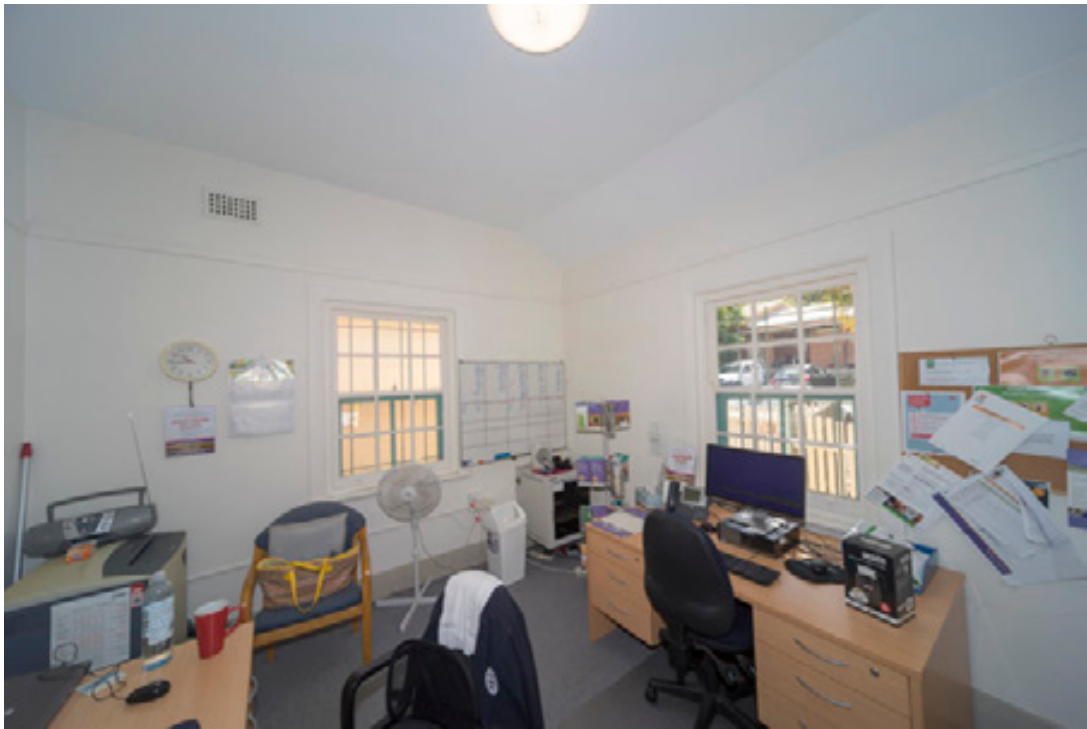
Figure 88: Interior view of office to south-western corner of Parkhill cottage showing original windows, picture rails, skirting boards

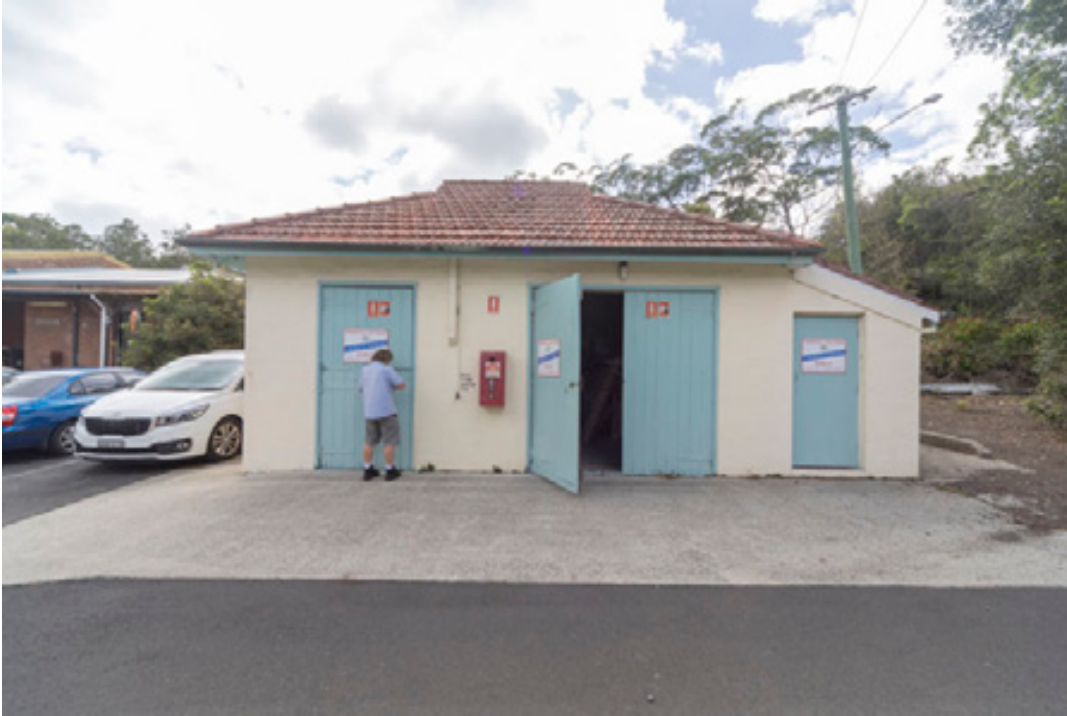
The stables are in a very intact condition, with the exception of a lean-to addition to the eastern end, and the building largely retains its original form including timber ledged and braced doors, rendered brick walls, hipped terracotta tiled roof form with gabled timber louvered vents at the peak of the roof, and internally timber tongue and grooved ceilings remain.

Figure 90: South elevation of the stables to Parkhill cottage (Building 20). The skillion section to the right (east) is clearly a later addition to the stables.

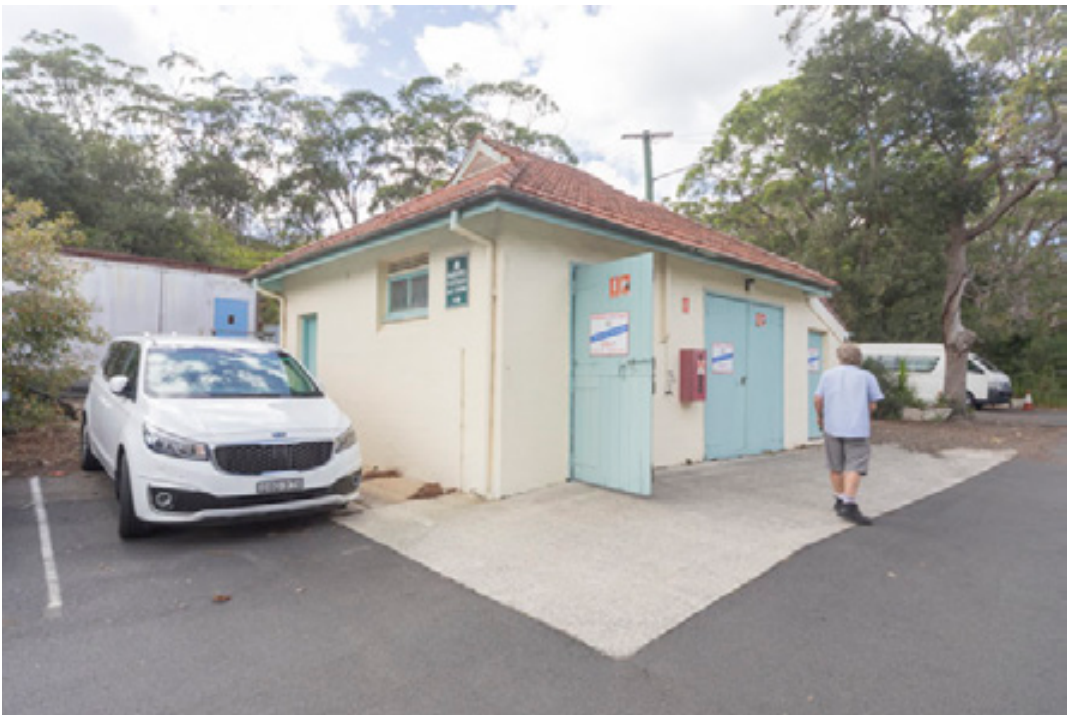
Figure 91: The stables to Parkhill cottage (Building 20), west and south elevations, showing original timber ledged and braced doors and original terracotta tiled roofing.

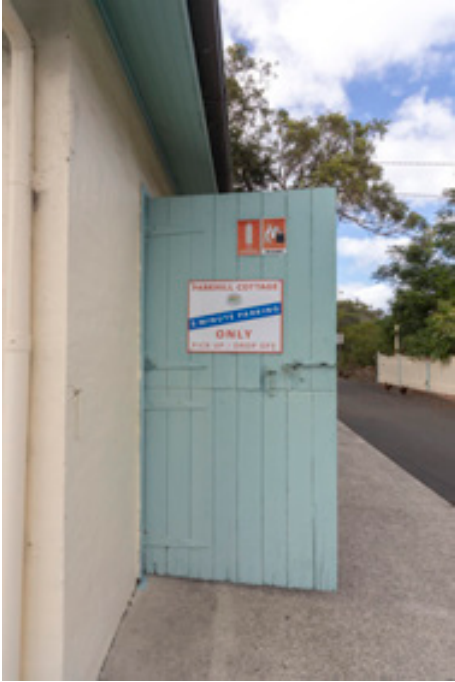
Figure 92: (Left) Detail of timber ledged and braced door to the Parkhill cottage stables, also showing the timber tongue and grooved boarded eaves to the stables.

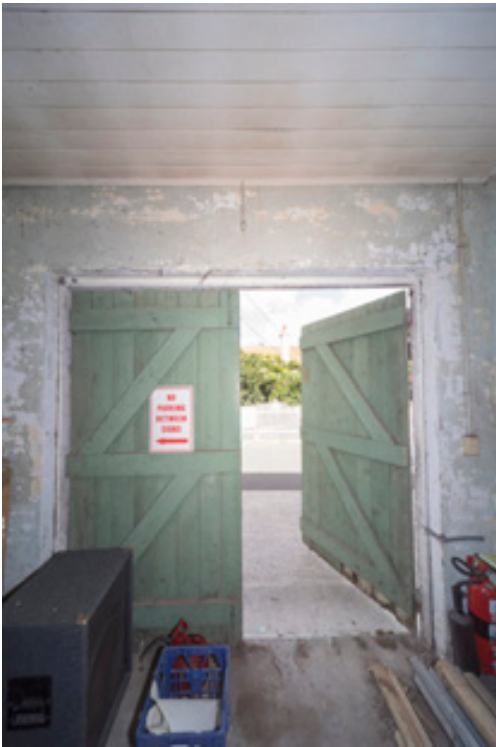
Figure 93: (Left) Detail of interior of timber ledged and braced double doors to the stables, also showing the timber tongue and grooved board ceiling to the stables.

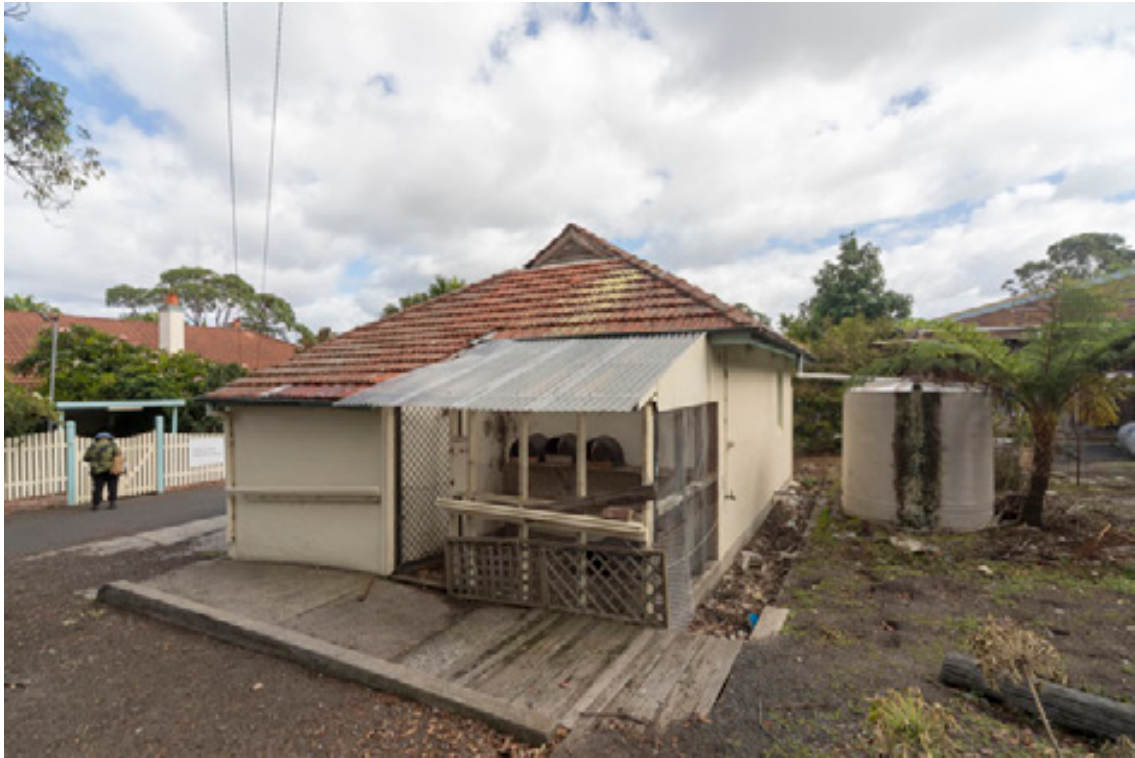
Figure 94: East and north elevations of the stables with water tank to the north of the stables.

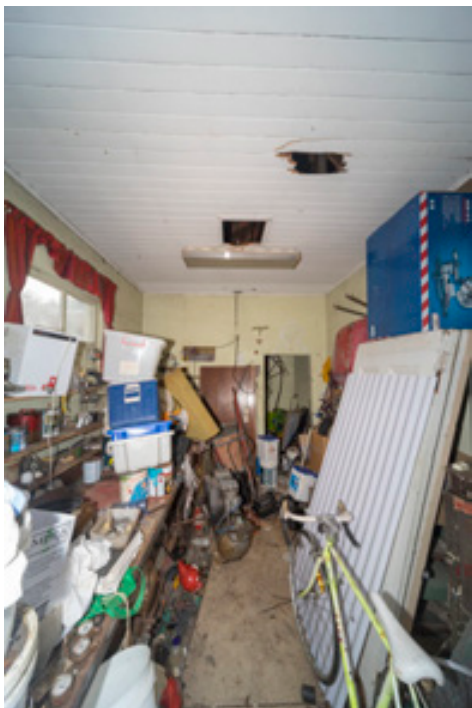
Figure 95: (Left) Original timber ceiling to interior of the stables.

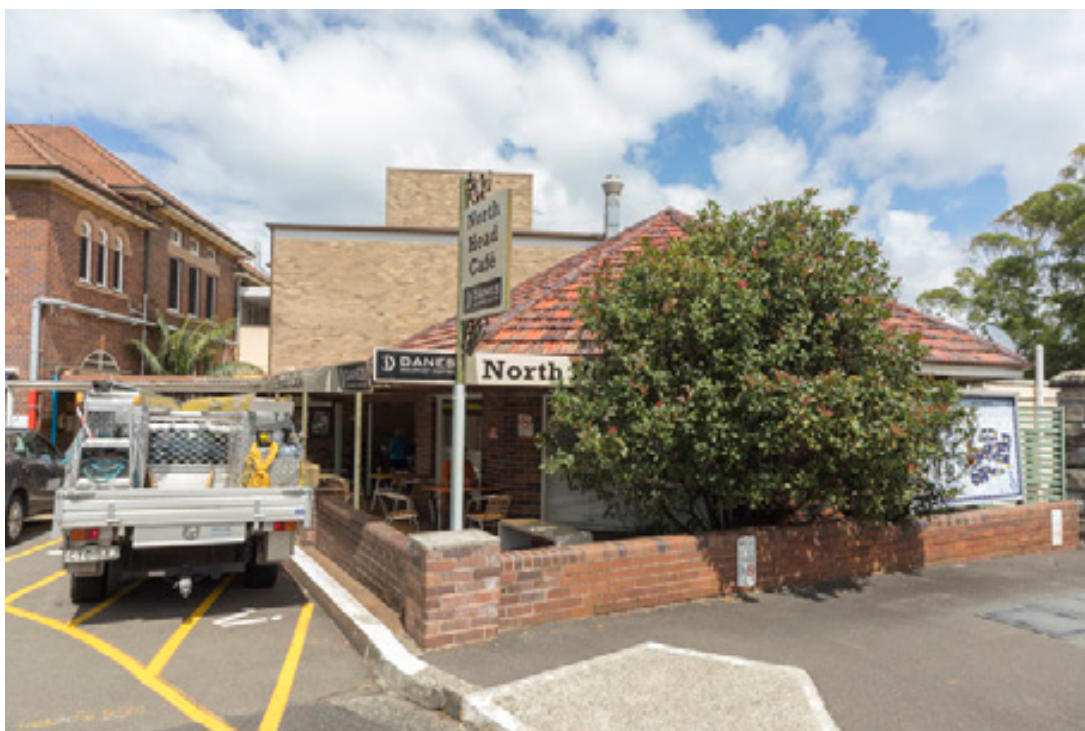
The Kiosk, a single storey brick polygonal building with a hipped terracotta tiled roof, was built in 1931. Though extended to the west and south to join onto adjacent buildings, the building retains its original polygonal form and roof form, some of its external brick walls and one original timber-framed double-hung Inter-war Georgian Revival style window with 6-paned sashes. Large external doors have been added as well as openings into the later extensions to the building. The interior has been completely modernised.

Figure 96: The Kiosk, Building 5 from the north.

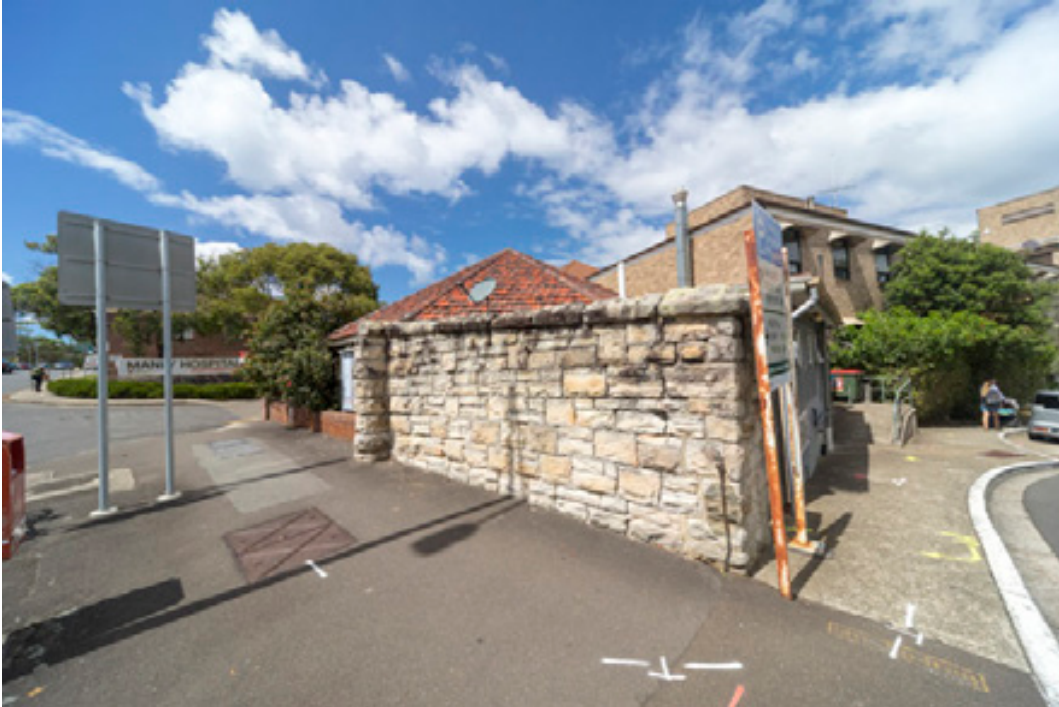
Figure 97: The Kiosk from the north-west. Note the andstone wall shown here is of recent construction (possibly using stone from the demolished section of the eastern boundary wall of the core hospital site). Building 3 is visible beyond at right.

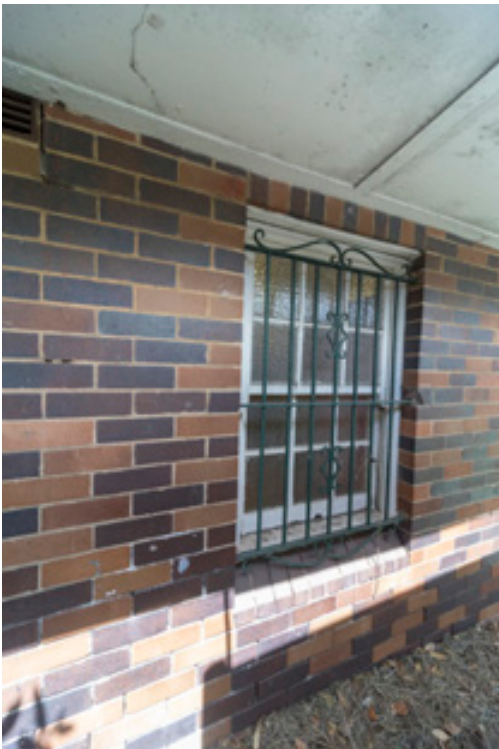
Figure 98: (Left) The only original window of the Kiosk, on the northern elevation.
