Manly Hospital
150 Darley Road, Manly
Stage 1: Heritage Assessment
Report

April 2018

prepared by Paul Davies Pty Ltd
for NSW Health Infrastructure

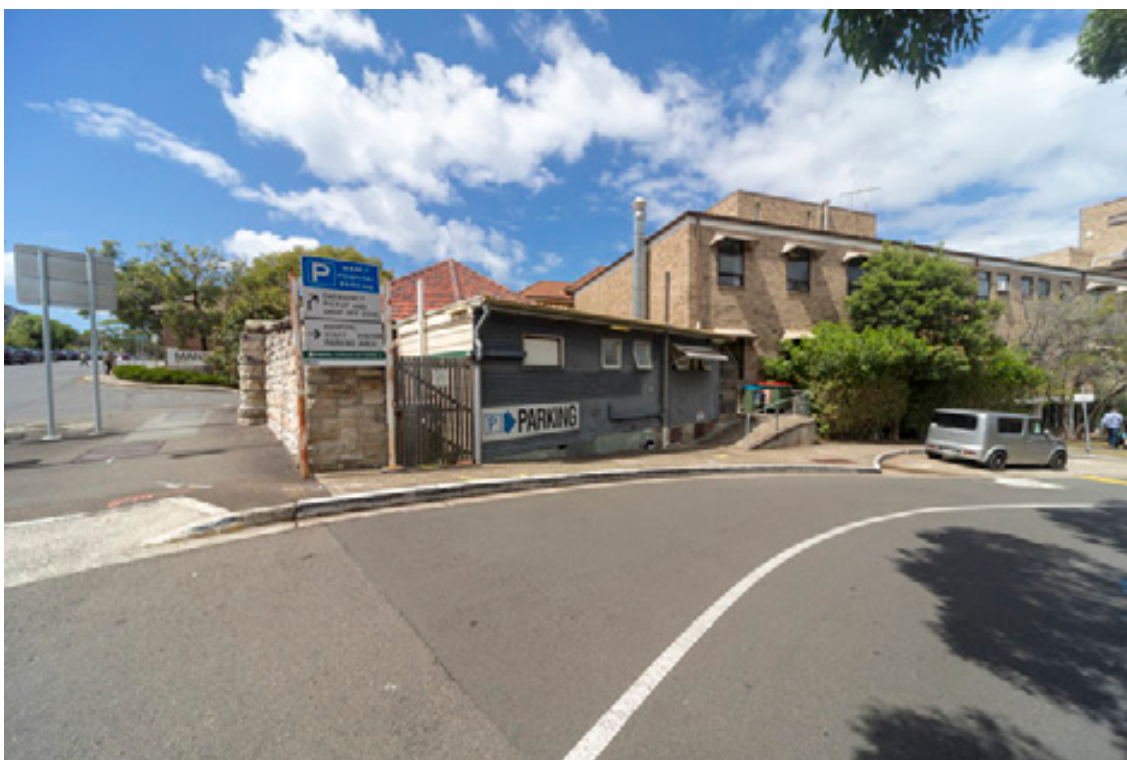
Figure 99: The Kiosk from the west (roof arrowed), with later additions, and Building 3 at right. Note the sandstone wall to the north of the Kiosk appears to be of recent construction.

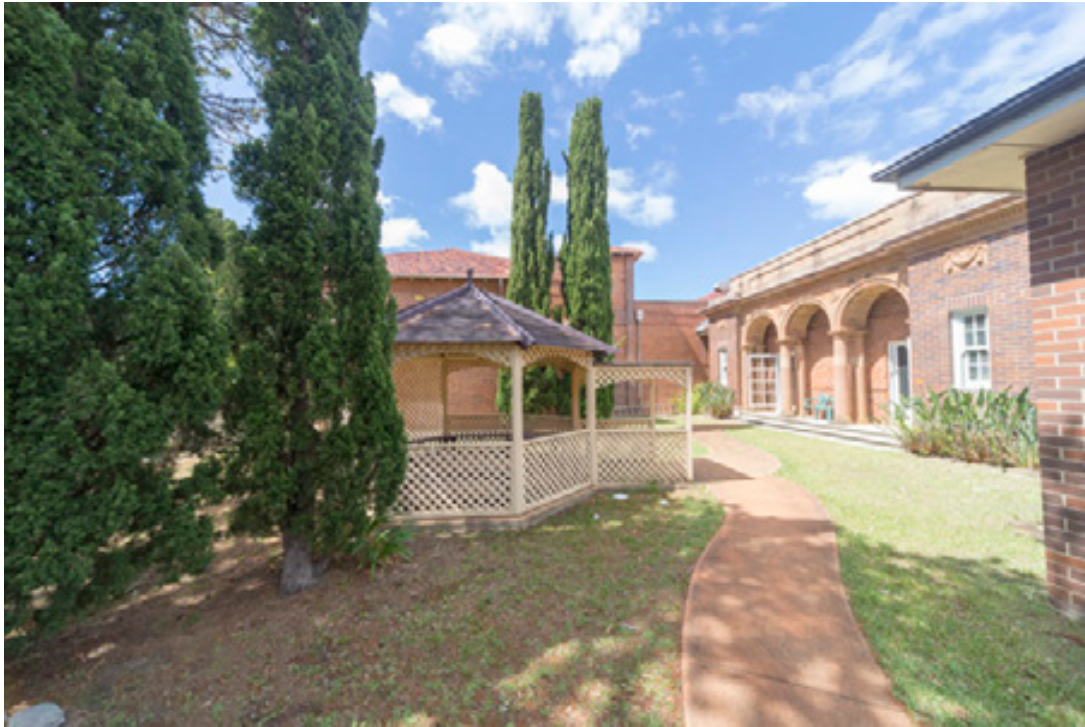
Figure 100: View towards the remnant façade of the 1928 Building 1 (right) with the west elevation of Building 30 beyond and a recent summer house (centre)

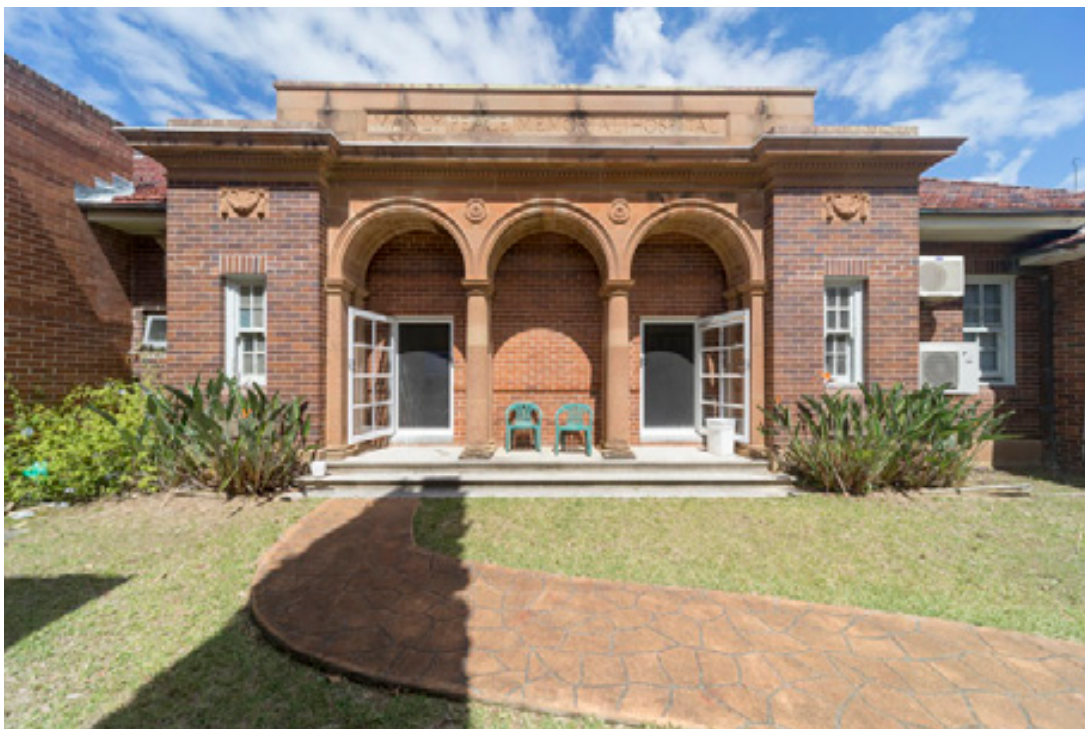
Figure 101: The remnant façade of Building 1. This is virtually all that remains of the north elevation of the original 1928 Building 1. The wall behind the sandstone arches was constructed in 1992.

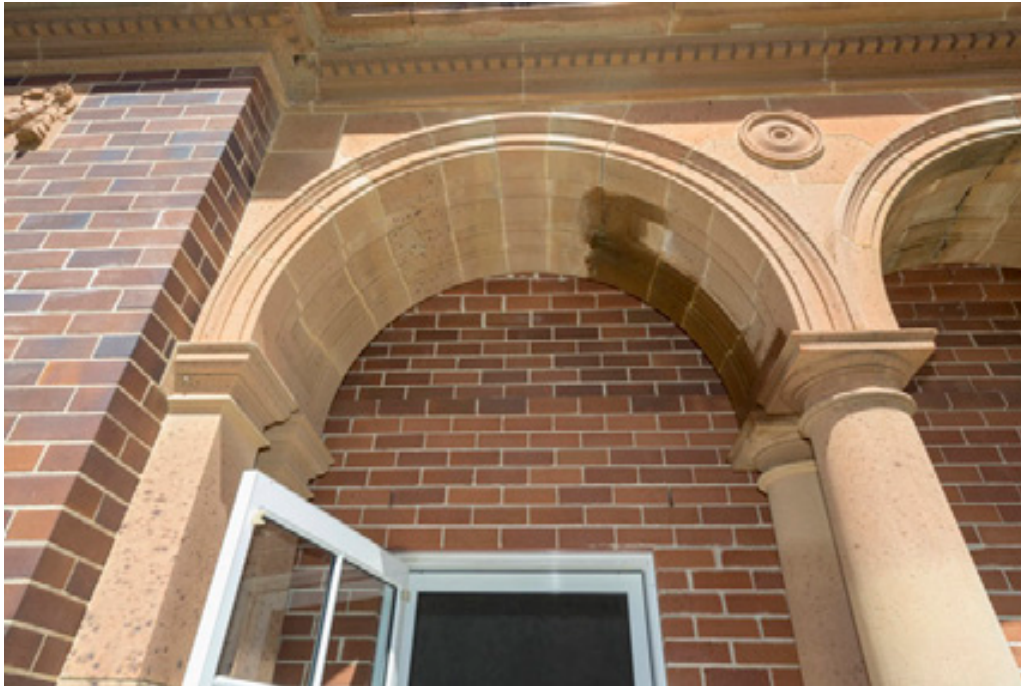
The only part of the original building that remains and which has significance is the small section of facade. This is the most architecturally distinguished built element of the site and even though in remnant form is a fine example of institutional design of the time. It appears to be in overall sound condition.

Figure 102: Detail of sandstone arches to the remnant façade of Building 1. Note the wall visible beyond is part of 1992 alterations and additions which included construction of Building 30 to the east.

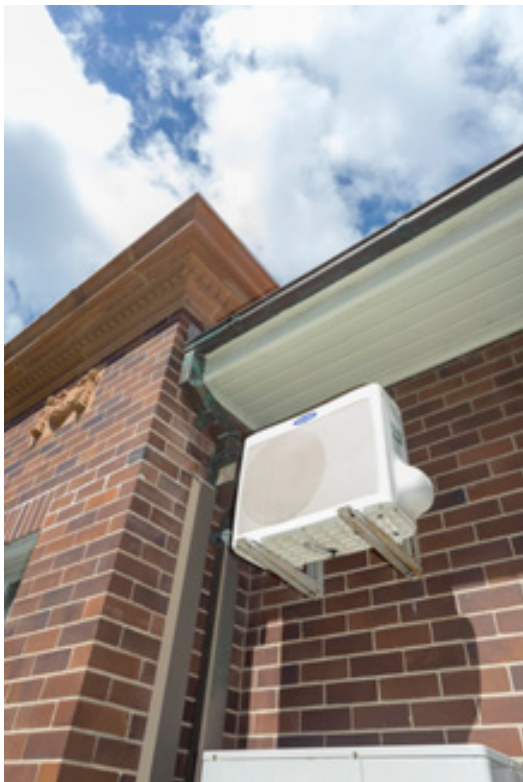
Figure 103 : (Left) Detail of the remnant façade parapet and timber tongue and groove boarded eaves

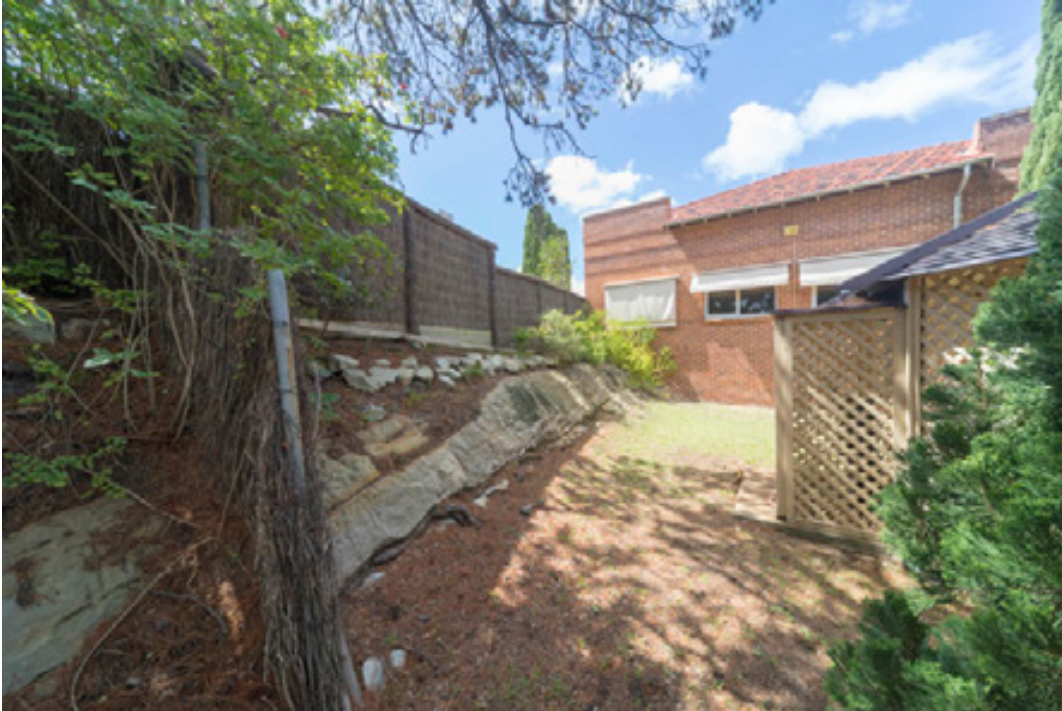
Figure 112: View of western end of Building 30 constructed 1992, with the tall brush fence along the Darley Road frontage.

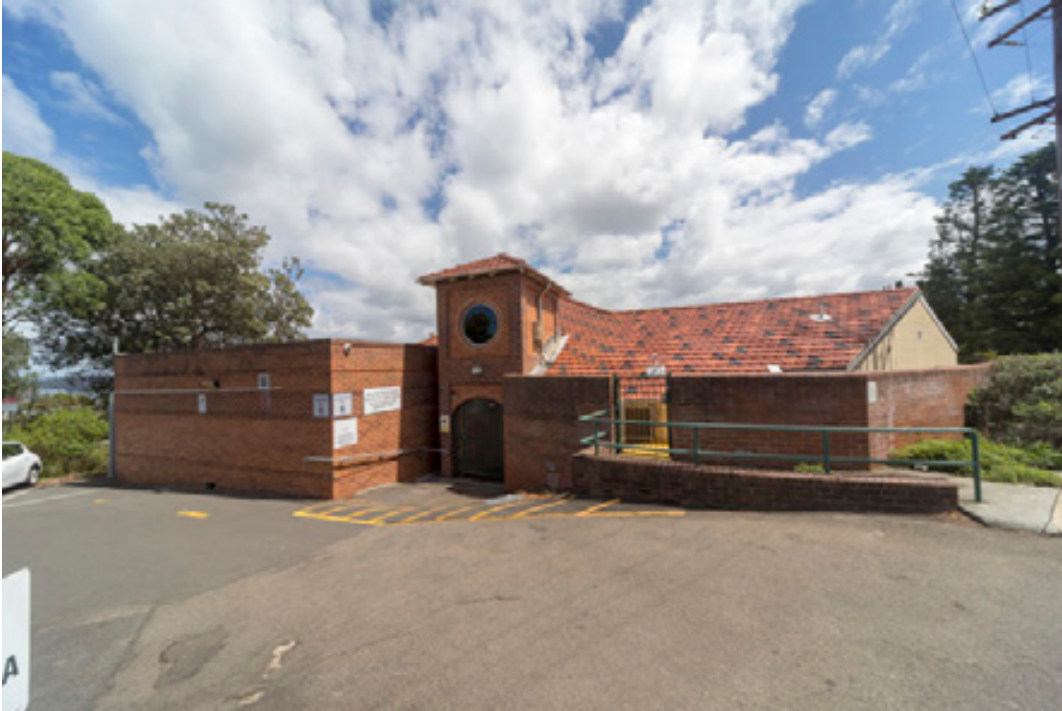
Figure 114; The eastern end of the north (Darley Road) elevation of Building 30, constructed in 1992.

Apart from the western boundary wall and the remains of the eastern boundary wall of the core hospital site, fencing around the site is not significant, consisting of 1990s tall brush fencing along Darley Road in front of Building 30, and some cyclone wire fencing including to Car parking area P6. It is noted that Darley Road has been widened in front of the hospital at the eastern end, with the loss of some of the northern end of the eastern boundary wall of the core hospital site. The Darley Road boundary of the site was open in 1943 with some formal entrance planting beds in front of Building 1 original entry (evidenced by the 1943 aerial photo) with little vegetation, however is currently obscured by vegetation and at its eastern end by 1990s tall brush fencing.

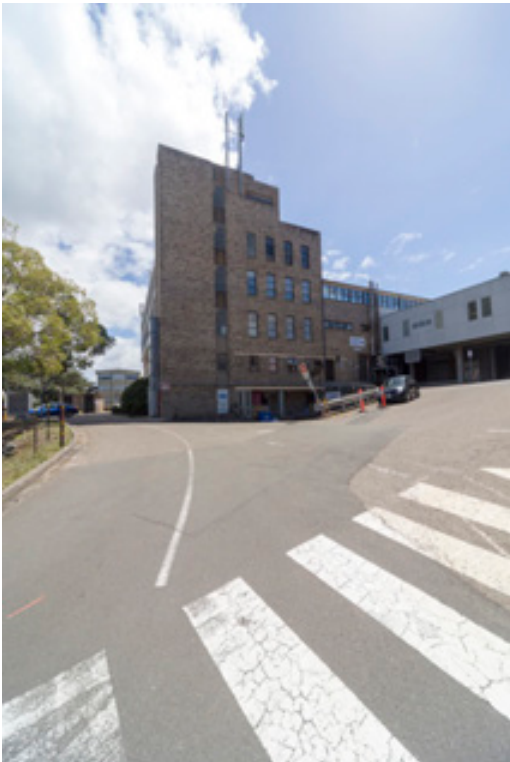
Figure 115: (Left) The south elevation of Building 3 constructed in 1965,

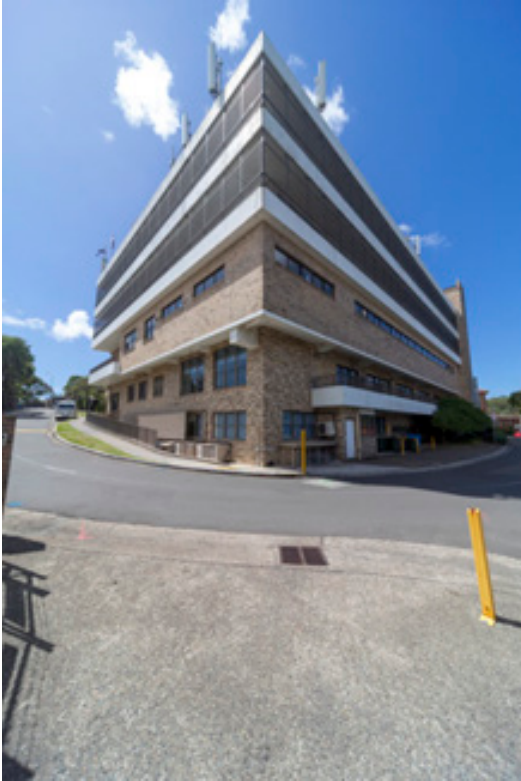
Figure 116: (Left) Building 4, constructed in 1975

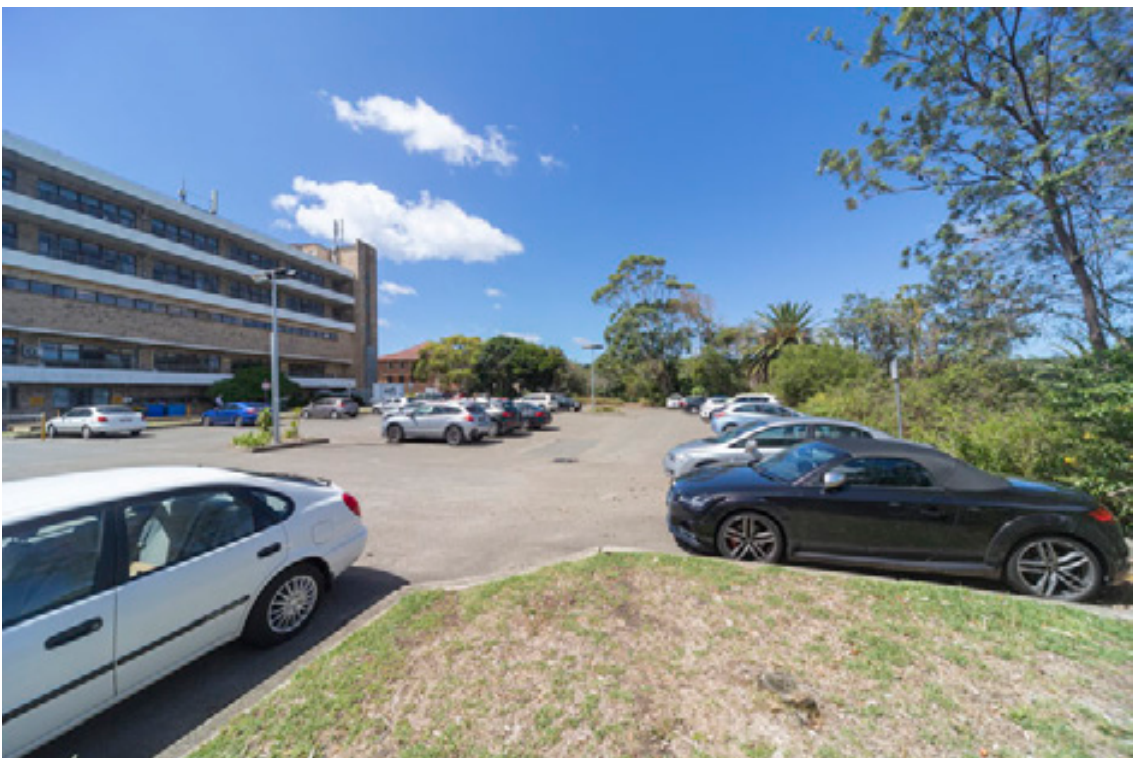
Figure 117: View across the southern end of the site from the west looking east, with Building 4 to left and car parking area P1

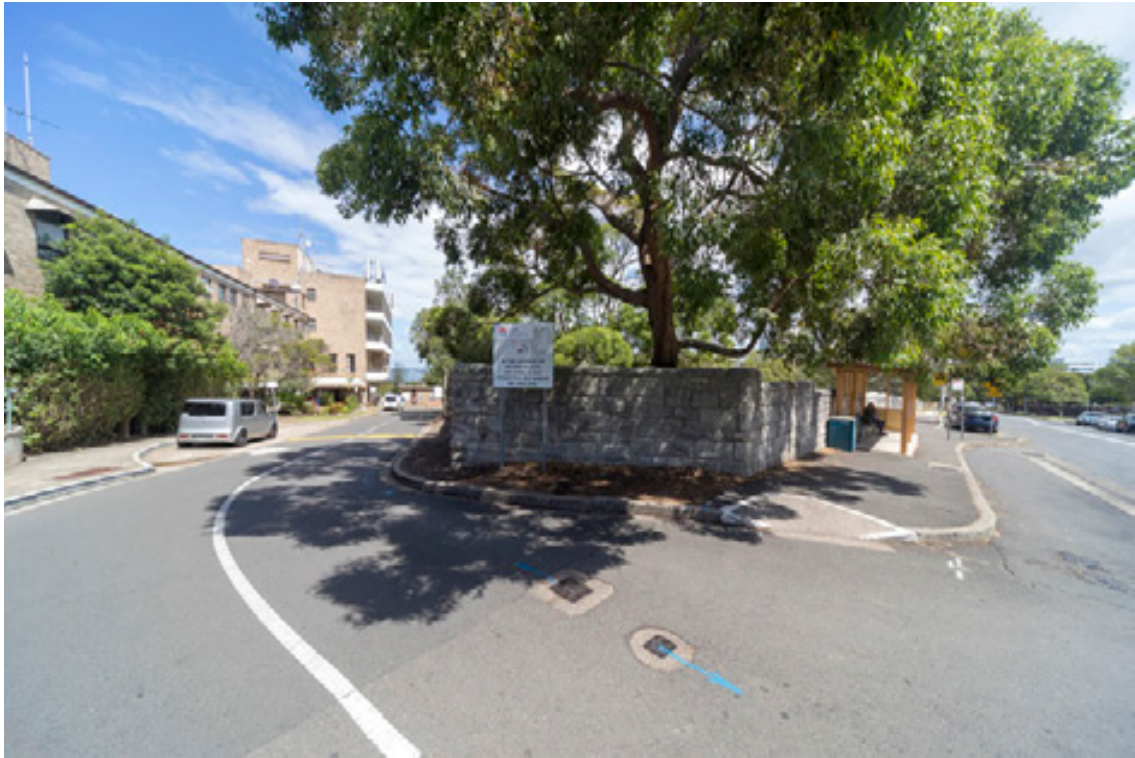
Figure 118: Buildings 3 and 4 (Left) and the road along the western boundary of the hospital. The sandstone wall (shared with adjacent Catholic school) at right is the eastern boundary wall of the core hospital site.

The east boundary wall is missing in sections, however attains its full height adjacent to carpark P6 near Darley Road and in sections east of Building 13, with a section between these two areas where the wall has been reduced in height to function as a retaining wall and is crossed by paths and steps.

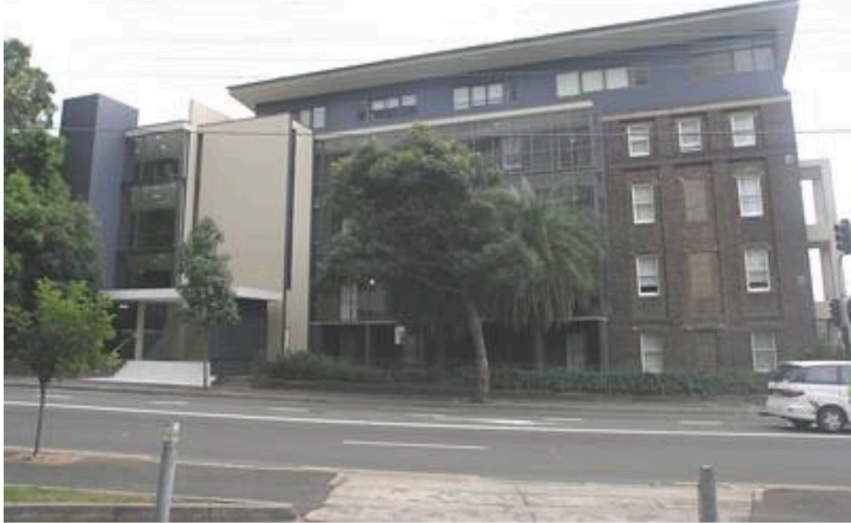
<p>Venables house following modern alterations and conversion to apartments</p>

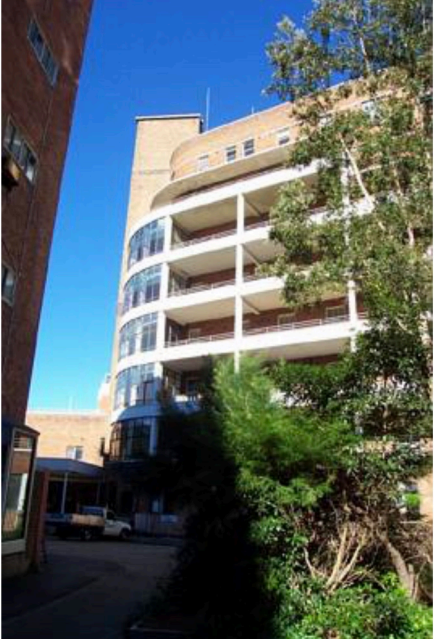
Item Name	Address	Suburb	LGA	Heritage Listing details	Comment
Former St Margaret's Hospital Building Including Interior	437-441 Bourke Street, Surry Hills,	Surry Hills	City of Sydney	Heritage listed in the Sydney LEP 2012	8 storey hospital building + basement designed in 1938 by G.A. Cobden Parkes. In late 20 th century converted to apartments with ground floor retailing.

(Left) Former St Margarets hospital building in Bourke Street, Surry Hills, designed in the Inter-war Functionalist style in 1938.

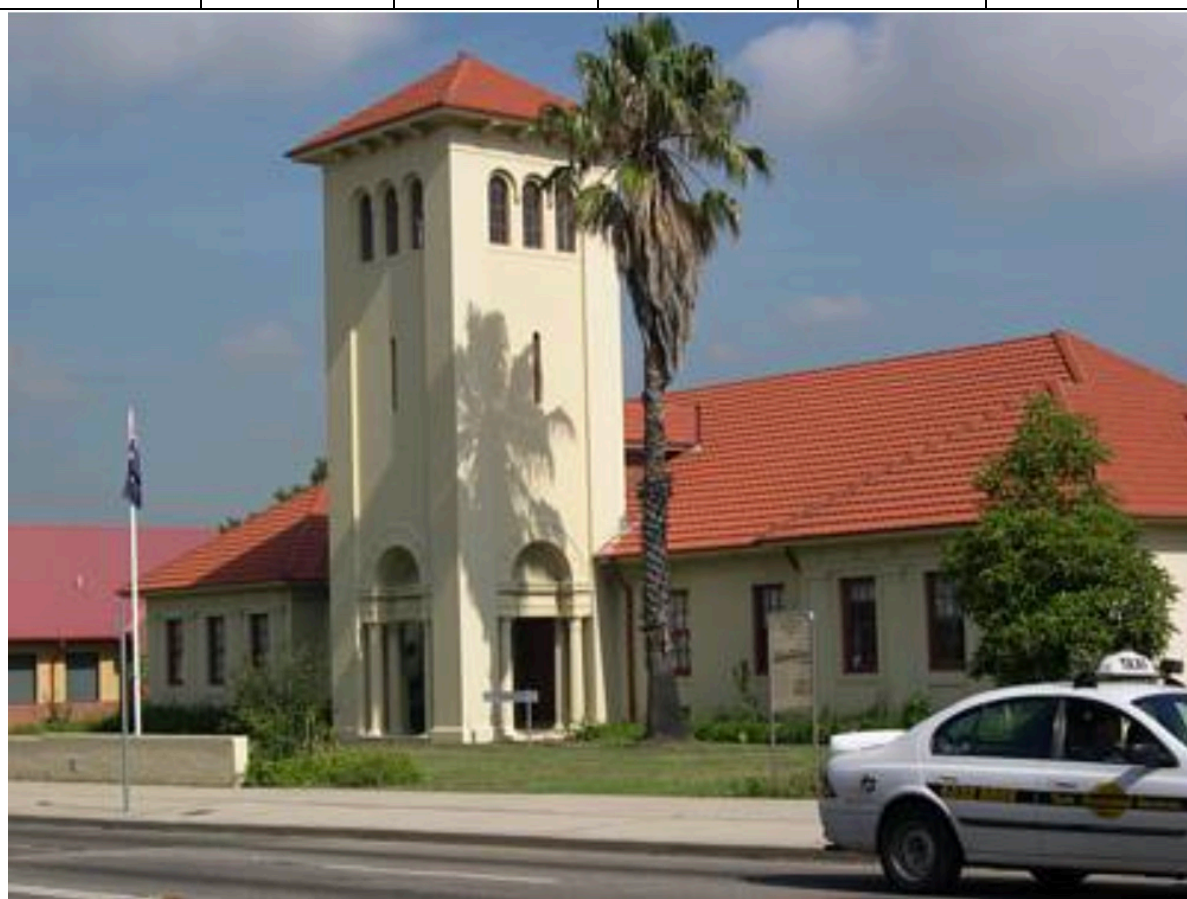
Item Name	Address	Suburb	LGA	Heritage Listing details	Comment
Canterbury Hospital	575 Canterbury Road	Campsie	Canterbury-Bankstown	Canterbury Hospital buildings facing Canterbury Rd listed in the Canterbury LEP as an item of local significance (Item No. 146)	Built 1928 in the Inter-war Spanish Mission style

1928 Canterbury Hospital building

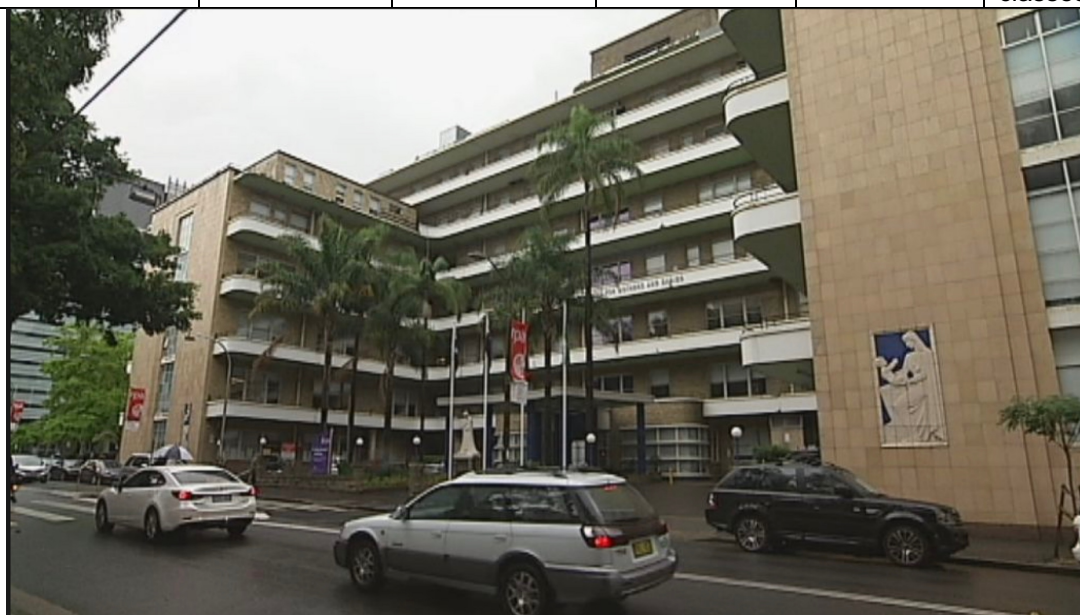
Item Name	Address	Suburb	LGA	Heritage Listing details	Comment
Gloucester House (part of RPA hospital complex)	10 Missenden Road	Camperdown	Sydney City	Listed on the Sydney LEP 2012 as part of the State significant Royal Prince Alfred Hospital Group (Item No. 168); also listed on the NSW Health S170 Register	Designed by architects Stephenson Meldrum & Turner, constructed 1936 (opened by the NSW Governor on 25 th August 1936) as the first purpose-designed private hospital ward building in Australia, designed to cater to the middle classes.

Gloucester House (now offices), part of the RPA complex. A superb Inter-war functionalist style building.
