57 Cutler Road Clontarf NSW 2093 Arboricultural Impact Assessment

Prepared for Crookwell Constructions

Project Name	57 Cutler Road Clontarf NSW 2093 Arboricultural Impact Assessment
Project Number	AIA23/10/2024
Prepared by	Alex de Jong – AQF Level 5 Arborist
Status	Final
Version	v2
Last saved on	7/11/2024

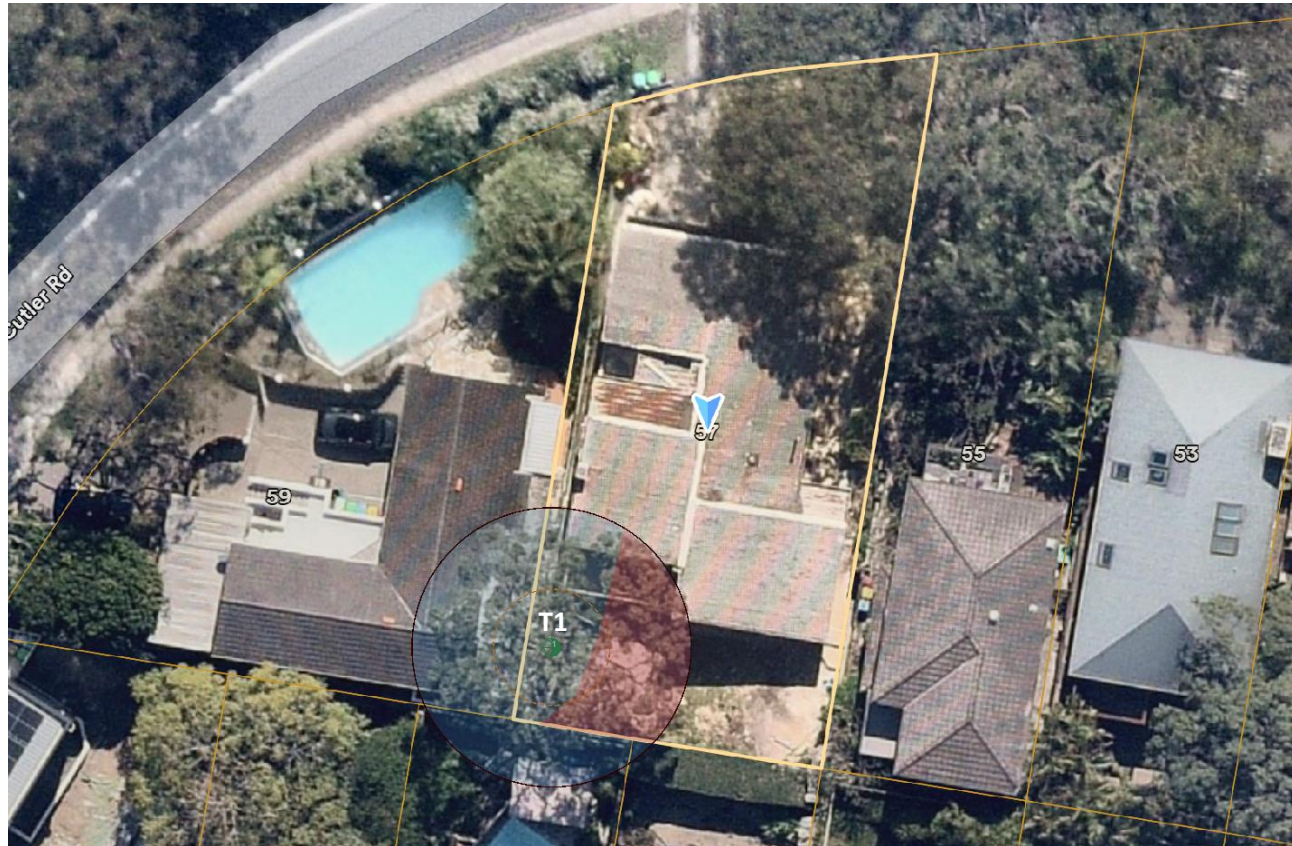
4. Arboricultural Impact Assessment

Tree #	Botanical Name (Common Name)	Height (m)	Canopy (m)	DBH (mm)	DAB (mm)	TPZ (m)	SRZ (m)	TPZ Encroachment	SULE	Retention Value	Action
1	<i>Angophora costata</i> (Sydney Red Gum)	13	9	602	800	7.20	3.01	27.5% - Major encroachment	2A	Moderate	Remove

Tree 1 has a major encroachment of 27.5% due to the development. Removal of this tree has been recommended to accommodate the project because of the significant encroachment into the Tree Protection Zone (TPZ) and associated root loss. The development includes the installation of a new sewer line connecting to the main sewer, which is necessary to address existing major sewer issues, as the gully is higher than the internal floor level. Excavation to a depth of 1.2m is required for the sewer works to locate and install the new sewer line. Hand digging was attempted to route the sewer line beneath the existing root system, but this was unsuccessful due to the substantial amount of rock that needed to be removed.

This rock cannot be removed without the use of an excavator which would impact the root system of Tree 1. Every attempt has been made to avoid the impact to the tree but it is unachievable. As such removal of Tree 1 is required to install the new sewer line connecting to the main sewer.
