J3802. 20<sup>th</sup> October, 2021. Page 1.

# **GEOTECHNICAL INVESTIGATION:**

New Granny Flat at **30 Irrubel Road, Newport**

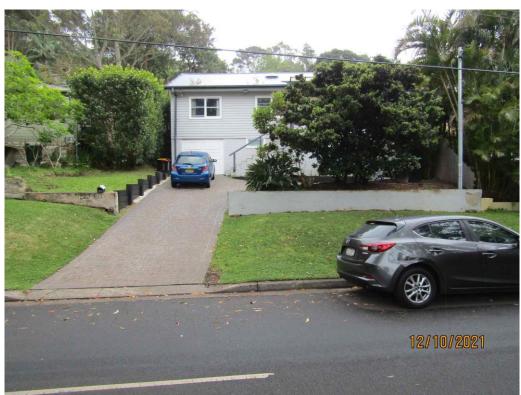
Photo 1

**2.3** At the road frontage, a concrete driveway runs up the slope to a garage attached to the house (Photo 1). Low rendered brick and timber retaining walls support filled garden and lawn areas beside the driveway. The single storey brick and timber clad house with garage below is supported by brick walls, brick piers and steel posts (Photos 1 & 2). The supporting walls, piers and posts stand vertical and show no significant signs of movement (Photo 3). Low timber retaining walls support the cut for the garage and a cut and fill on the uphill side of the house. A moderately sloping lawn extends off the uphill side of the house (Photos 2 & 4). A steel shed in good condition is located on the lawn. No signs of slope instability were observed on the

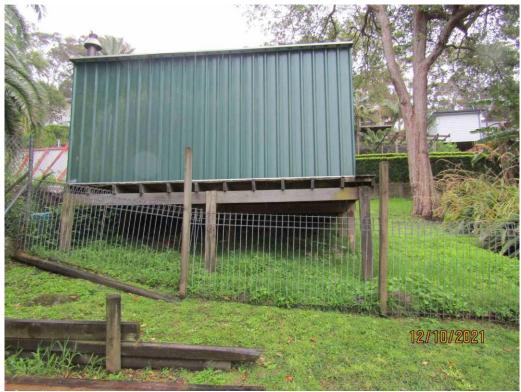
Photo 5

- Flush with the W common boundary and W common boundary steel fence.
- Flush with the steel fence on the subject property, near the N common boundary.
- ~0.4m from the N common boundary and ~0.9m from the N neighbouring shed (Photo 5).

The N neighbouring shed will be outside the zone of influence of the excavation, provided the foundations supporting the shed posts are at least 0.4m below the current surface. The W and N common boundaries and steel fences will be within the zone of the excavation. In this instance, the zone of influence is the area above a theoretical 30° line through soil and a theoretical 45° line through clay from the base of the excavation towards the surrounding structures and boundaries.

If the W and N boundary steel fences are to remain, they are to be braced prior the excavation commencing.

The W and N cuts are to be permanently or temporarily supported. The shoring support is to be installed systematically as the excavation is progressed to ensure the integrity of the neighbouring properties. If the support is temporary, such as braced form ply or similar, it is to remain in place until the retaining wall is built as a sacrificial-type system. See the Site Plan attached for the minimum extent of the required shoring shown in blue.

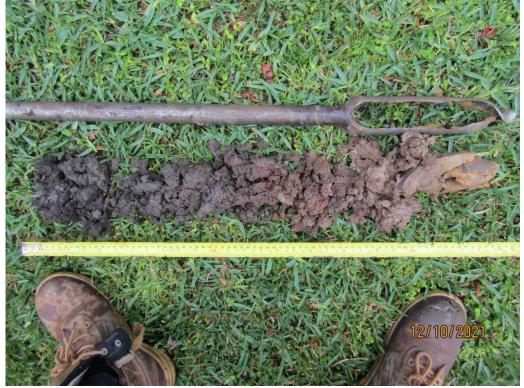
Photo 6: AH1 – Downhole is from left to right.

# AUGER HOLE 1 (~RL38.6) - AH1 (Photo 6)

Depth (m)	Material Encountered
0.0 to 0.3	<b>TOPSOIL</b> , sandy soil, dark brown, damp, fine to medium grained with fine trace organic matter.
0.3 to 0.6 0.6 to 0.7	<b>CLAYEY SOIL</b> , brown and orange, damp. <b>CLAY</b> , light orange brown, firm to stiff, damp.

End of hole @ 0.7m in firm to stiff clay. No watertable encountered.

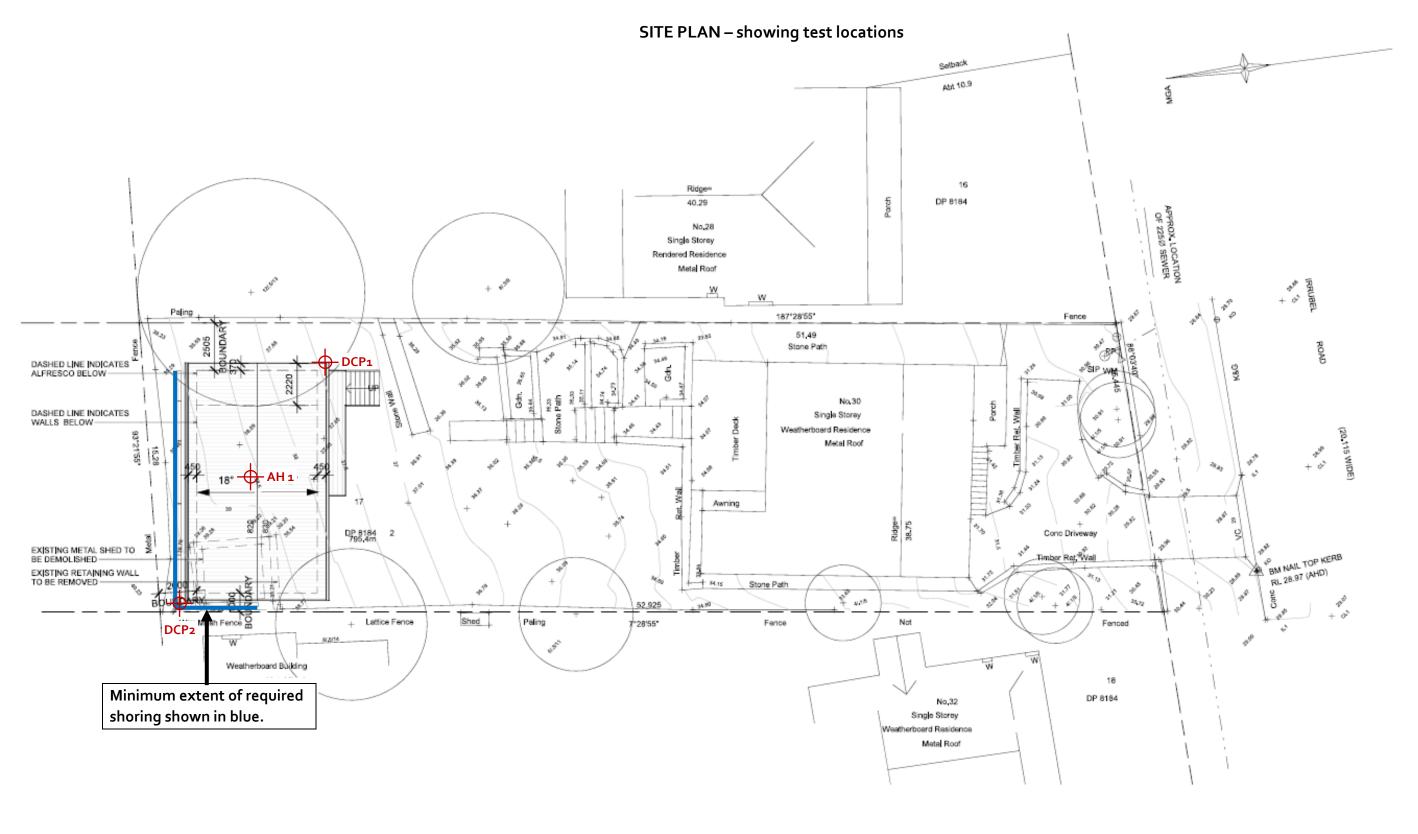
# SITE AND ROOF PLAN

One hand auger hole (AH) was put down to identify the soil materials. Two Dynamic Cone Penetrometer (DCP) tests were put down to determine the relative density of the overlying soil and the depth to weathered rock. The locations of the tests are shown on the site plan. It should be noted that a level of caution should be applied when interpreting DCP test results. The test will not pass through hard buried objects so in some instances it can be difficult to determine whether refusal has occurred on an obstruction in the profile or on the natural rock surface. This is not expected to have been an issue for this site. But due to the possibility that the actual ground conditions vary from our interpretation there should be allowances in the excavation and foundation budget to account for this. We refer to the appended "Important Information about Your Report" to further clarify. The results are as follows:

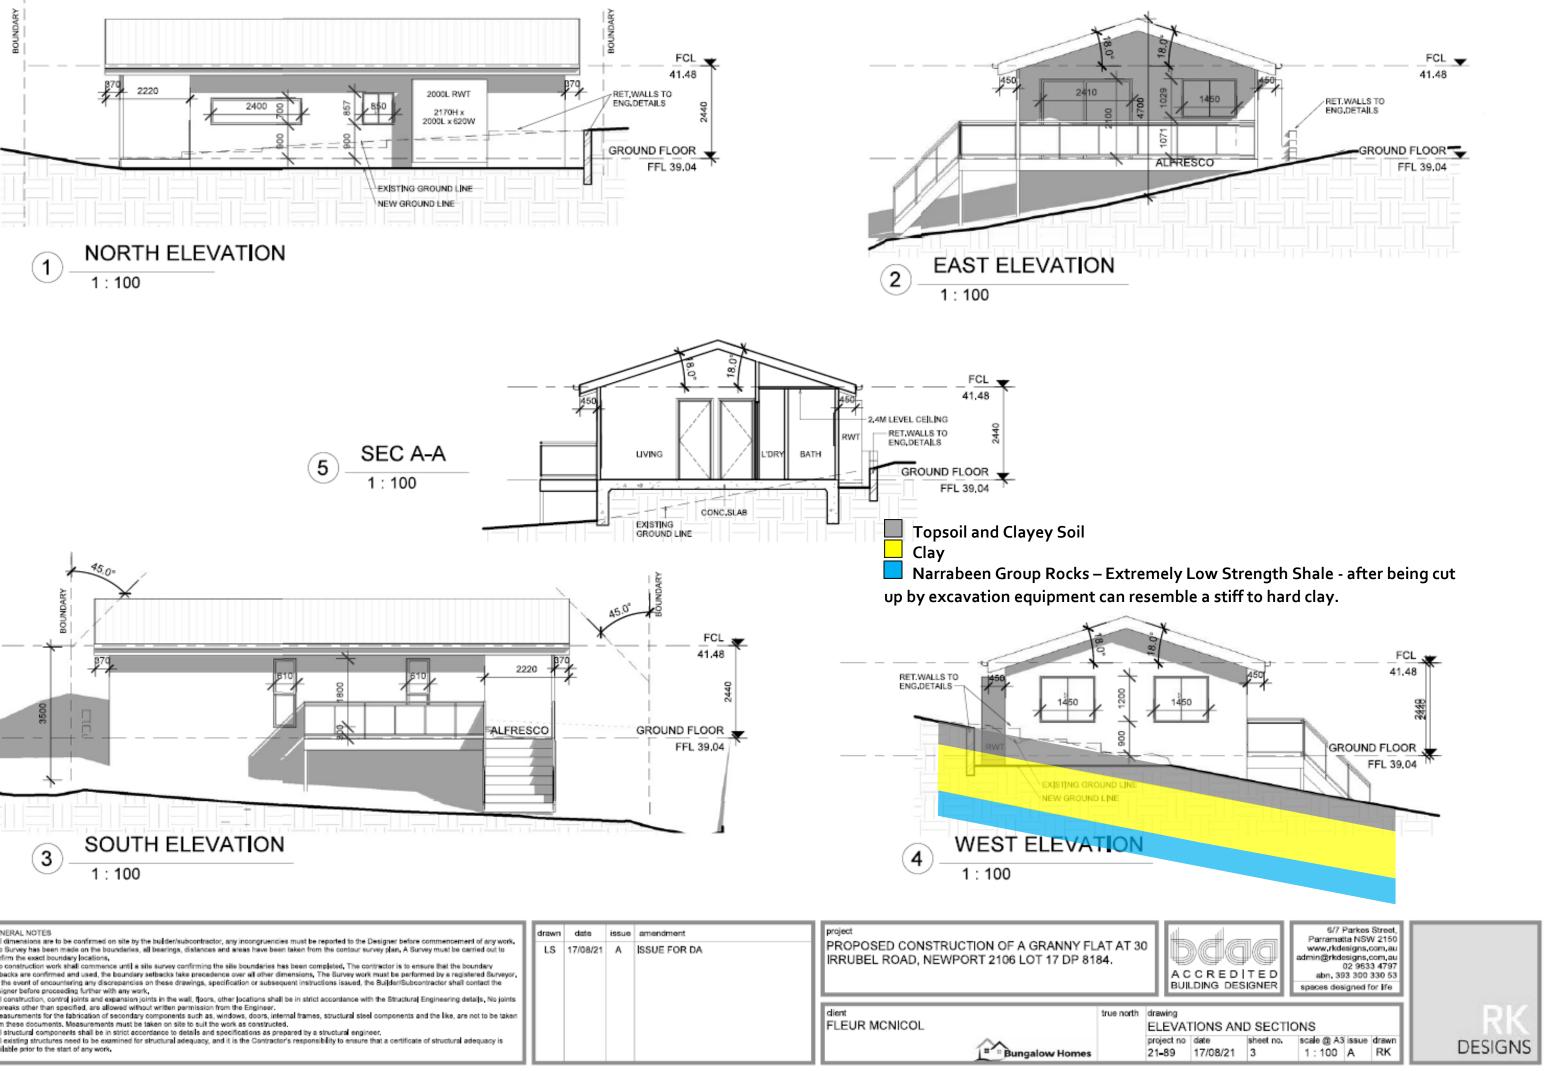
# **TYPE SECTION – Diagrammatical Interpretation of expected Ground Materials**

The natural slope materials are colluvial at the near surface and residual at depth. In the test locations, the ground materials consist of a sandy topsoil and clayey soil over firm to stiff clays. In the test locations, the clays merge into the underlying weathered rock at depths from between ~1.5m to ~2.1m below the current surface. The weathered zone of the underlying rock is interpreted as Extremely Low Strength Shale. It is to be noted that this material is a soft rock and can appear as a mottled stiff clay when it is cut up by excavation equipment. See Type Section attached for a diagrammatical representation of the expected ground materials.
