Acid Sulfate Soil Management Plan

Proposed School Upgrades
Narrabeen Education Precinct
Namona Street, Narrabeen

Prepared for
NSW Department of Education

Project 86973.04
August 2022

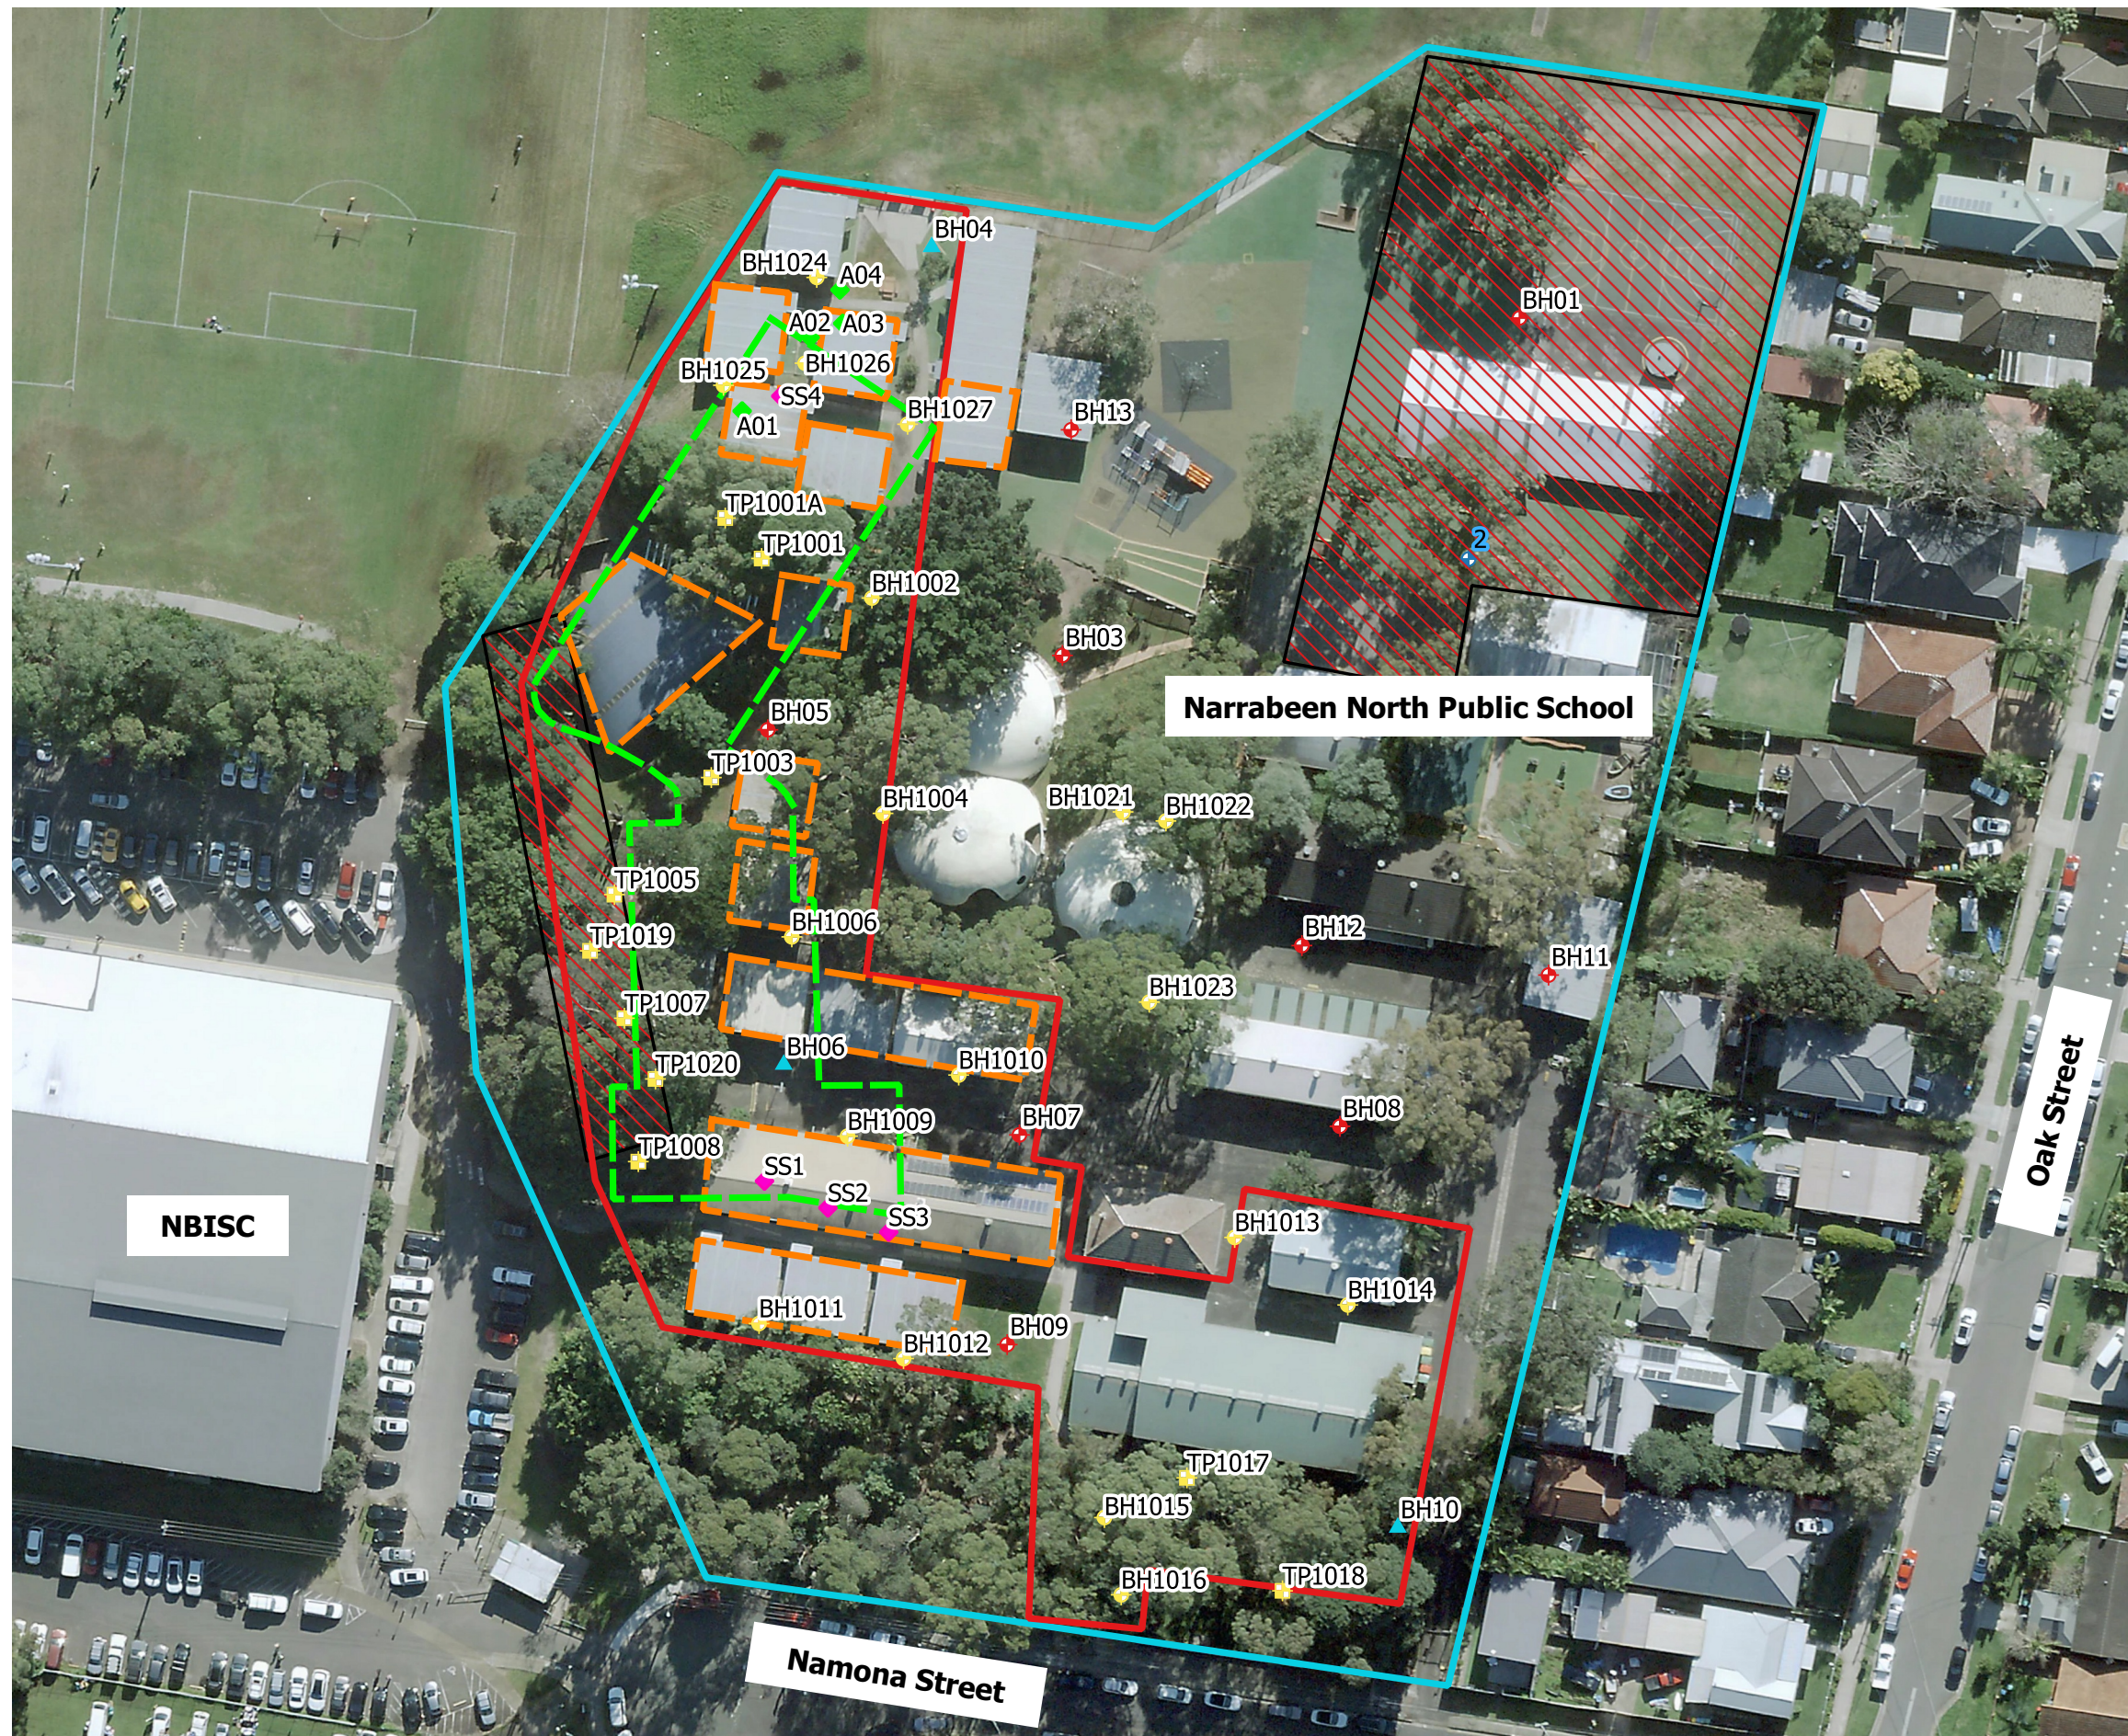
- Notes:
1. Basemap from metromap.com
 2. Locality map from OSM Standard
 3. Test locations and boundaries shown are approximate only
 4. NNPS AMP Asbestos Zones were sourced from Figure 1 of the AMP and are approximate only
 5. CPTs were also undertaken at some borehole locations
 6. ASS samples taken from BH04, BH09, TP1001A, BH1004, TP1005, TP1008, BH1009 and TP1018
