## **Arboricultural Impact Assessment**

Proposed Alterations & Additions at  
167 Plateau Road, Bilgola Plateau

**Date:** January 2019

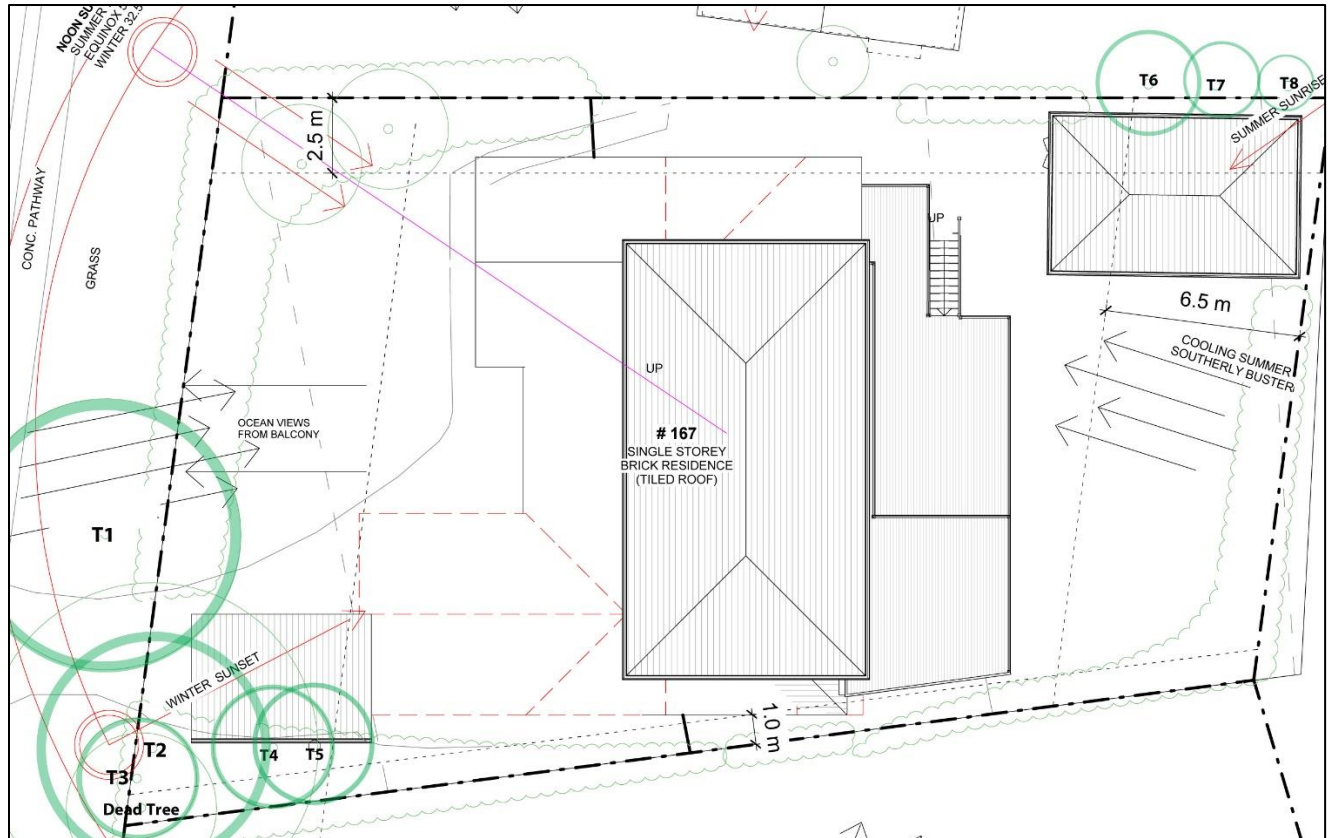
**Figure A:** Excerpt from the Site Analysis plan showing tree locations and numbering.

Eight (8) trees have been assessed due to their proximity to the proposed works. Refer to Figure A (following page) for tree locations. These are made up of the following species:

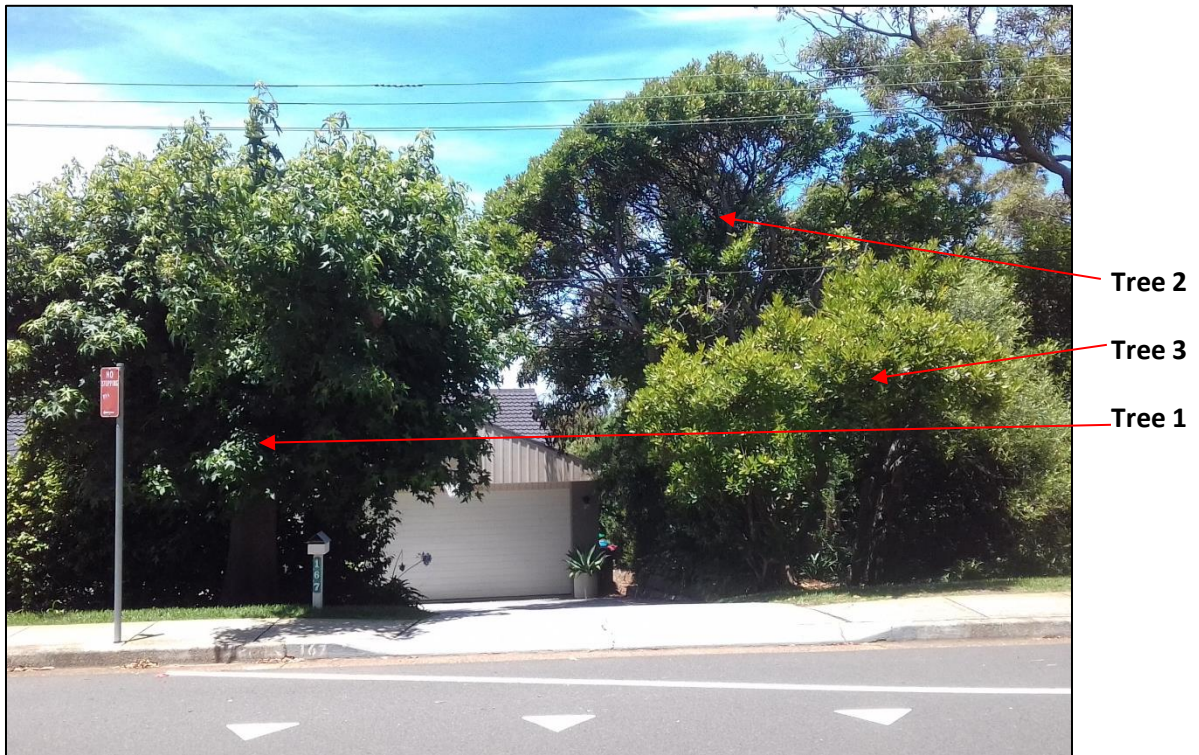
**Photo A:** Trees 1, 2 and 3 taken facing south.

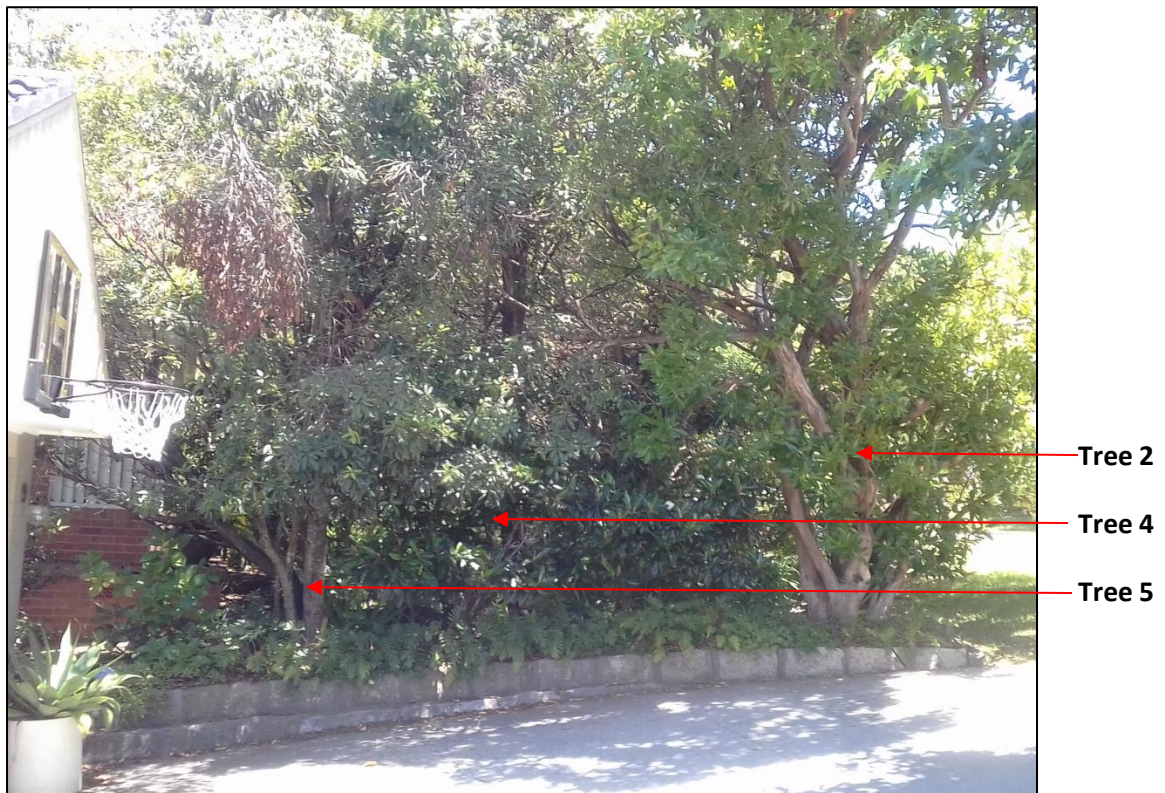
<b>Comments:</b> Thinning of the central and upper canopy.									
5	Sweet Pittosporum <i>Pittosporum undulatum</i>	200mm, 80mm	9m	2m	Mature	Fair	Fair	Short (0-10 yrs)	3	Low
	<b>Comments:</b> Thinning of the central and upper canopy. Loose broken branch suspended in the canopy overhanging the driveway.									
6	Bay Laurel, <i>Laurus nobilis</i>	300mm, 300mm, 300mm	13m	3m	Mature	Good	Good	Long (30+ yrs)	3	Medium
	<b>Comments:</b> Located on the neighbouring property.									
7	Bangalow Palm, <i>Archontophoenix cunninghamiana</i> (Group of 3)	200mm	11m	3m	Mature	Good	Good	Long (30+ yrs)	3	Medium
	<b>Comments:</b> Located on the neighbouring property.									
8	Weeping Bottlebrush, <i>Callistemon viminalis</i>	150mm	7m	2m	Mature	Fair	Fair	Medium (10-30 yrs)	4	Low
	<b>Comments:</b> Located on the neighbouring property.

**Photo B:** Trees 2, 4 and 5.

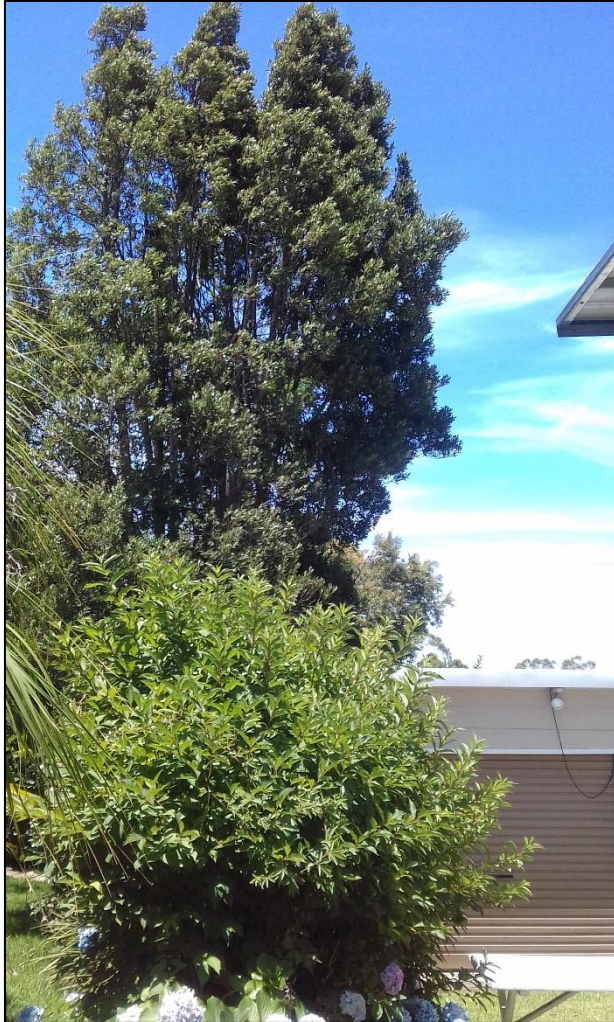
**Photo C:** Tree 6 taken facing south.

**Canopy Pruning:** The canopy of Tree 6 overhangs the roof of the existing studio building. Canopy pruning will be required to allow for construction and clearance of the new extended roof line. Canopy pruning should be undertaken by an AQF Level 2 (minimum) Arborist in accordance with AS 4373-2007- *Pruning of Amenity Trees*, Section 7.2.4 (Selective Pruning). Pruning should allow for clearance of the external wall and roof-line by 1.0m.

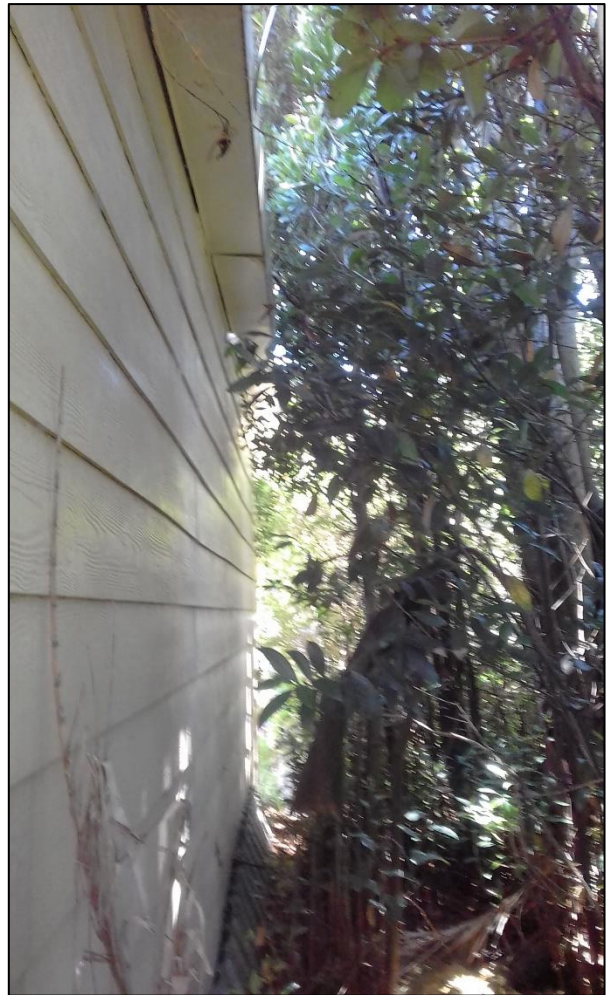
**Photo D:** Tree 6 taken facing north.

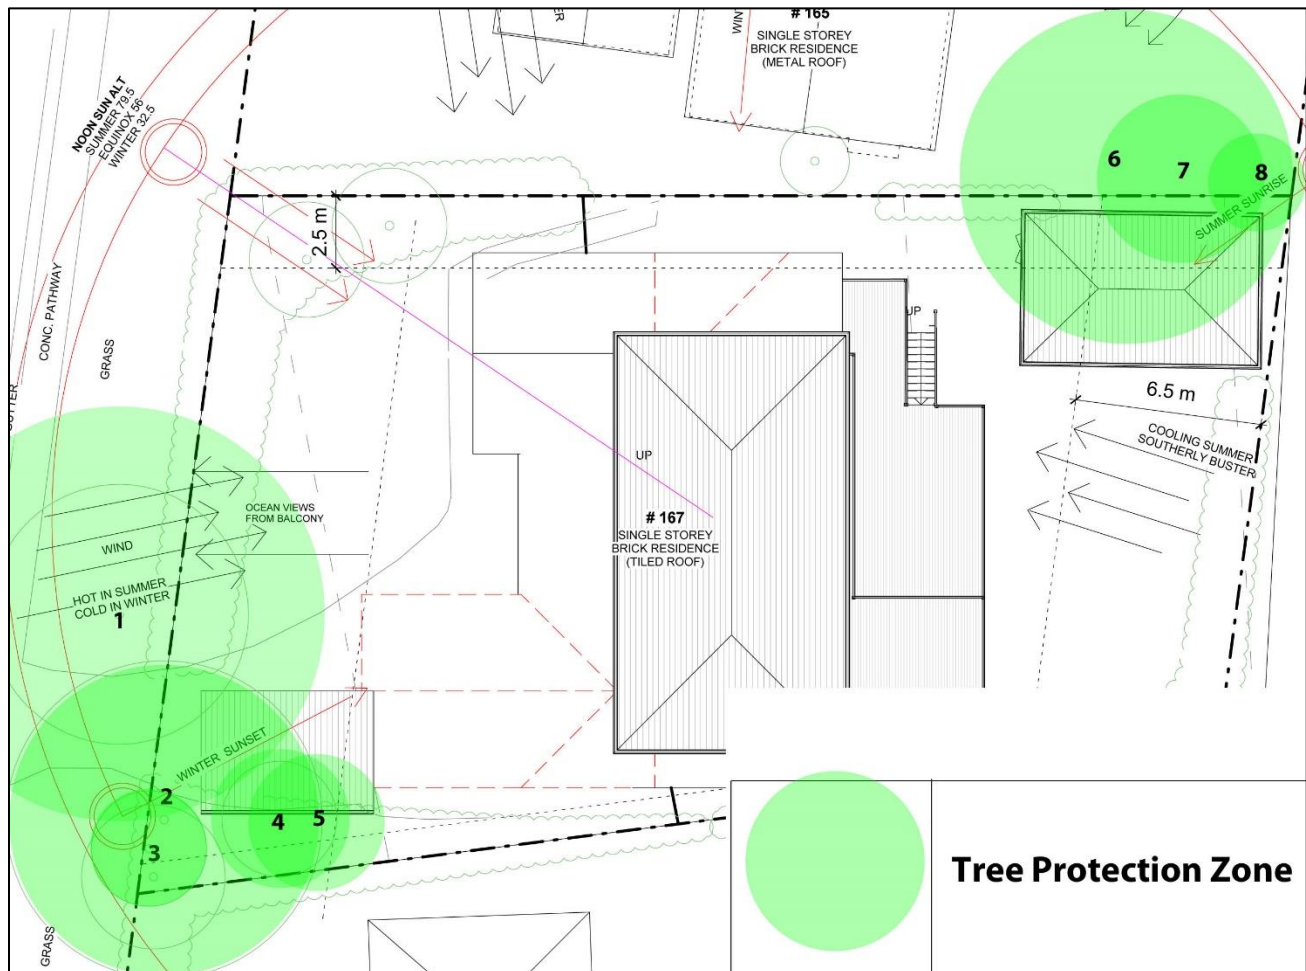
Tree Protection Offsets based on <i>AS4970-2009-Protection of Trees on Development Sites</i>		
Tree Number	Tree Protection Zone radius	Structural Root Zone radius
1	7.3m	2.7m
2	5.6m	2.4m
3	2.0m	1.5m
4	2.5m	1.7m
5	2.4m	1.7m
6	6.2m	2.5m
7	3.0m	1.0m
8	2.0m	1.5m

**Figure B:** Excerpt from the Site Analysis plan showing the TPZ of retained trees.

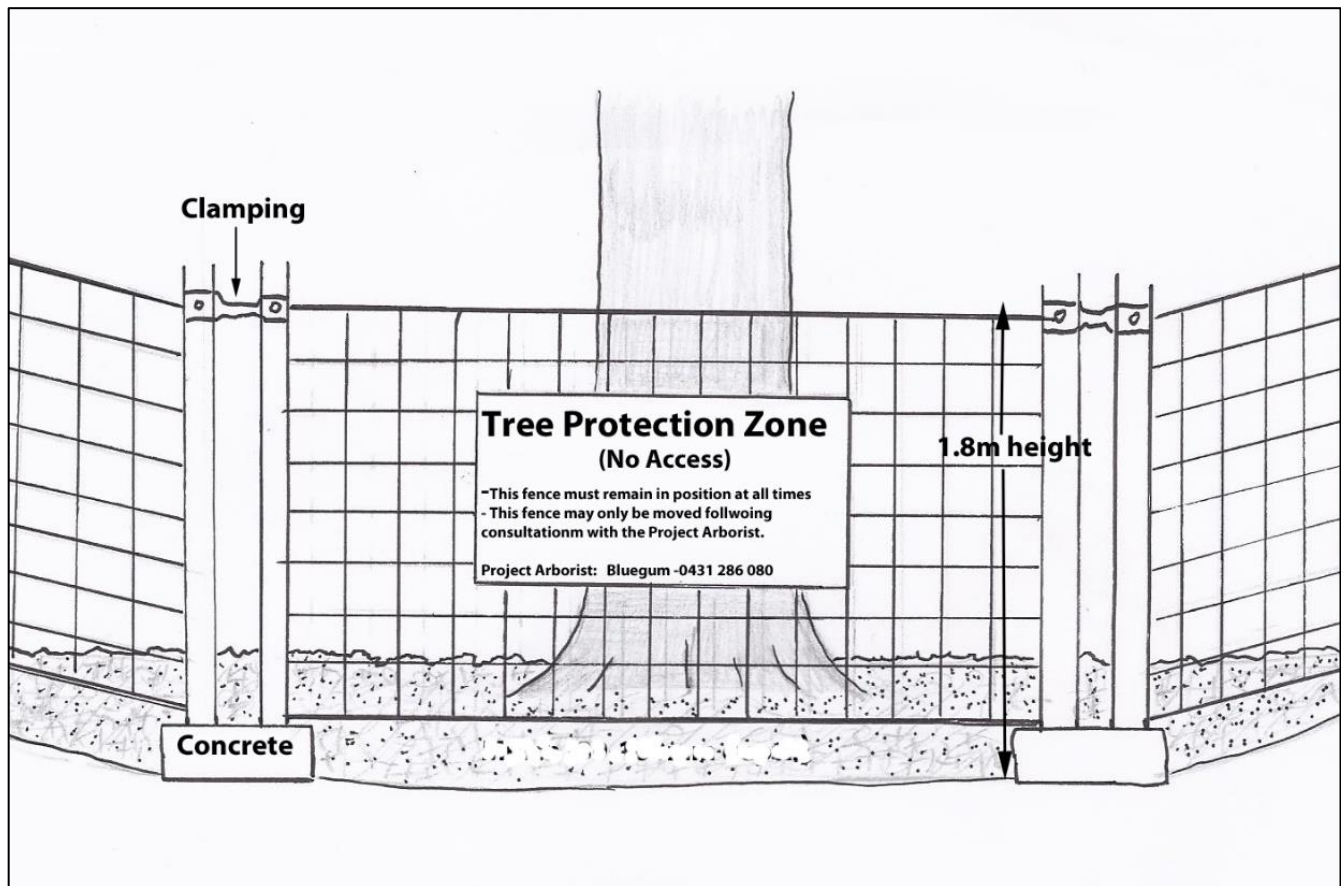
**Figure C:** Example of adequate tree protection fencing.

**Tree Protection Fencing:** Tree protection fencing is recommended for each of the assessed trees. This should be installed prior to commencement of works. The fencing should be in position prior to commencement of construction. Refer to Figure E for the recommended positioning of the Tree Protection Fencing. Detail of adequate tree protection fencing is outlined in Figure D below.

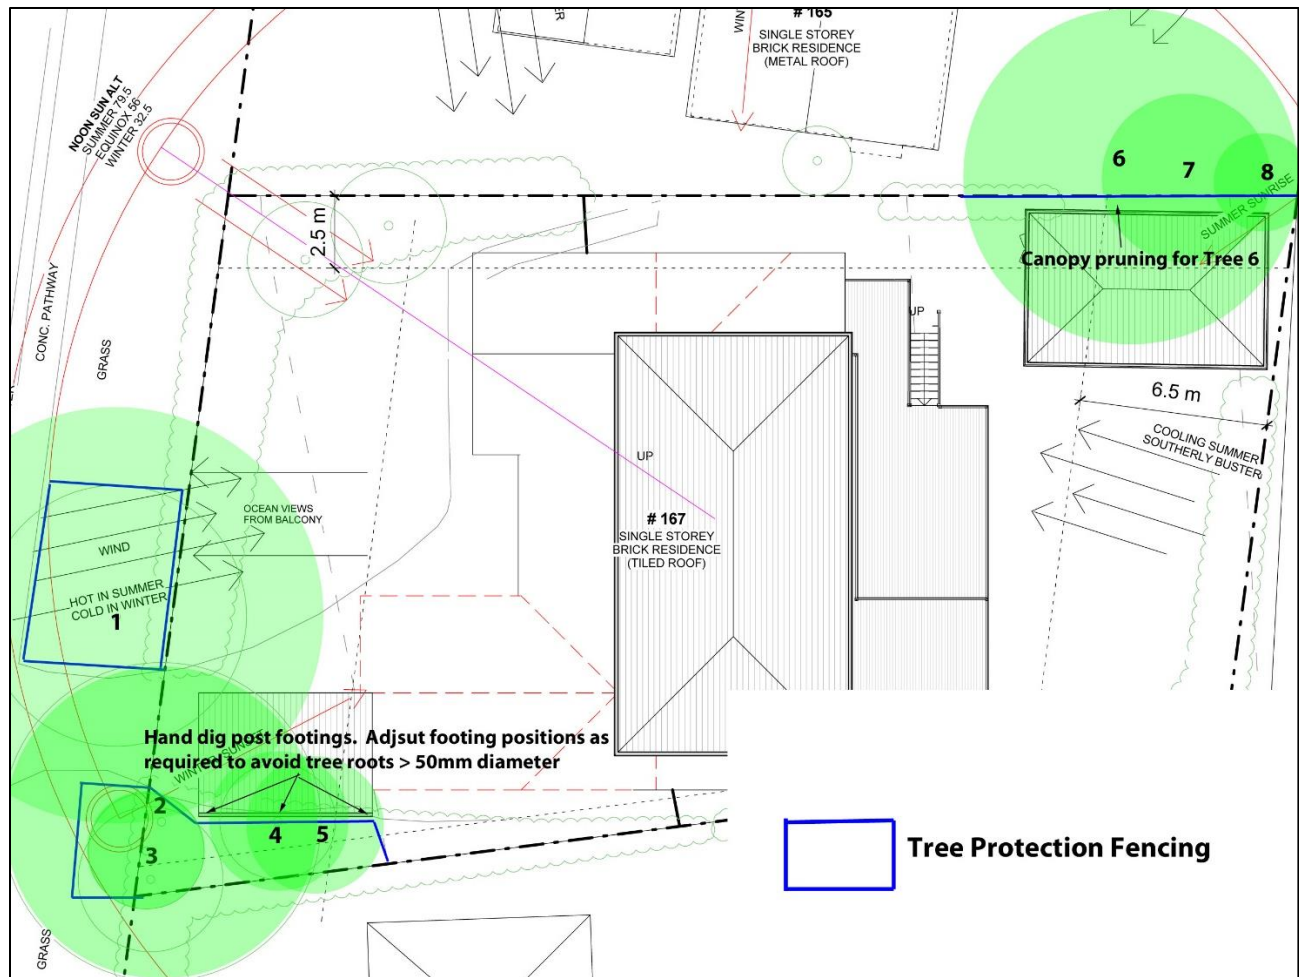
**Figure D:** Recommended position of the tree protection fencing.
