GEOTECHNICAL INVESTIGATION:

Alterations and Additions at 21 Heather Street, Wheeler Heights

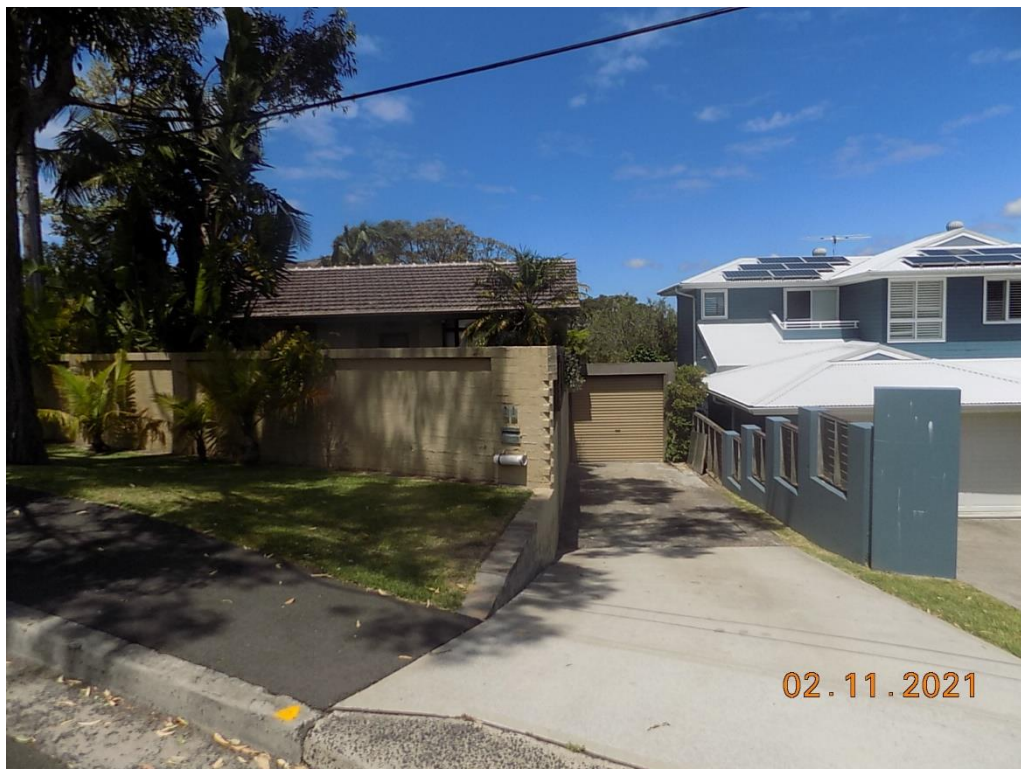
Photo 1

- 2.1** The site was inspected on the 2nd November, 2021, and previously on the 9th February, 2021.
- 2.2** This residential property is on the low side of the street and has a S aspect. It is located on the gentle to moderately graded middle reaches of a hillslope. The slope falls across the property at an average angle of ~5° before falling at moderate angles to the natural bushland reserve below. The slope above the property continues at similar angles.
- 2.3** At the road frontage, a concrete driveway runs down the slope to a parking area on the W side of the house (Photo 1). Between the road frontage and the house is a level lawn area (Photo 2). The cut for the level lawn area is supported by a ~0.8m high stable brick retaining wall that lines the upper boundary and the fill is supported

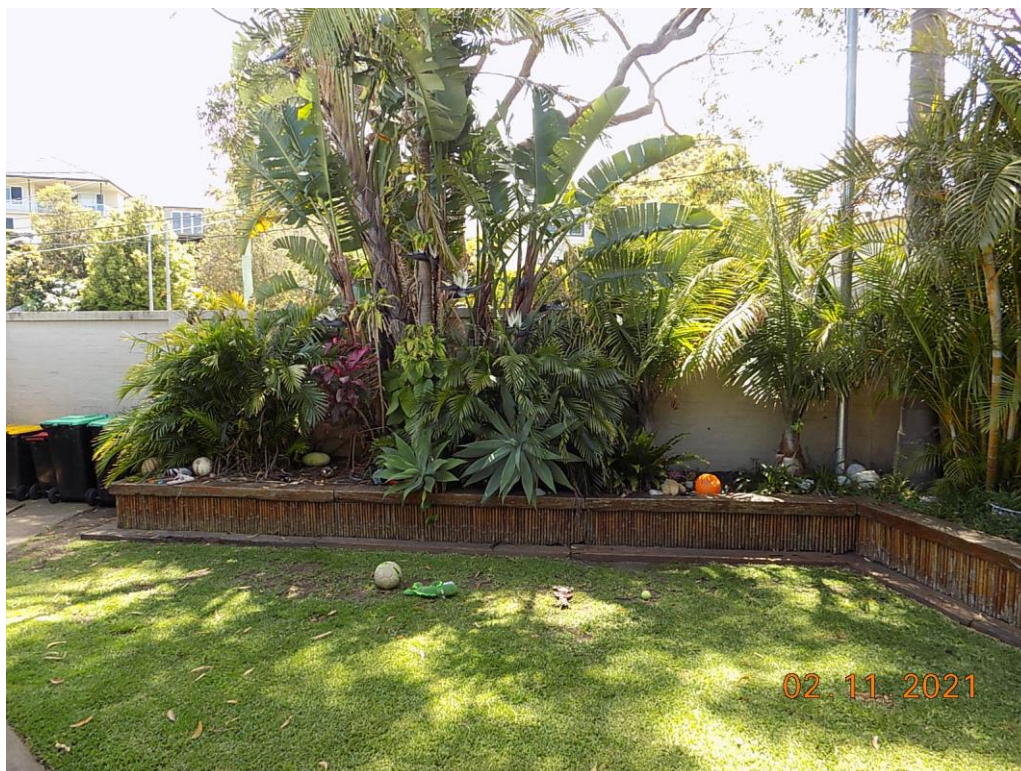
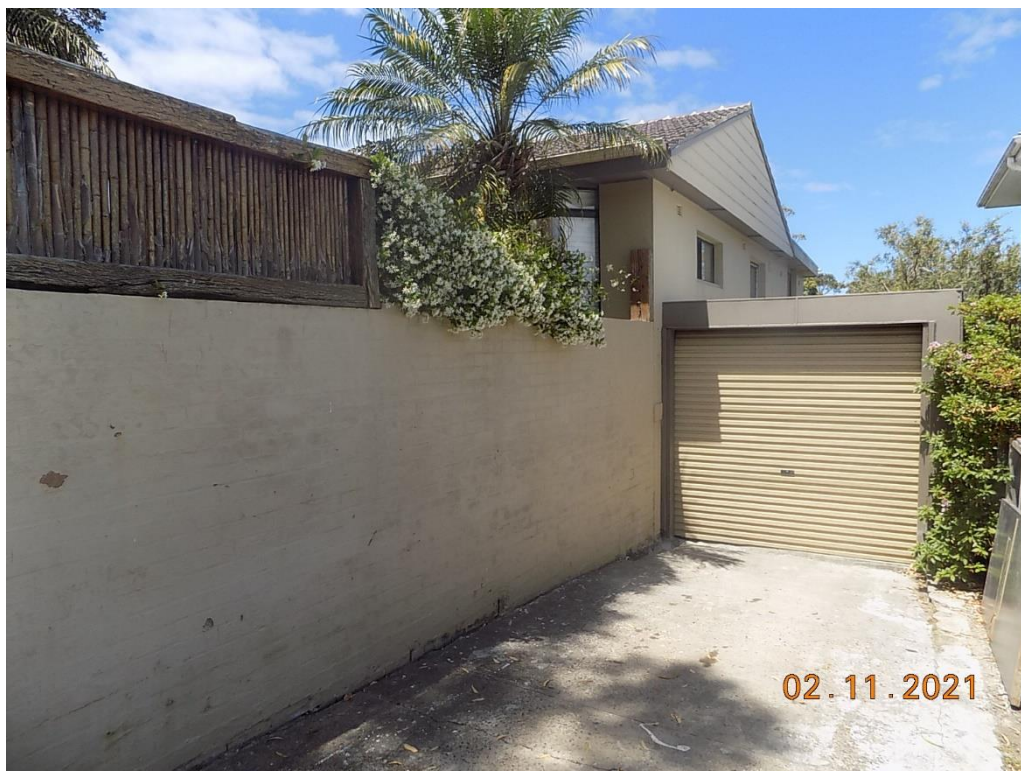
Photo 3

by a stable brick retaining wall reaching up to ~1.2m high on the W side of the lawn (Photos 3 & 4). The two-storey brick house is supported on brick walls and brick piers (Photo 5). The brick walls show no significant signs of movement. Access to the foundation space was not available at the time of this inspection. A gently sloping lawn area that extends off the downhill side of the house is supported by a low stable concrete block and brick retaining wall (Photo 6). Below the slope falls at moderate angles to the lower boundary and natural bushland reserve below (Photo 7).

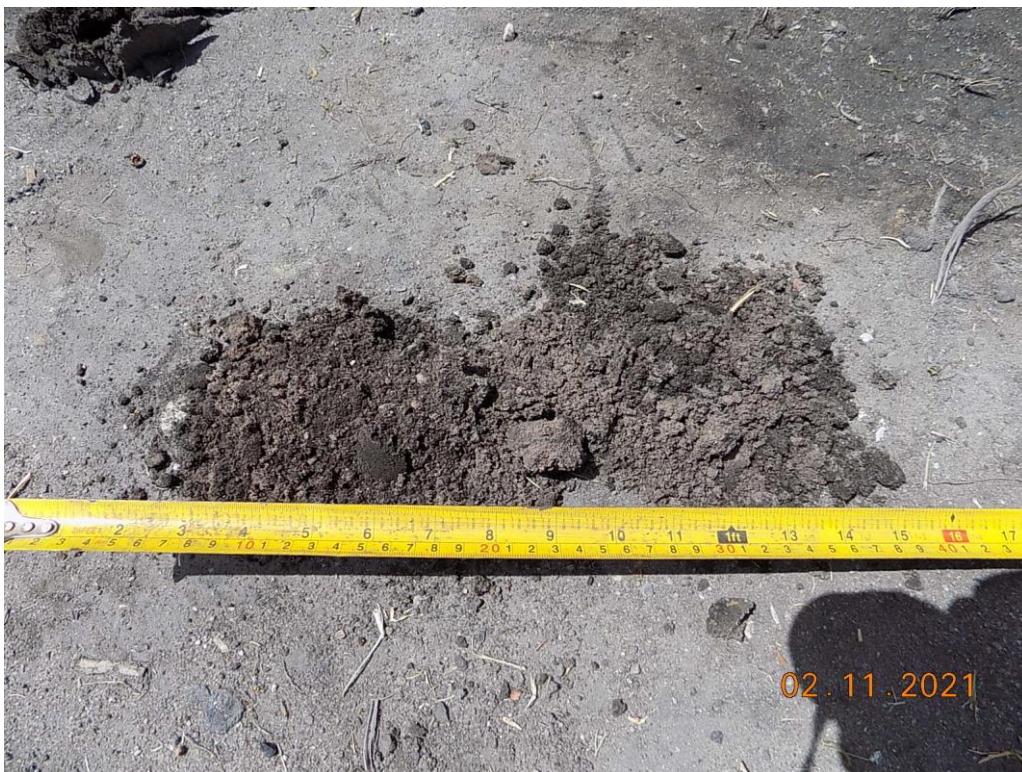
Photo 8 (Left to right)

AUGER HOLE 1 (~RL60.8) – AH1 (Photo 8)

Depth (m)	Material Encountered
0.0 to 0.1	TOPSOIL , dark brown, medium grained, loose to medium dense, dry.
0.1 to 0.3	SAND , dark brown and grey, medium grained, loose to medium dense, damp.

Refusal @ 0.3m on rock. Auger grinding. No water table encountered.
